**GEOTECHNICAL STUDIES OF SELECTED ROCKFALL SITES
IN AND AROUND AIZAWL, MIZORAM**

**A THESIS SUBMITTED IN PARTIAL FULFILMENT OF THE
REQUIREMENTS FOR THE DEGREE OF DOCTOR OF PHILOSOPHY**

**DEPARTMENT OF GEOLOGY
SCHOOL OF EARTH SCIENCE AND NATURAL RESOURCE
MANAGEMENT**

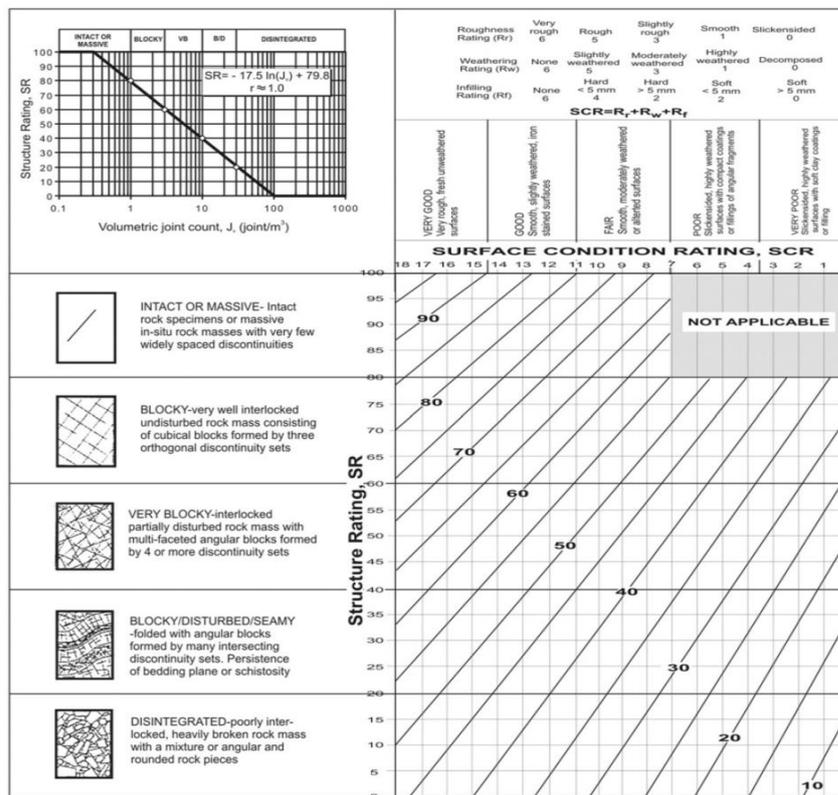
Figure 2. 5 The Quantitative GSI chart proposed by Somnez and Ulusay (Somnez and Ulusay, 1999)

To provide a more quantitative numerical basis for evaluating the GSI, the GSI classification was modified by Somnez & Ulusay, 1999. They introduce two-term such as Structural rating (SR) and Surface condition rating (SCR). This is based on Volumetric joint count and SCR is based on RMR parameters such as surface roughness (R_r), weathering (R_w), and infilling (R_f). The rating of SR and SCR is plotted in the chart provided by Somnez and Ulsay to produce a GSI value. Block size is an extremely important indicator of a rock mass and it must be considered in any proposed rock mass classification (Taheri & Tani, 2007)

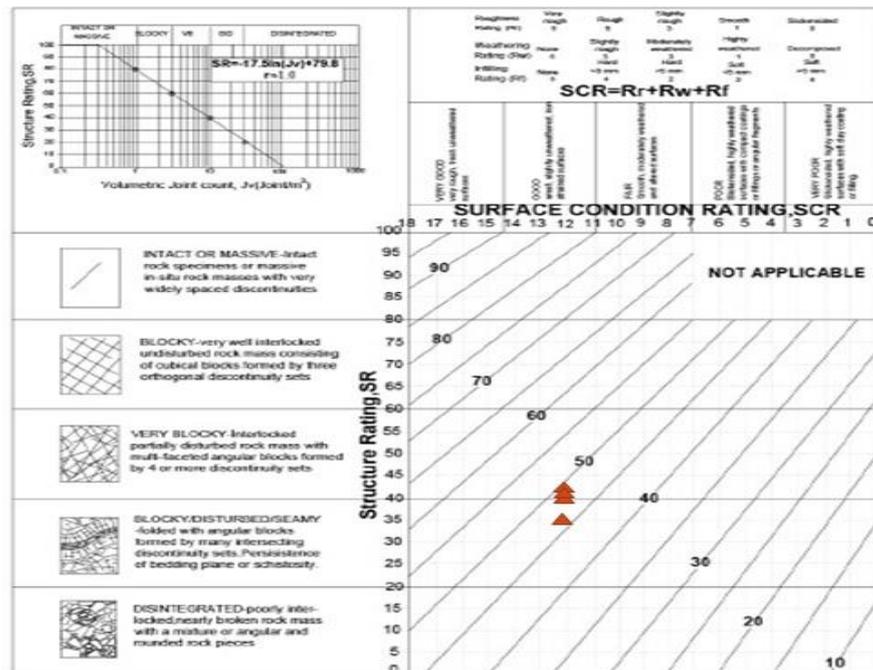
Figure 4. 15: Bawngkawn –Edenthar Plot on GSI Chart

Spot No	Structure Rating (SR) SR=- $17.5j_n(J_v)+79$.8	Surface Condition Rating (SCR)			Total SCR Rating	GSI Value from Graph (SR Vs SCR)
		Roughness Rating (Rr)	Weathering Rating (Rw)	Infilling Rating (Rf)		
Spot 1	$J_v=7$	Rough	Highly	None	12	49
Rating	42.7	5	1	6		
Spot 2	$J_v=9$	Rough	Highly	None	12	50
Rating	41	5	1	6		
Spot 3	$J_v=13$	Rough	Highly	None	12	45
Rating	35	5	1	6

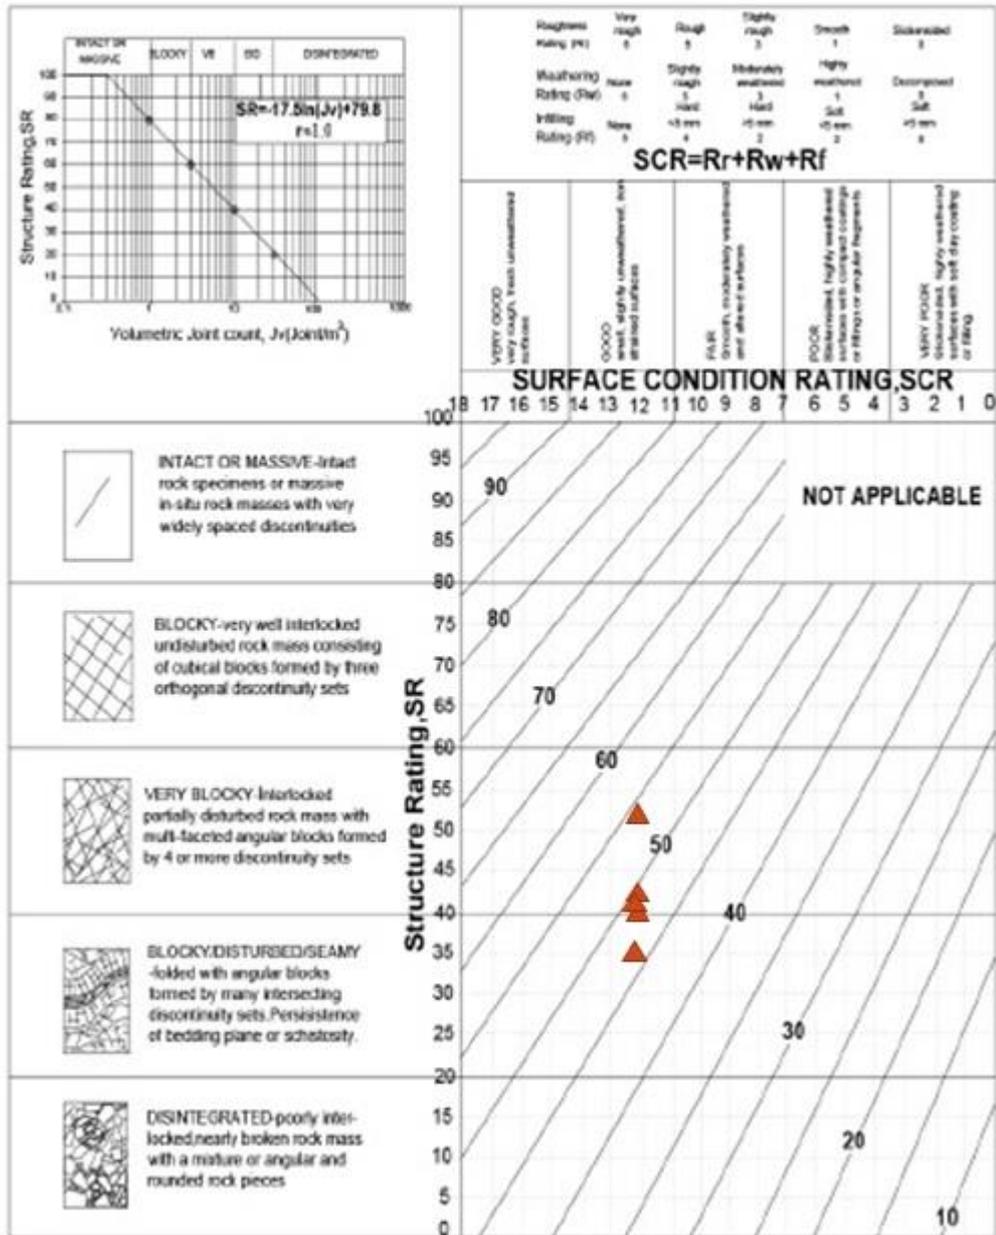
Figure 4. 16: Ngaizel Plot on GSI Chart

Spot No	Structure Rating (SR) SR=- $17.5j_n(J_v)+79.8$	Surface Condition Rating (SCR)			Total SCR Rating	GSI Value from Graph (SR Vs SCR)
		Roughness Rating (Rr)	Weathering Rating (Rw)	Infilling Rating (Rf)		
Spot 1	$J_v=7$	Rough	Highly	None	12	49
Rating	42.7	5	1	6		
Spot 2	$J_v=10$	Rough	Highly	None	12	50
Rating	40	5	1	6		
Spot 3	$J_v=8$	Rough	Highly	None	12	51
Rating	42	5	1	6		
Spot4	$J_v=5$	Rough	Highly	None	12	54
Rating	51	5	1	6		
Spot 5	$J_v=13$	Rough	Highly	None	12	46
Rating	35	5	1	6

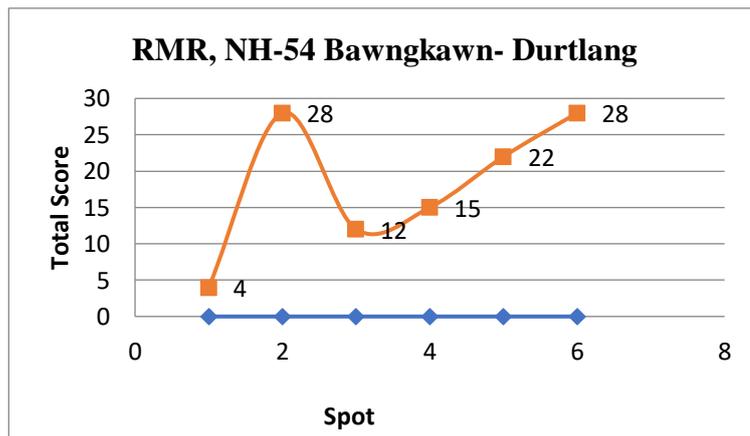
Figure 4. 18: Line chart representing RMR Bawngkawn-Durtlang

Cumulative RMR Score of NH-54 Bawngkawn- Durtlang						
Site	Spot 1	Spot 2	Spot 3	Spot 4	Spot 5	Spot 6
Total Score	4	28	12	15	22	28

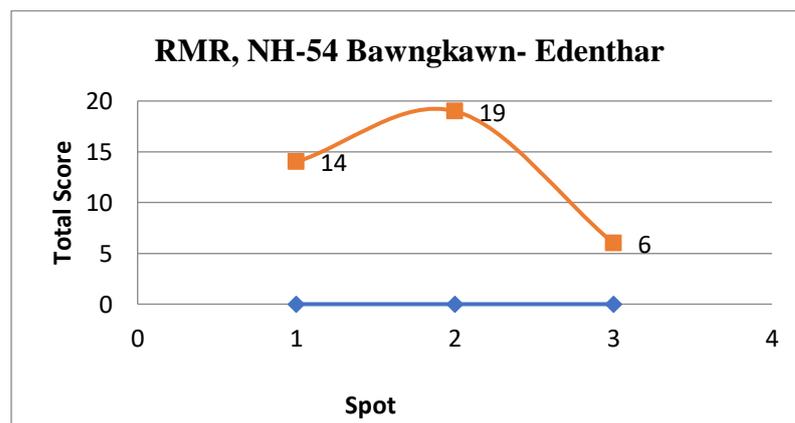
Figure 4. 20: Line chart representing RMR Bawngkawn-Edenthlar

Cumulative RMR Score of NH-54 Bawngkawn- Edenthlar			
Site	Spot 1	Spot 2	Spot 3
Total Score	14	19	6

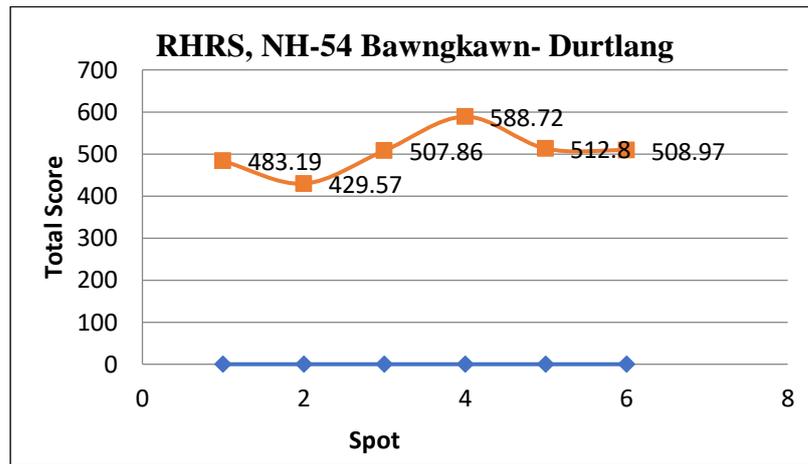
Figure 4. 21: Line chart representing RHRS Bawngkawn-Durtlang

Cumulative RHRS Score of NH-54 Bawngkawn- Durtlang						
Site	Spot 1	Spot 2	Spot 3	Spot 4	Spot 5	Spot 6
Total Score	483.19	429.57	507.86	588.72	512.80	508.97

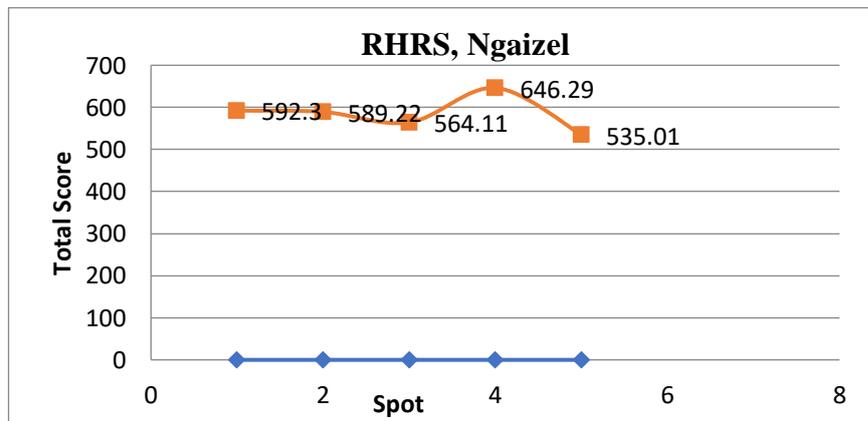
Figure 4. 22: Line chart representing RHRS Ngaizel

Cumulative RHRS Score of Ngaizel					
Site	Spot 1	Spot 2	Spot 3	Spot 4	Spot 5
Total Score	592.30	589.22	564.11	646.29	535.01

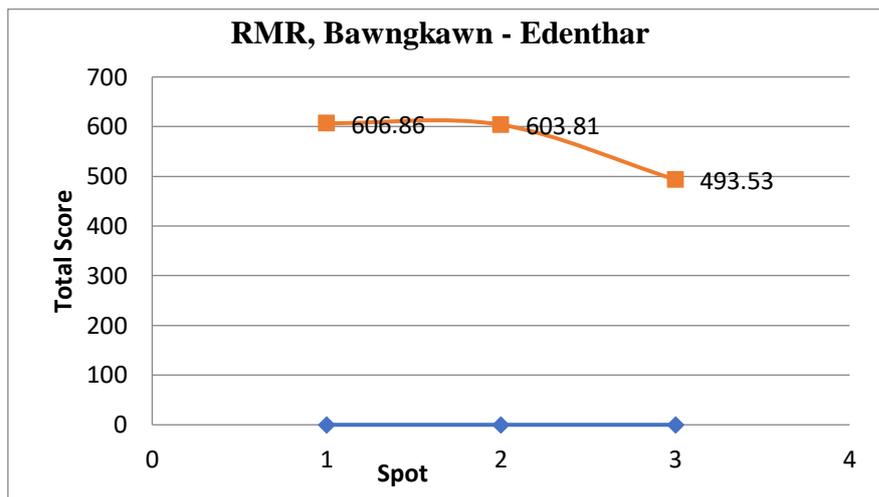
Figure 4. 23: Line chart representing RHRS Bawngkawn-Edenthar

Cumulative RHRS Score Bawngkawn-Edenthar			
Site	Spot 1	Spot 2	Spot 3
Total Score	606.86	603.81	493.53

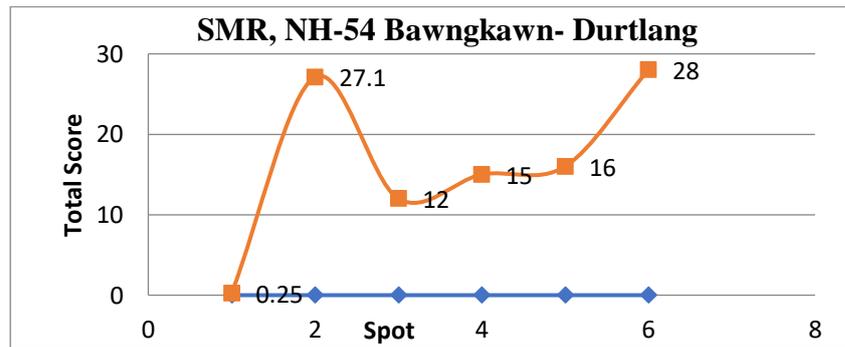
Figure 4. 24: Line chart representing SMR Bawngkawn-Durtlang

Cumulative SMR Result For NH-54: Bawngkawn-Durtlang						
<i>Site</i>	<i>Spot 1</i>	<i>Spot 2</i>	<i>Spot 3</i>	<i>Spot 4</i>	<i>Spot 5</i>	<i>Spot 6</i>
Rating	0.25	27.1	12	15	16	28

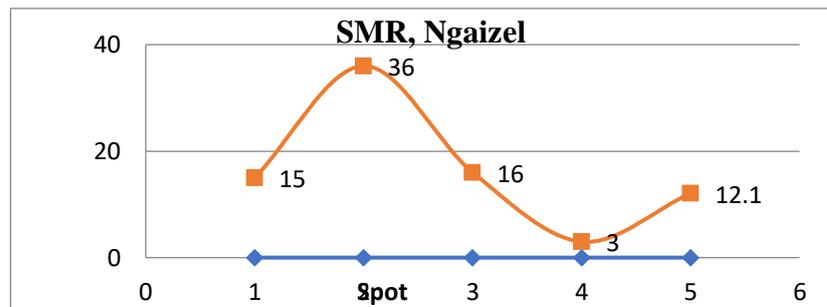
Figure 4. 25: Line chart representing SMR Ngaizel

Cumulative SMR Result For Ngaizel					
Site	Spot 1	Spot 2	Spot 3	Spot 4	Spot 5
Rating	15	36	16	3	12.1

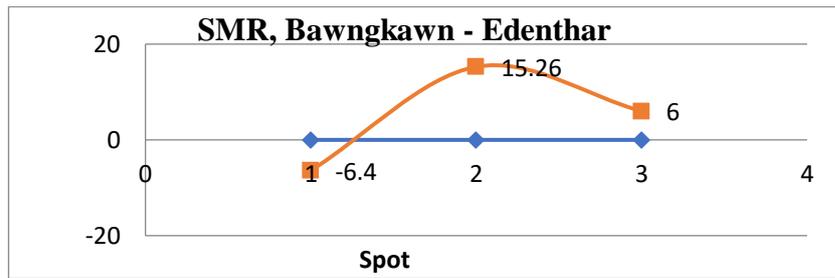
Figure 4. 26: Line chart representing SMR Bawngkawn Edenthar

Cumulative SMR Result For Bawngkawn – Edentharr			
Site	Spot 1	Spot 2	Spot 3
Rating	-6.4	15.25	6

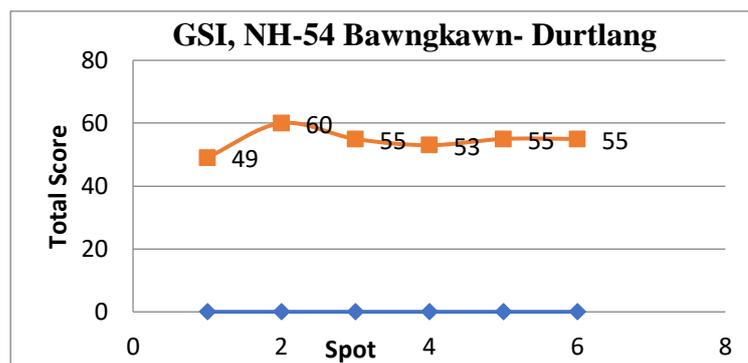
Figure 4. 27: Line chart representing GSI Bawngkawn-Durtlang

Cumulative result of GSI: NH-54 Bawngkawn- Durtlang						
Site	Spot 1	Spot 2	Spot 3	Spot 4	Spot 5	Spot 6
GSI	49	60	54	53	55	55

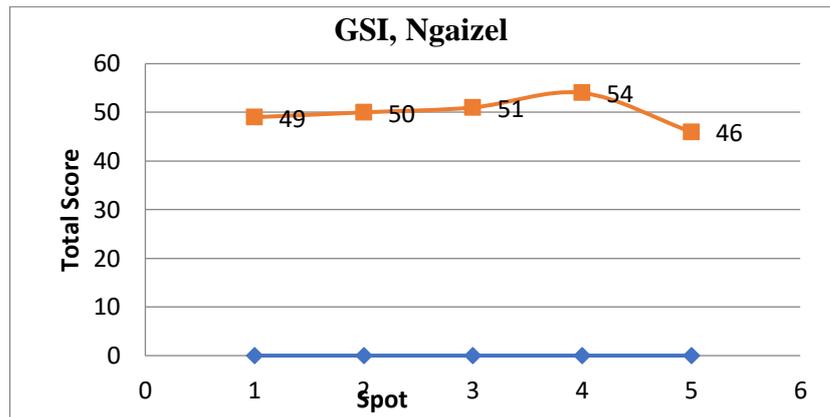
Figure 4. 28: Line chart representing GSI Ngaizel

Cumulative result of GSI: Ngaizel					
Site	Spot 1	Spot 2	Spot 3	Spot 4	Spot 5
Rating	49	50	51	54	46

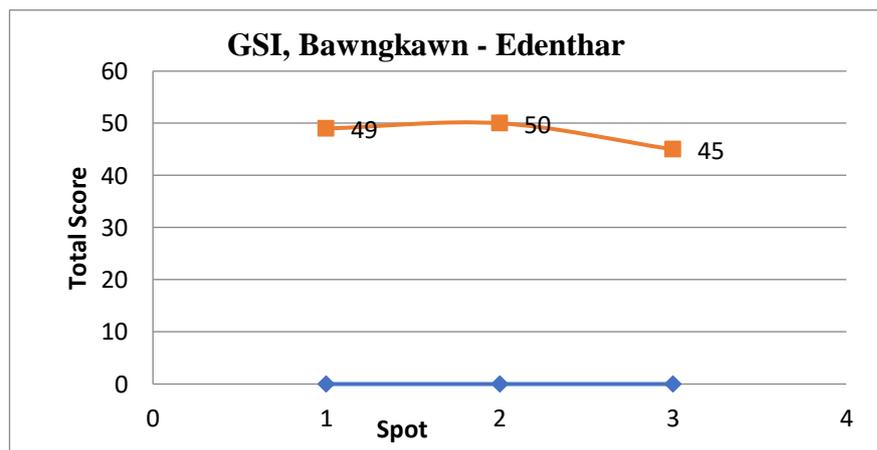
Figure 4. 29: Line chart representing GSI Bawngkawn – Edenthlar

Cumulative result of GSI: Bawngkawn-Edenthlar			
<i>Site</i>	<i>Spot 1</i>	<i>Spot 2</i>	<i>Spot 3</i>
Rating	49	50	45
