**EVALUATION OF PREMATURE FAILURE OF FLEXIBLE PAVEMENT
IN HILLY AREA OF MIZORAM**

**A THESIS SUBMITTED IN PARTIAL FULFILMENT OF THE
REQUIREMENTS FOR THE DEGREE OF DOCTOR OF PHILOSOPHY**

**DEPARTMENT OF CIVIL ENGINEERING
SCHOOL OF ENGINEERING AND TECHNOLOGY**

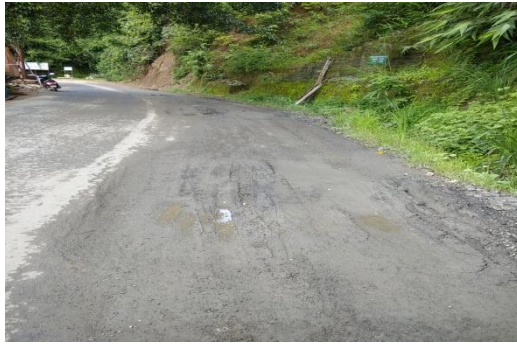
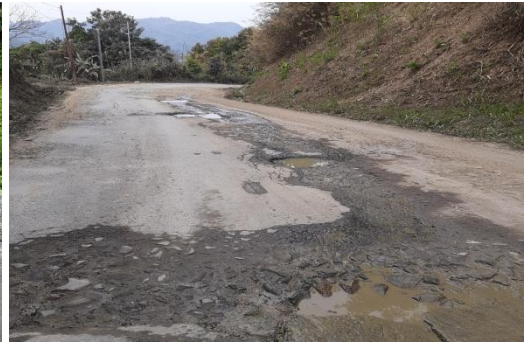
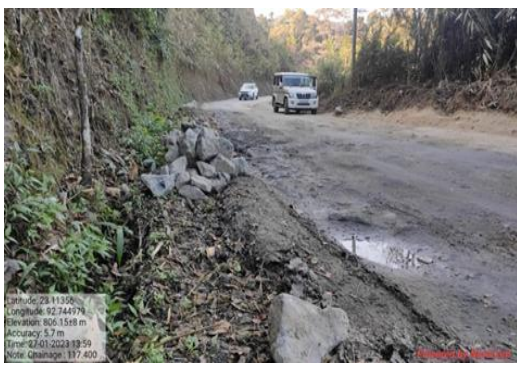
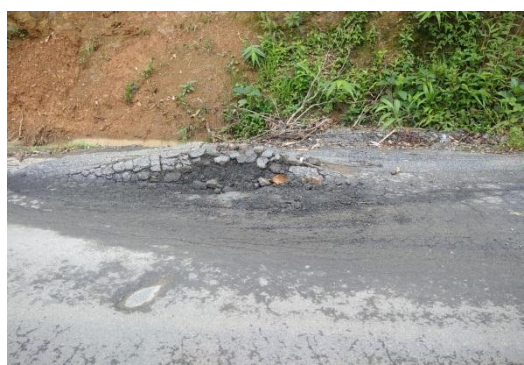
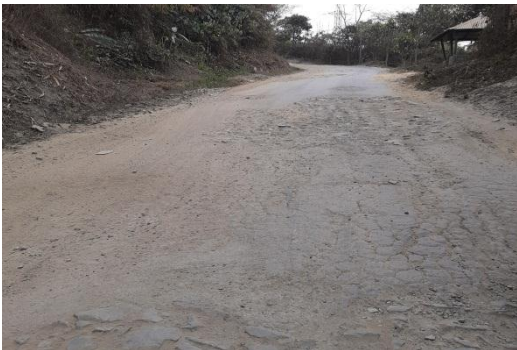
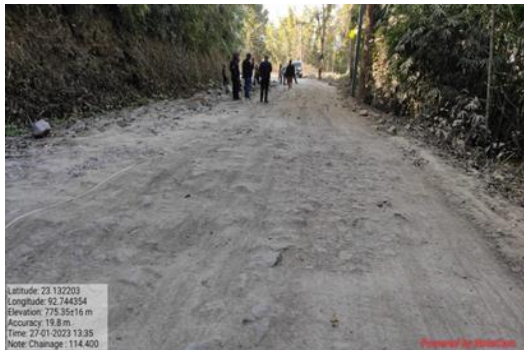
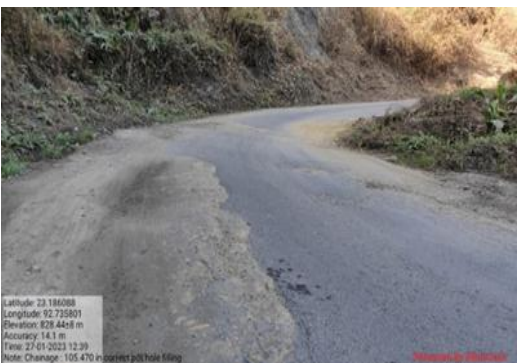
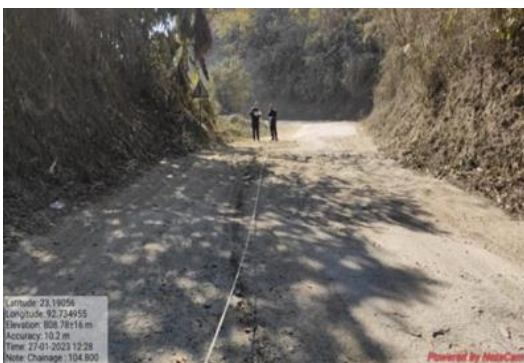
Fig.1.7 Some of the pavement condition in the study area (a), (b),(c),(d), (e),(f),(g),(h),(i)

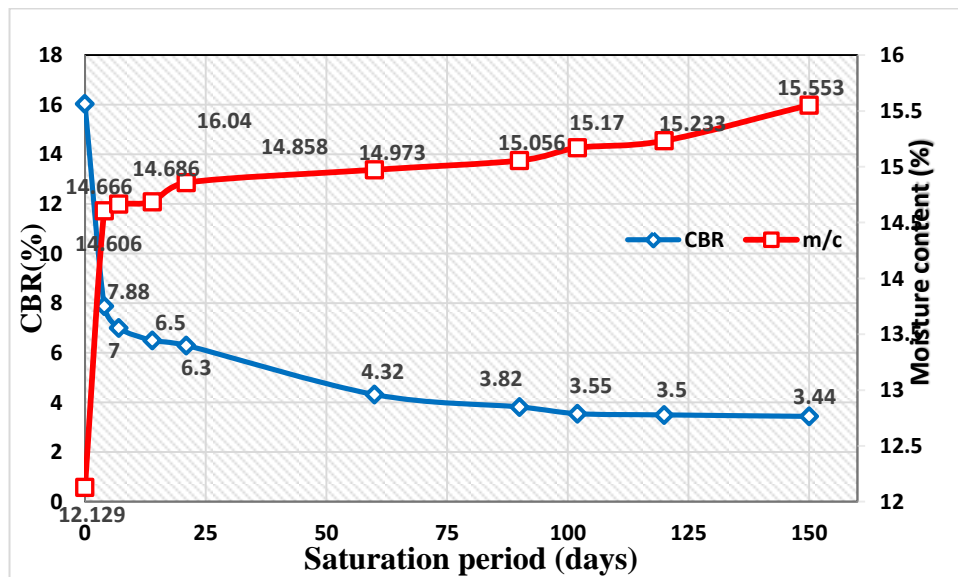
It is observed that the CBR value of the soil sample prepared at a particular density decreases rapidly after 4 days of soaking. The rate of decrease of CBR value beyond 4 days soaking is minimal. It is also observed that there are not much significant variations in CBR values from 90th day of soaking. The soil strength reduces as the water saturation period of soil increases as shown in the figure 3.3. Subsurface moisture reaches lower layers of pavement from different sources like pavement surface, seepage from shoulders and seepage from adjoining hills and capillary rise of moisture from the ground. If water is able to enter the pavement, there must be a way for it to depart. Soil resistance to compression may drop substantially if its moisture content increases. Increased moisture content reduces the load-carrying capacity of the road and causes premature pavement failure, resulting in shorter pavement life.

Fig.3.3 Effect of moisture saturation period in soil strength

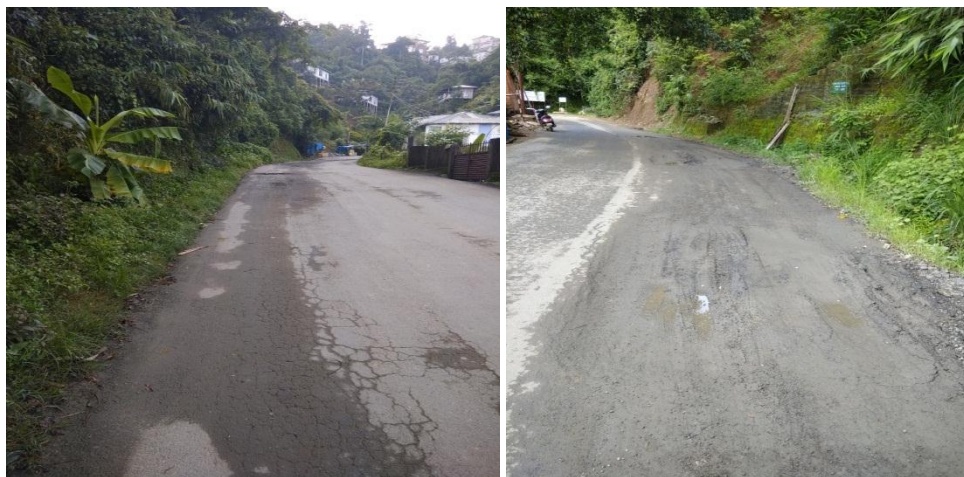
Fig.3.4 Raised shoulder and tall grass blocking surface drainage

The alignment passing via a Box cut (through cut) normally creates drainage issues mainly due to the water sources coming from both sides of the hill slope.

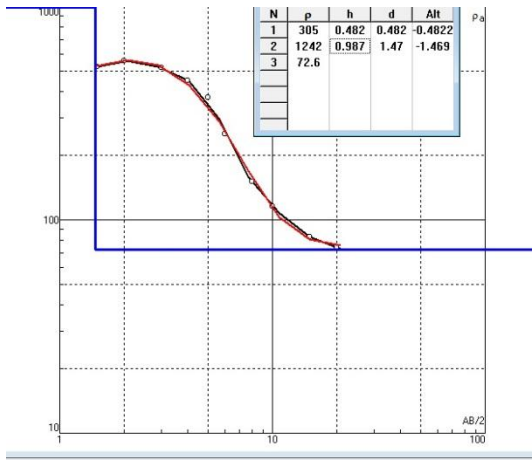
Fig. 4.1 VES Station 01-Mel 5 (7 km)

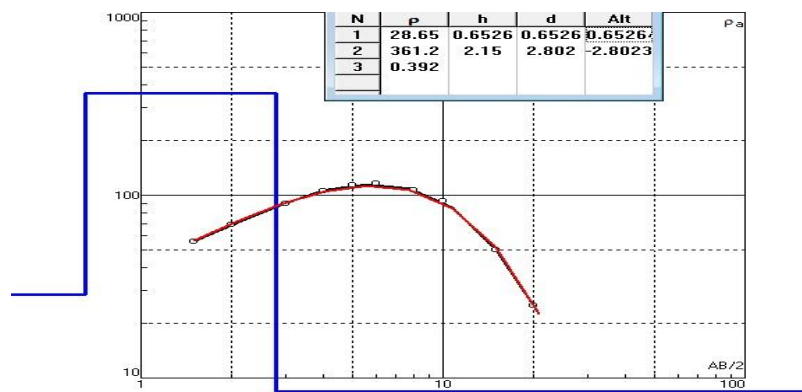
Fig. 4.5 VES Station 05- MLT (19 km)

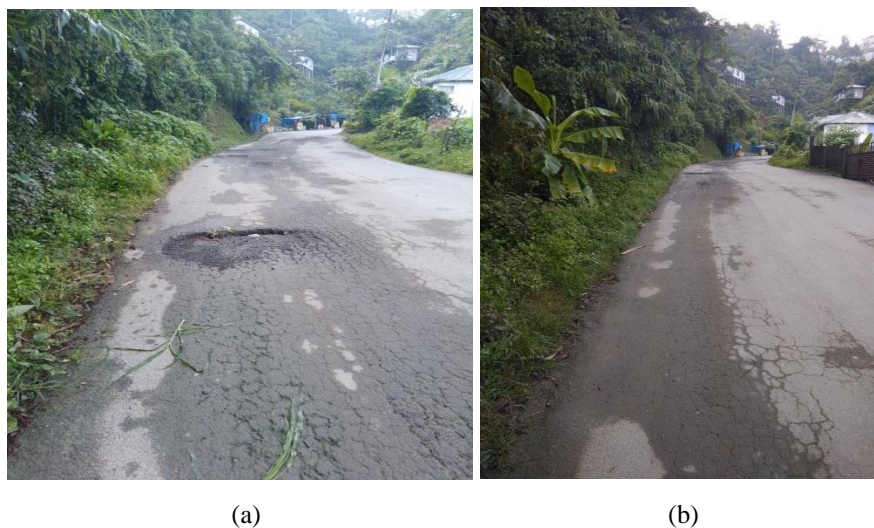
Pavement cross-sectional element includes carriage width, shoulder, side drain, camber, and formation cutting. The road with a high/elevated shoulder obstructs the surface water to drain off from the pavement and force water to flow on the pavement as shown in figure 4.6 (a) & (b). Delay/standing water seeps to lower layers and accelerates the process of stripping caused by tall grass at the shoulder and elevated shoulder.

Fig. 4.6 (a) & (b) Elevated shoulder & tall grass obstructing surface drainage

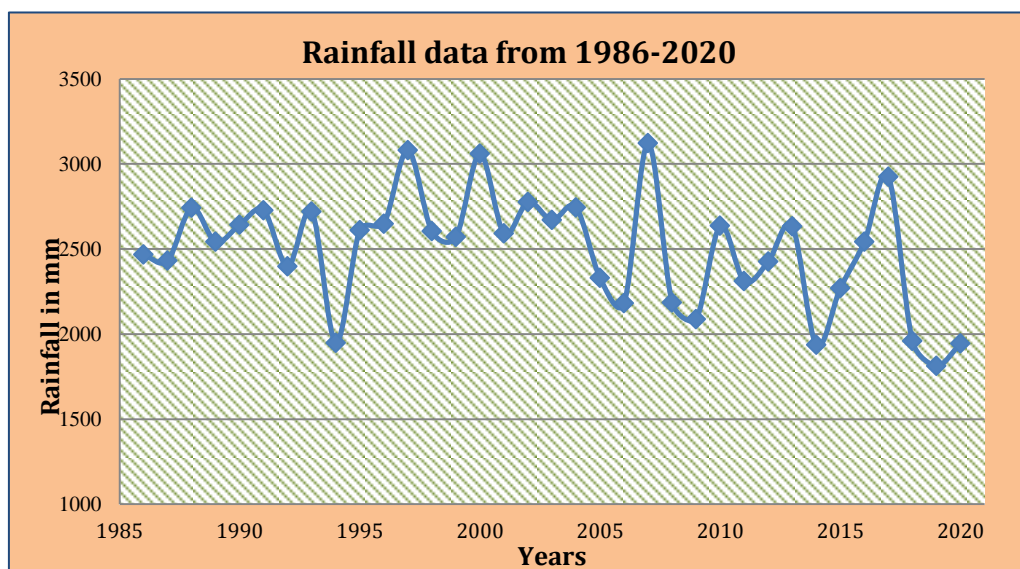
Fig. 4.7 Rainfall Data from 1986-2020

The 35-year average rainfall of Mizoram is 2379 mm as, shown in figure 4.7, which significantly impacts pavement softening by entering pavement structure through the shoulder, seepage and capillary rise. The rainy season (monsoon) lasts

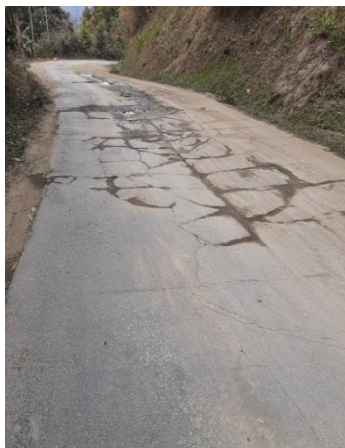
The presence of groundwater will result in lowering of shear strength of rocks, increased pore pressure and deterioration of foundation material. The water seepage is observed even during the dry season (November to April) at Pukpui stretches (between 150 km and 154 km) and Hualngo stretch (12 km), as shown in figure 4.9 and 4.10.

Fig. 4.9 High water table

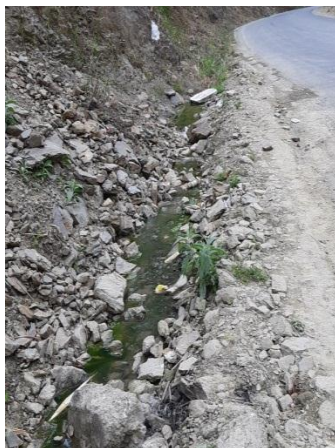
Fig. 4.10 Emanation of groundwater from the hill slope

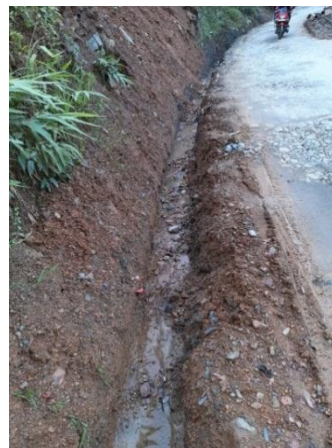
When moisture is trapped in the subgrade, pavement behaves like a spring, resulting in cracks, settlements, and ruts. Water trapped in the pavement layers reduces the structures load-bearing capacity.

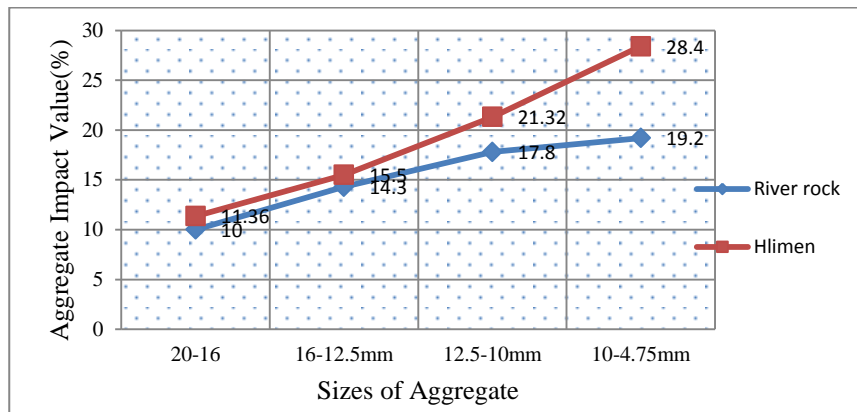
AIV is the test that measures toughness. This test simulate the wheel load pounding/dropping action occurs in the undulation or potholes. As shown in figures 5.1, larger sizes of aggregates have given better result over smaller size of aggregate. It means that a larger size of aggregate has a higher capability to withstand repetitive impact load as the larger aggregates are capable of absorbing more impact load due to more thickness. At pavement undulations, impact loads frequently lead to the degradation of soft rock.

Fig. 5.1 AIV of River rock and Hlimen with different size of rock

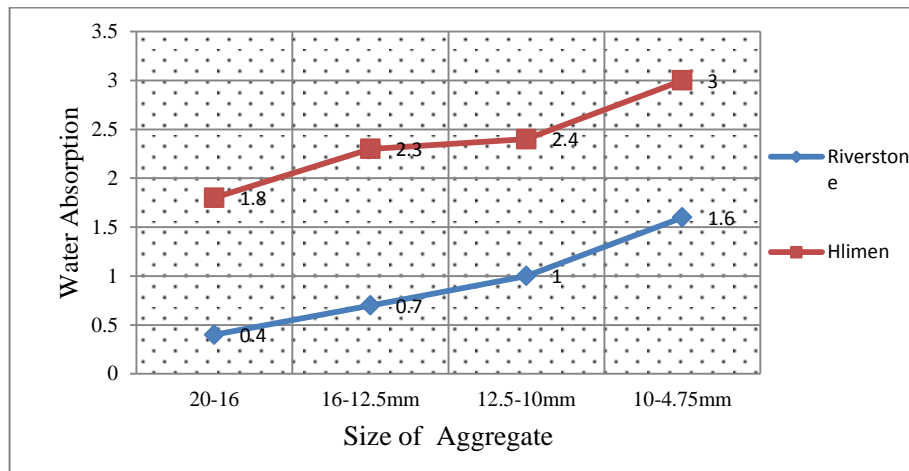
Water absorption values (WAV) measures the ratio between difference of dry weight aggregate and saturated surface dry weight of aggregate to dry weight of aggregate. Larger sizes of aggregates have given lower absorption values compared to smaller sizes as shown in figures 5.2. This may be due to the depth of water penetration to the rock remain the same regardless of the size within a specific period of time. The quantity of water absorbed by smaller and larger size of aggregates remains the same.

Fig. 5.2 WAV of River stone and Hlimen with different size of rock

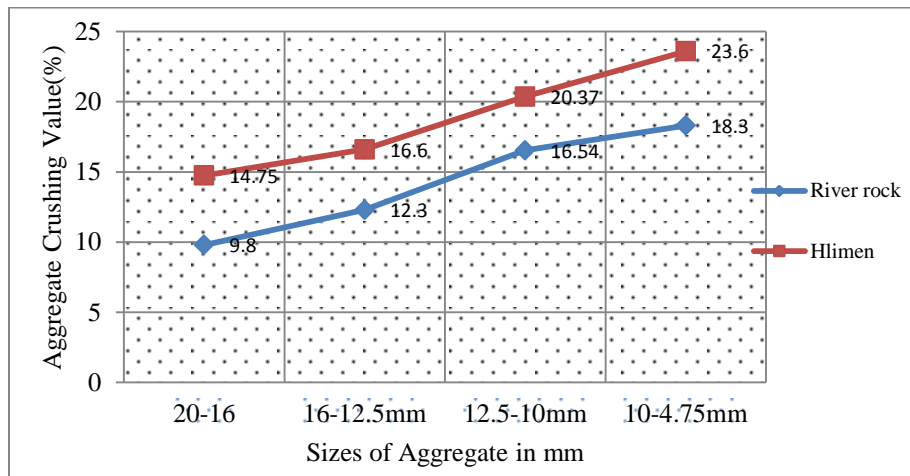
Aggregate Crushing Value is used to measure the strength of aggregate. As the size of aggregate gets larger, the strength of aggregate increases. The larger size has the ability to resist more loads (traffic load) due to individual thickness of aggregate that imparts more strength as shown in figure 5.4.

Fig. 5.4 ACV of Riverstone and Hlimen with different size of rock

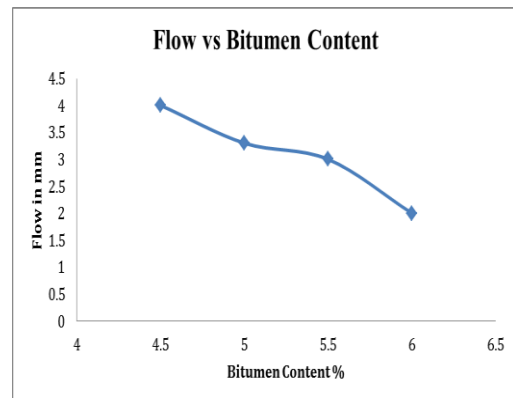
Fig 6.3 Flow versus bitumen content

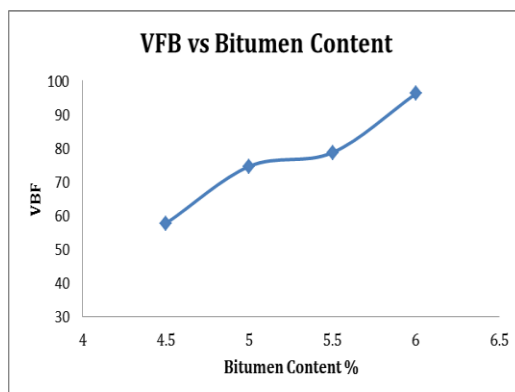
Fig. 6.4 Void filled bitumen vs bitumen content

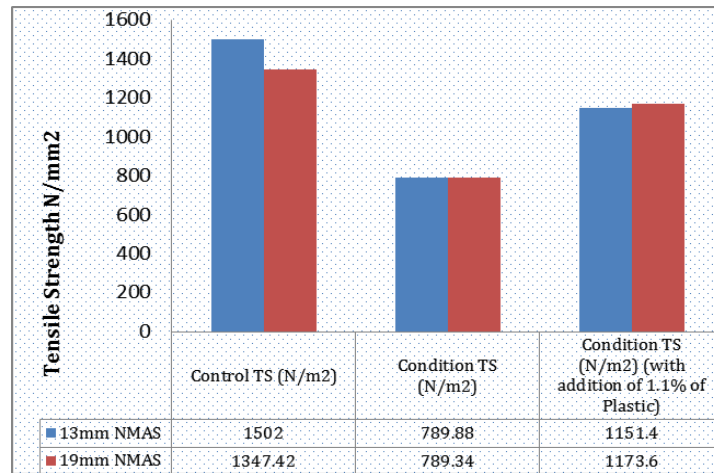
higher retained tensile strength over 13 mm gradation, mainly due to the less degradation that develops in a bituminous structure.

Fig 6.8 Tensile Strength of different gradation of BC

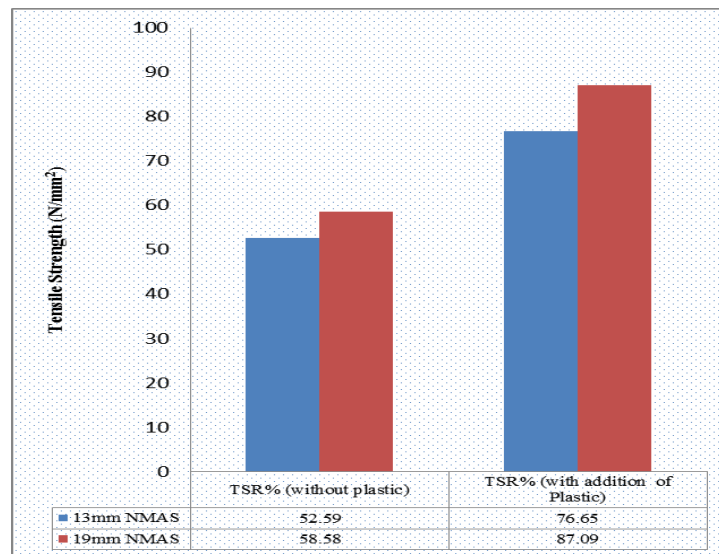
Fig 6.9 Retained tensile Strength of BC

The reduction of tensile strength after asphalt concrete sample undergoes the freeze and thaw cycle (weathering action) both in 19 mm and 13 mm gradation is mainly due to high water absorption of aggregate as well as the presence of small sequence of rock layer.
