**GEOTECHNICAL INVESTIGATIONS AND MONITORING OF  
ZUANGTUI AREA, AIZAWL, MIZORAM**

**A THESIS SUBMITTED IN PARTIAL FULFILLMENT OF THE  
REQUIREMENTS FOR THE DEGREE OF DOCTOR OF  
PHILOSOPHY**

**DEPARTMENT OF GEOLOGY  
SCHOOL OF EARTH SCIENCES AND NATURAL  
RESOURCES MANAGEMENT**

**APRIL, 2024**

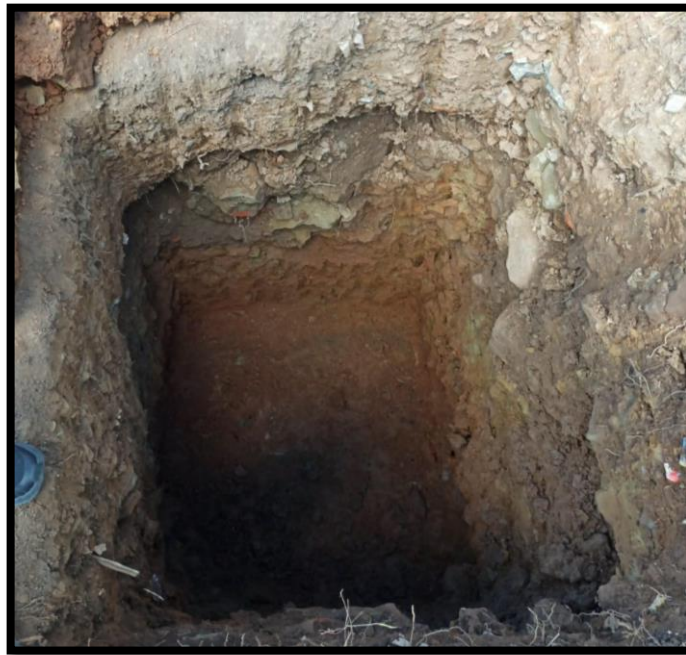
Figure 4.2. Soil sample pit

Undisturbed soil samples were collected at a depth of 5ft (Figure 4.2) using a core sampler and placed in a sample bag so that there was no loss in the moisture content.

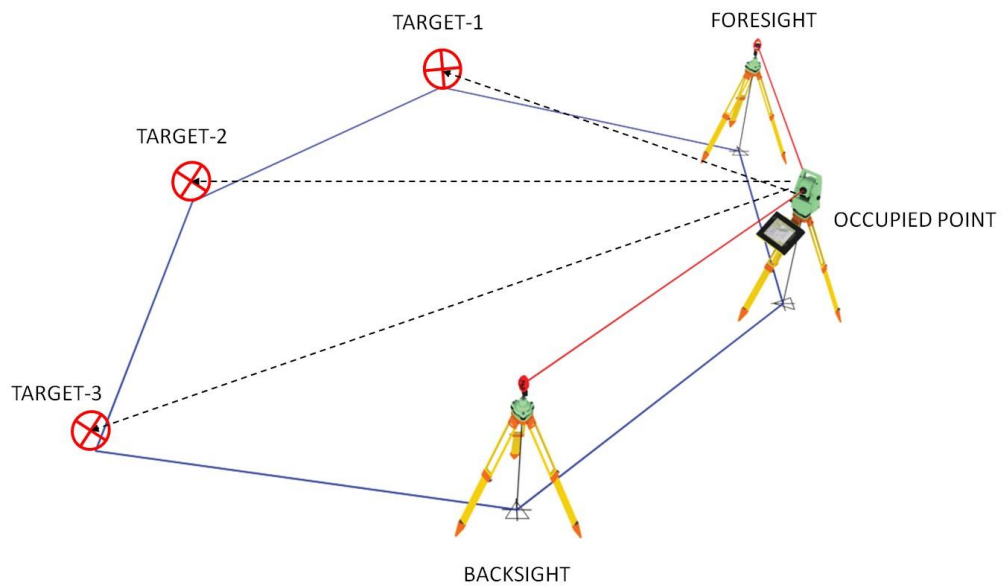
Figure 4.11: Total Station Monitoring station and reading points

- This monitoring was done monthly in two locations of the study area(Figure 4.12)
- The data collected was plotted in Microsoft Excel in order to show the rate of ground movement

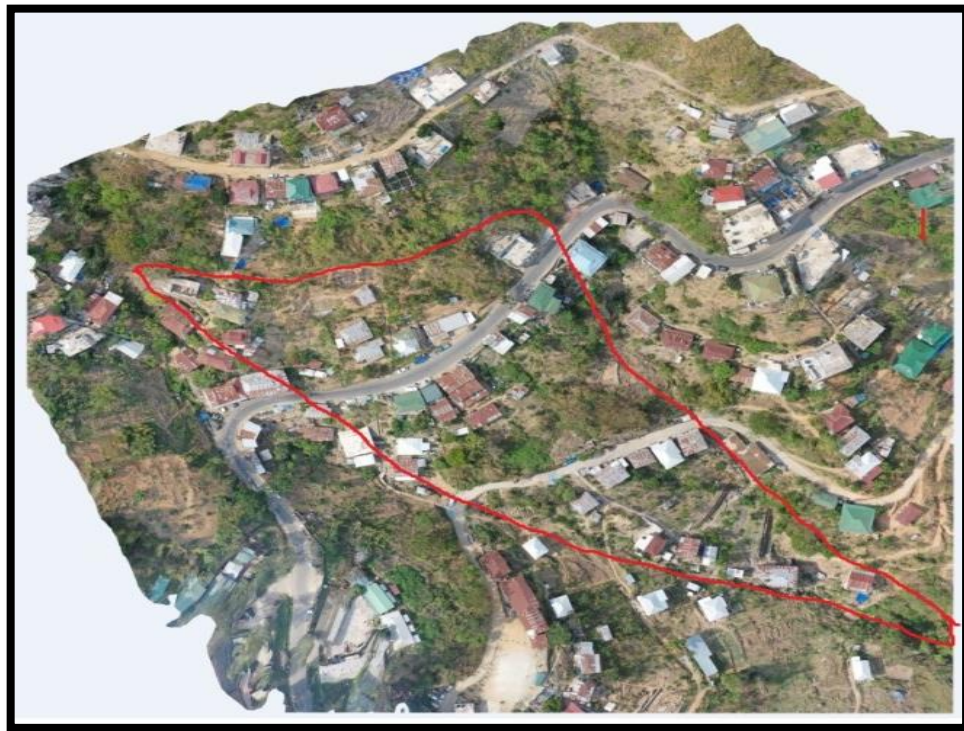
Figure 5.1 Subsidence area of location-1(zuangtui-Thuampui local council border)

A ground displacement of 1ft was observed in September 2022 (Figure 5.4). The lower portion of the public steps was detached and the foundations of Assam-type pillars were displaced (Figure 5.5). Two houses were vacant and demolished due to the collapse of the retaining wall (Figure 5.6). The area is covered by loose sediments. The average slope angle is  $37^\circ$  with a slope aspect of  $N183^\circ$ . An outcrop was observed on the southern portion of the study area. A soft friable Silty shale bed with a dip amount of  $26^\circ$  dipping towards  $N76^\circ$  was observed in the study area.

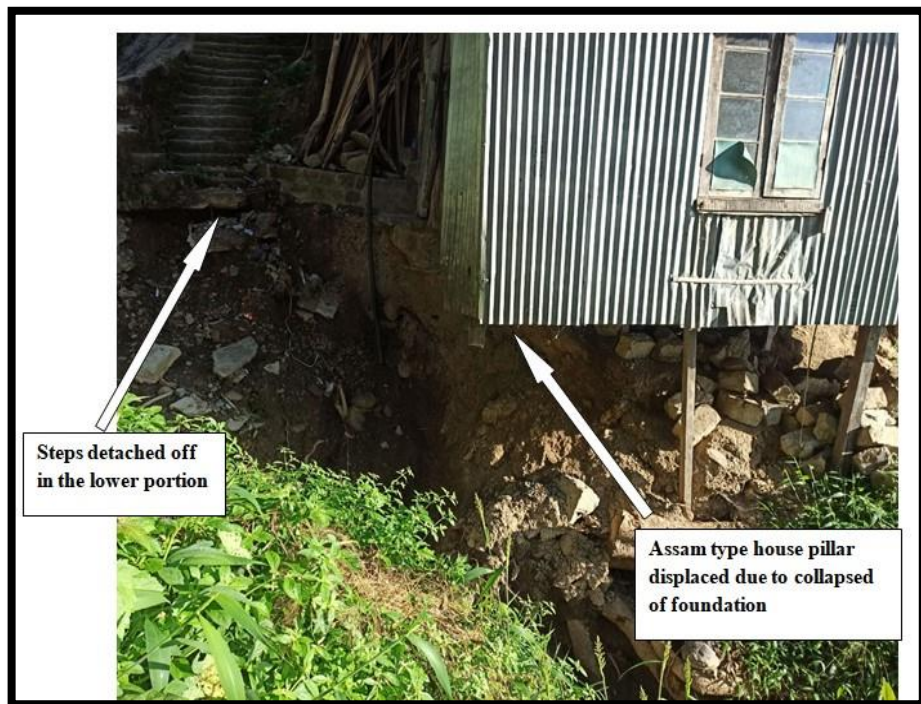
Figure 5.5. Collapsed of steps and building foundation

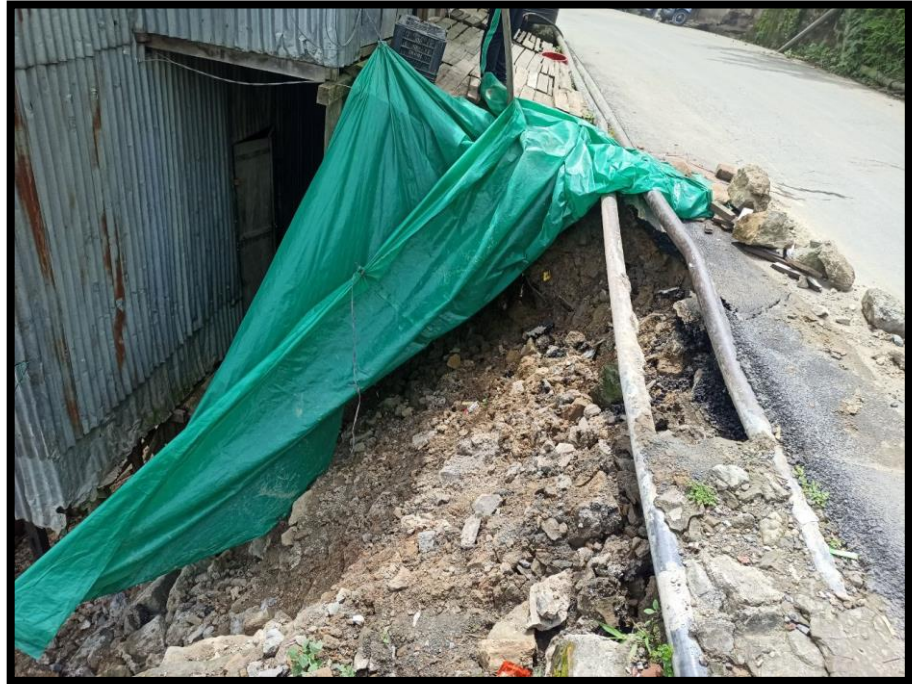
Figure 5.6. Collapsed of retaining wall

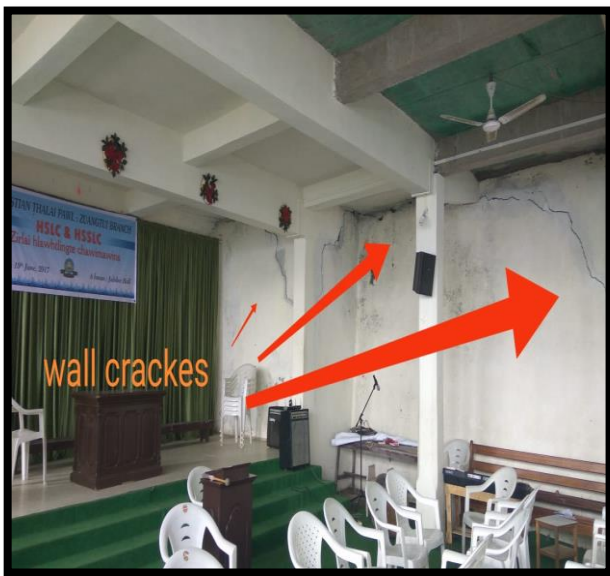
Figure 5.8. Cracks and fractures observed on the wall of Zuangtui Presbyterian Church

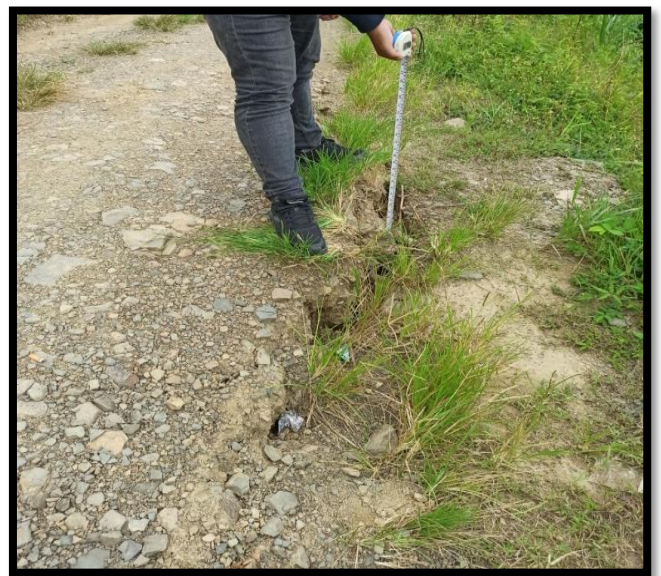
Figure 5.9. Tensional cracks observed in location-2

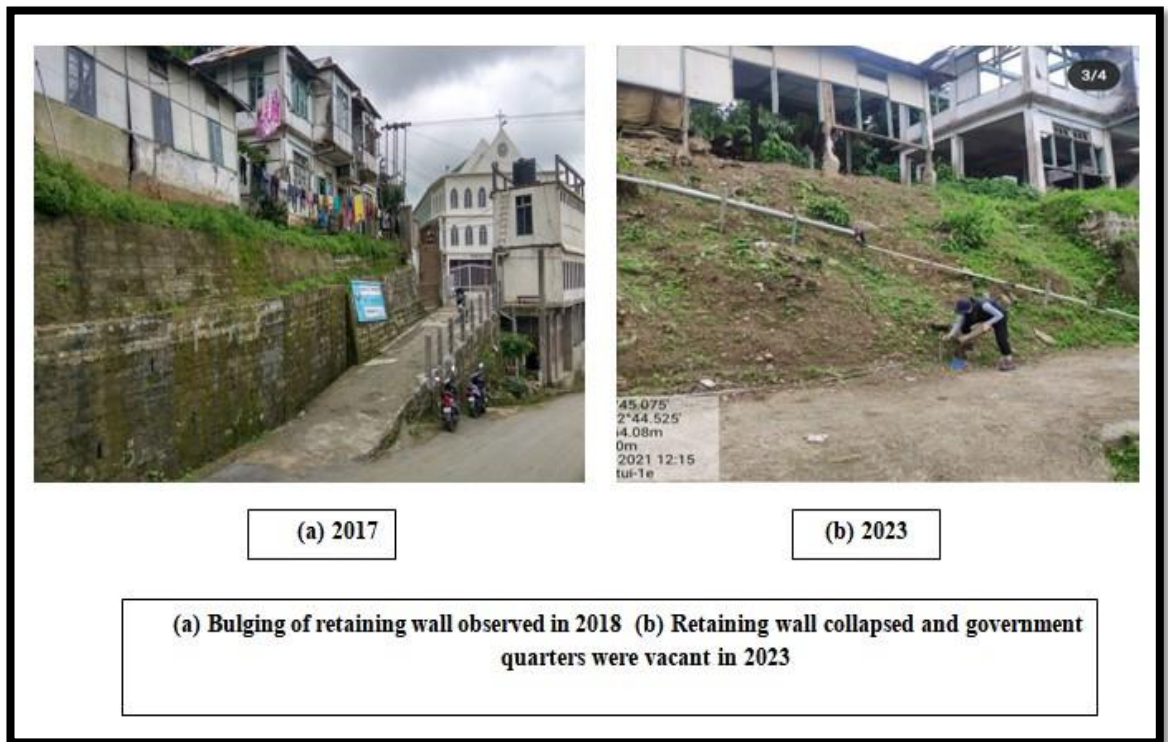
Figure 5.10. Collapsed Masonry retaining wall near Zuangtui Presbyterian Church
