**DISASTER RISK ASSESSMENT AND ROCK MASS
CHARACTERIZATION OF STATE HIGHWAY FROM
CHAMPHAI TO ZOKHAWTHAR, CHAMPHAI DISTRICT,
MIZORAM**

**A THESIS SUBMITTED IN PARTIAL FULFILLMENT OF THE
REQUIREMENTS FOR THE DEGREE OF DOCTOR OF
PHILOSOPHY**

**CENTRE FOR DISASTER MANAGEMENT
SCHOOL OF EARTH SCIENCES AND NATURAL RESOURCES
MANAGEMENT**

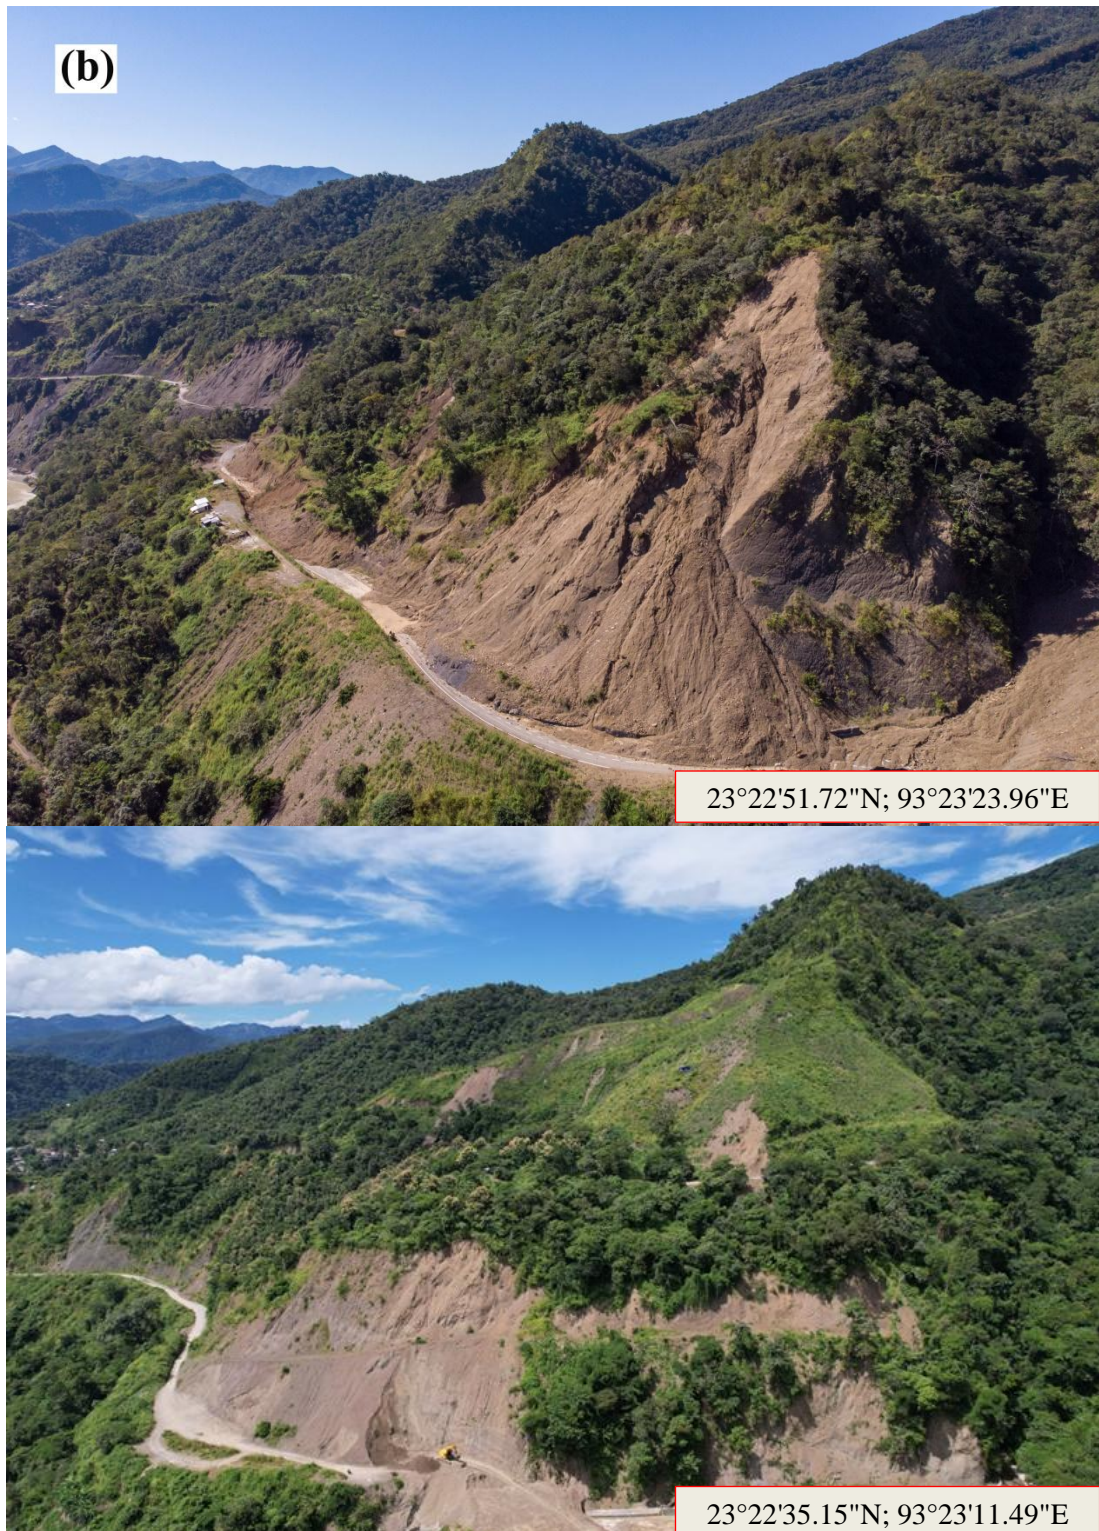
Fig. 1.3 Landslides in three different locations (a) Location LS2; (b) Location LS4; (c) Location LS6

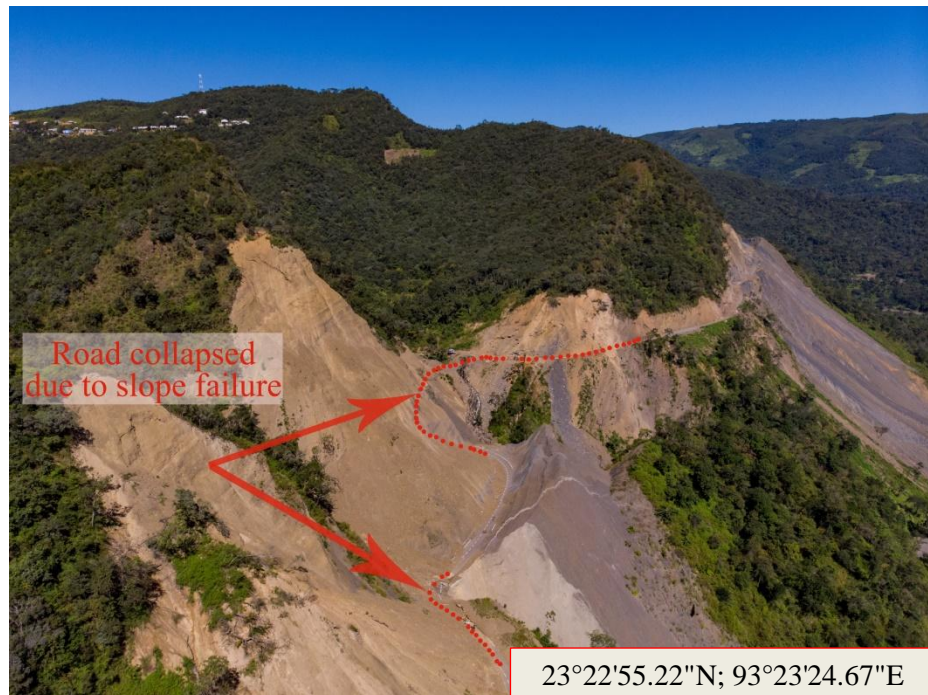
Fig. 4.1 Collapsed Road and Landslides (*The road collapsed and was inaccessible due to landslide.*
Dotted lines represent the road which was collapsed)

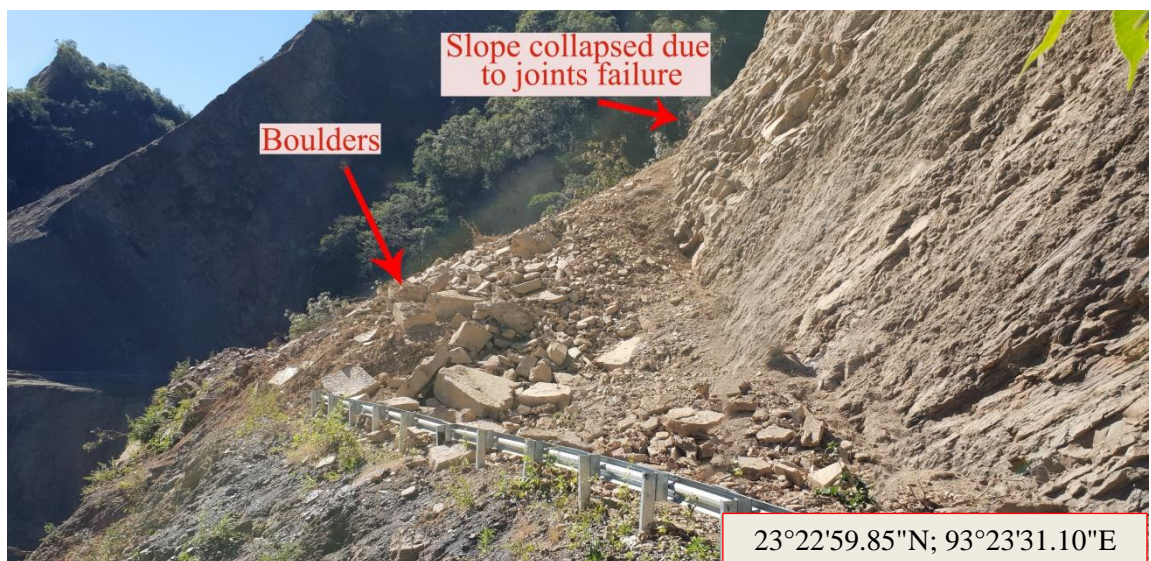
Fig. 4.4 Slope Failure (*The slope collapsed due to the failure of the joints. Boulders that fell from the slope completely blocked the road*)

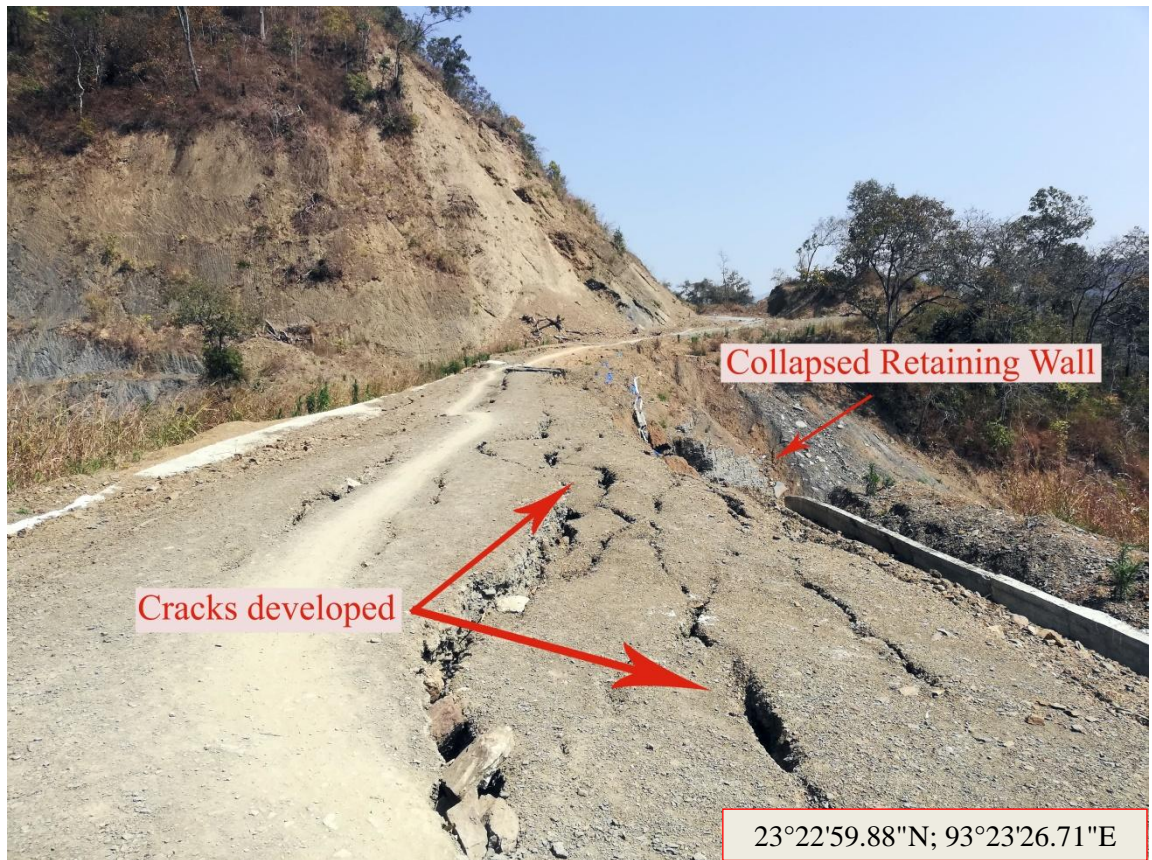
Fig. 4.5 Collapsed Retaining Wall (*Due to the collapse of the retaining wall, cracks developed on the road*)

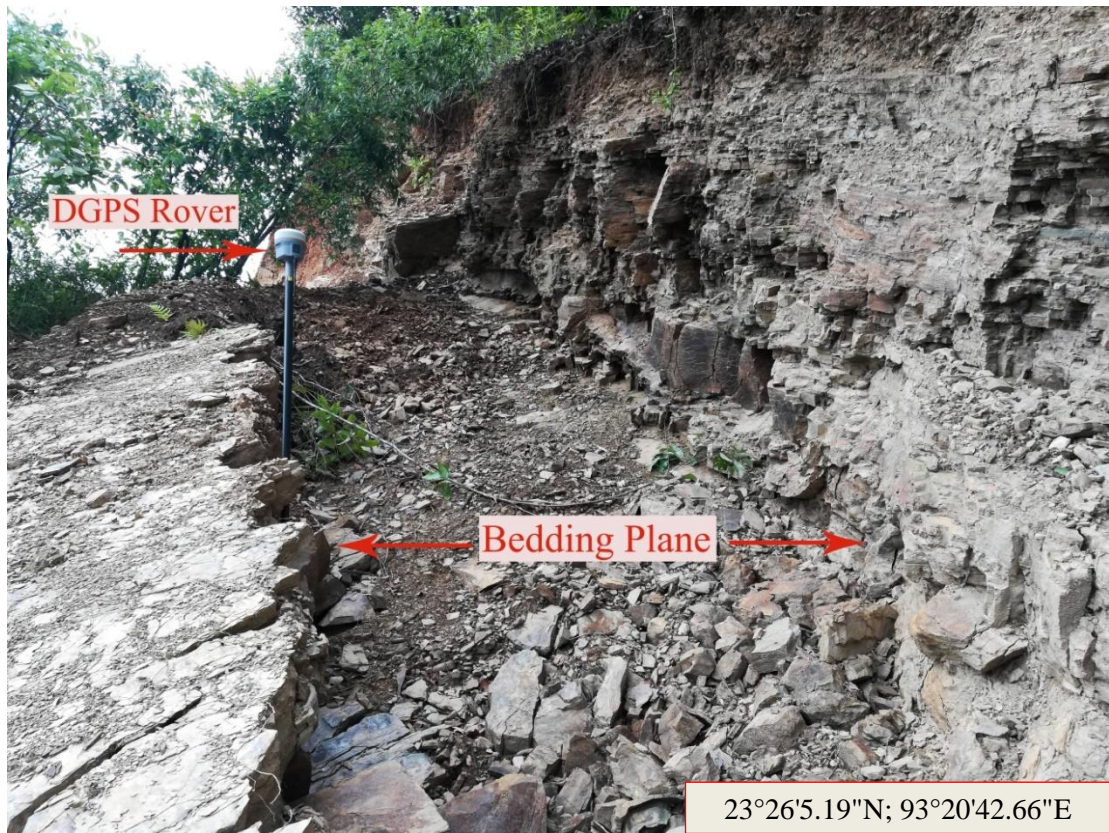
Fig. 4.6 Bedding Plane Failure

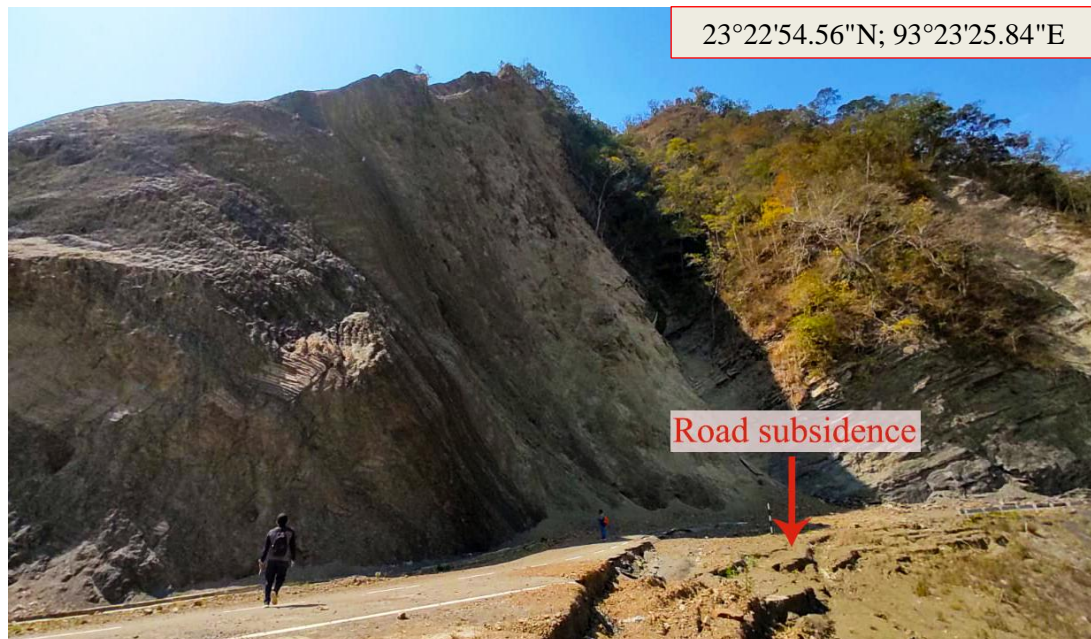
Fig. 4.7 Road subsidence (*caused by a landslide at the downhill*)

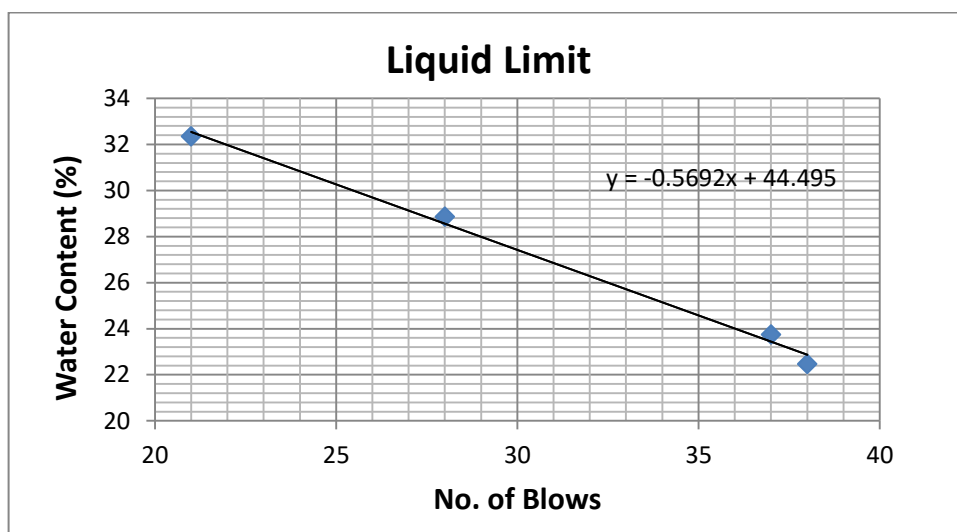
Fig. 4.8 Liquid Limit of LS1

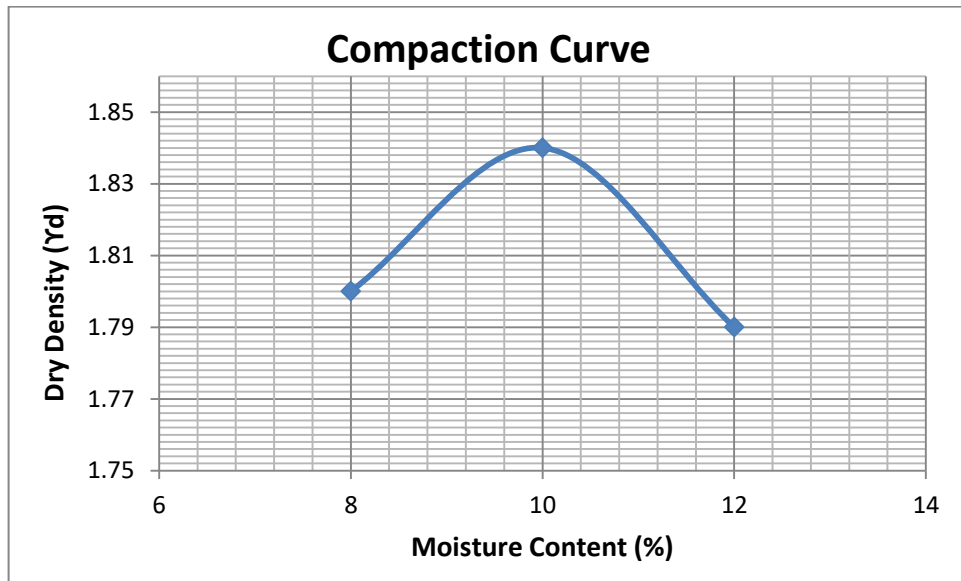
Fig. 4.14 Moisture Content Vs. Dry Density for LS1

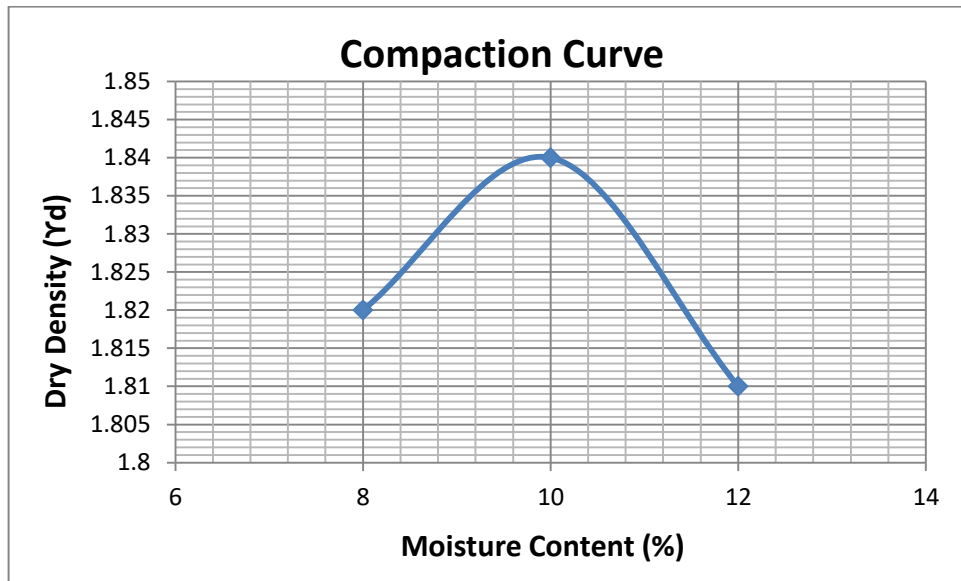
Fig. 4.15 Moisture Content Vs. Dry Density for LS2

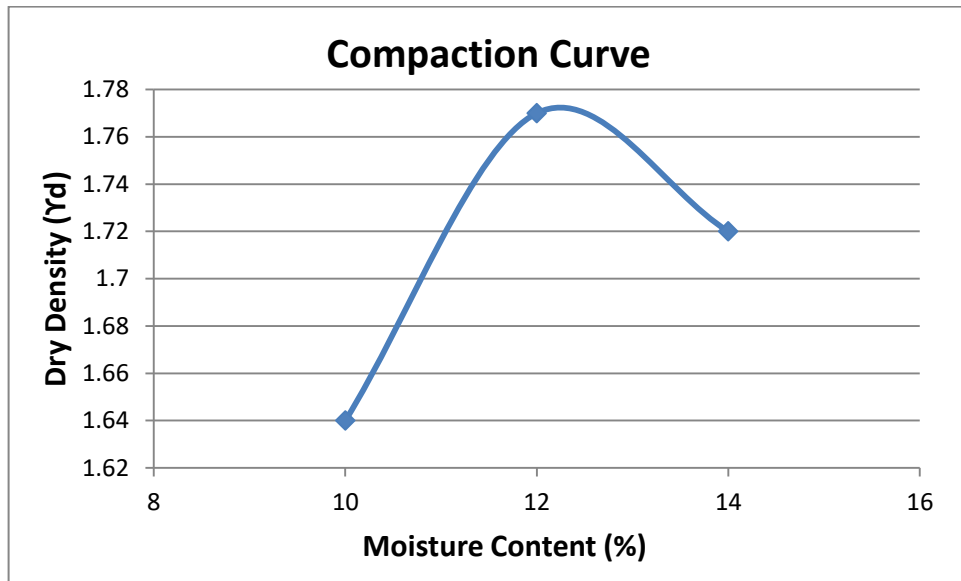
Fig. 4.16 Moisture Content Vs. Dry Density for LS3

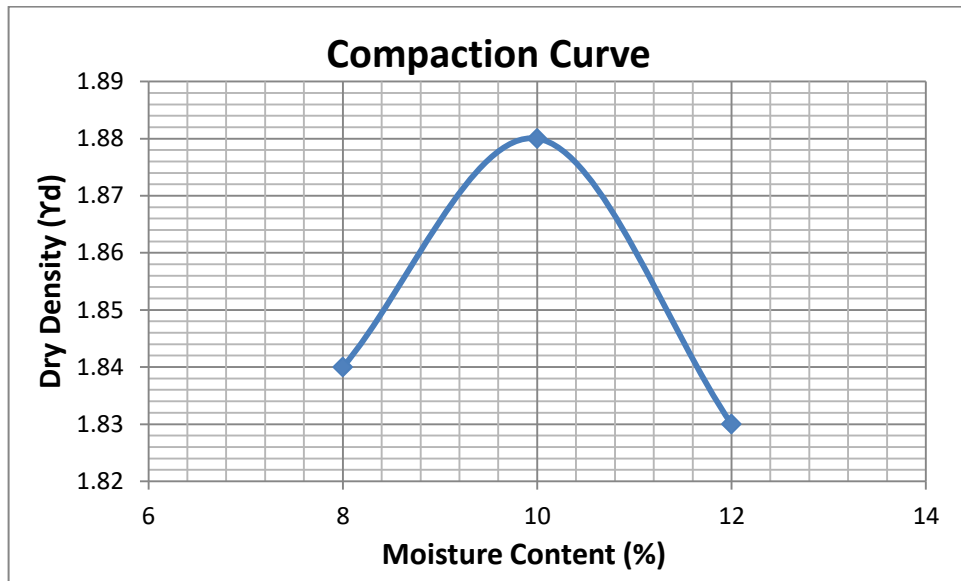
Fig. 4.17 Moisture Content Vs. Dry Density for LS4

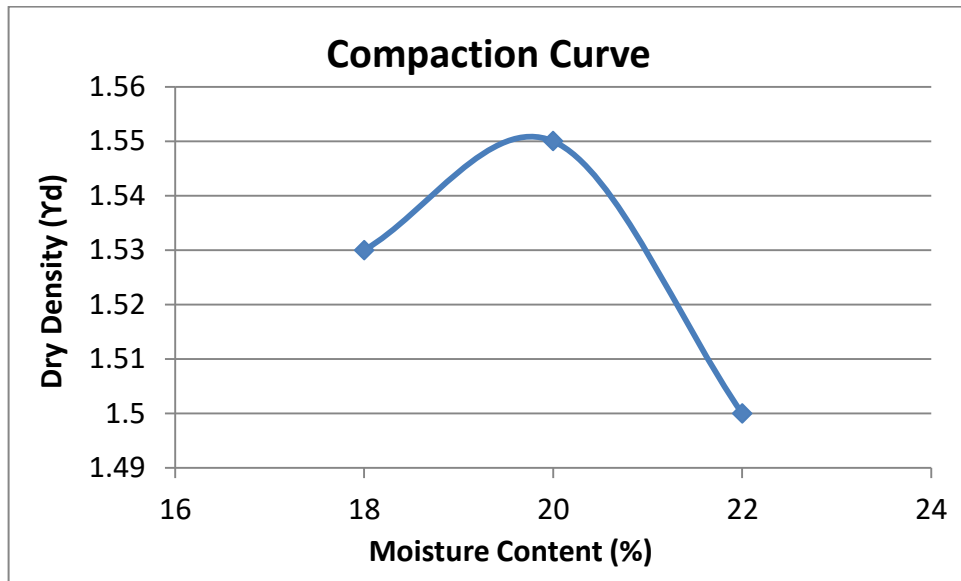
Fig. 4.18 Moisture Content Vs. Dry Density for LS5

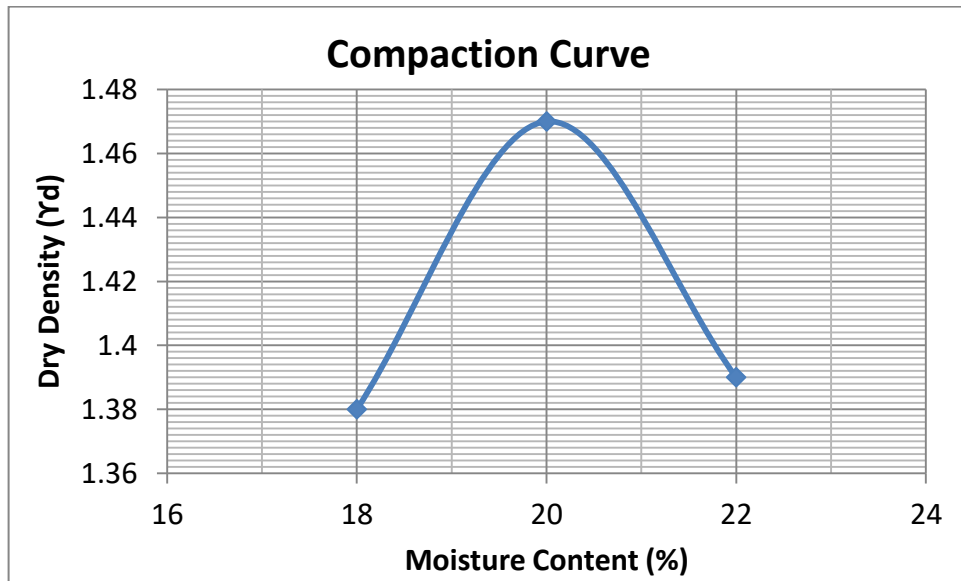
Fig. 4.19 Moisture Content Vs. Dry Density for LS6

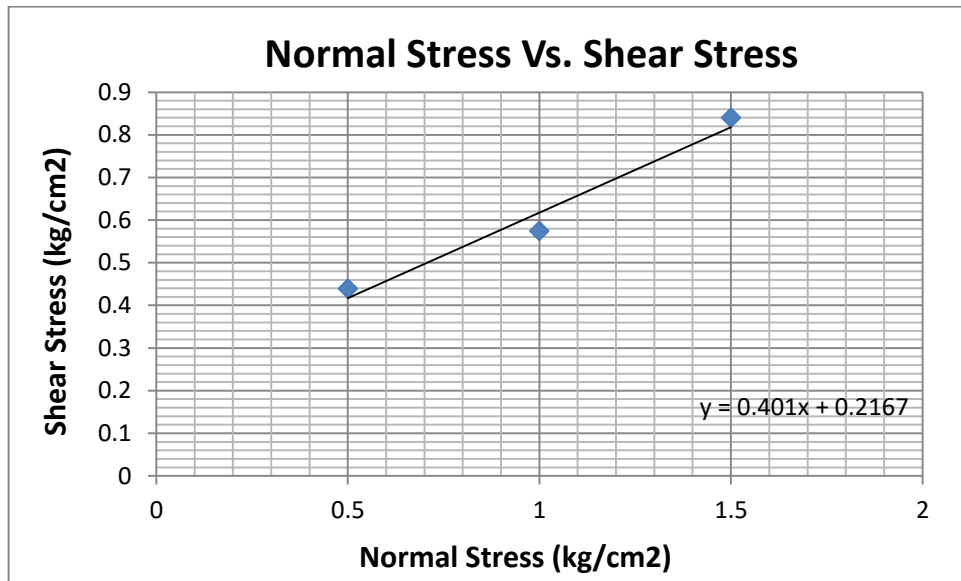
Fig. 4.20 Shear Stress at Failure for LS1

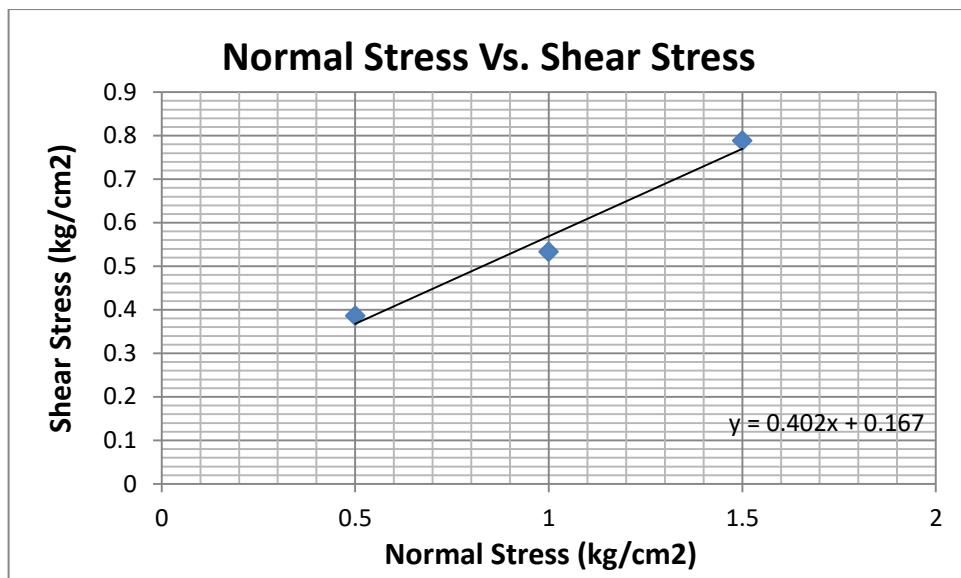
Fig. 4.21 Shear Stress at Failure for LS2

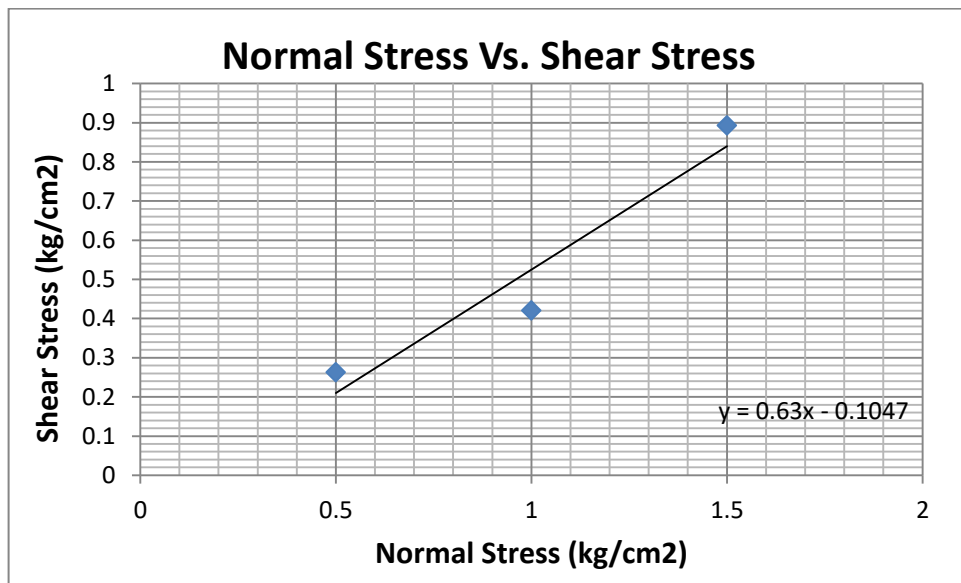
Fig. 4.22 Shear Stress at Failure for LS3

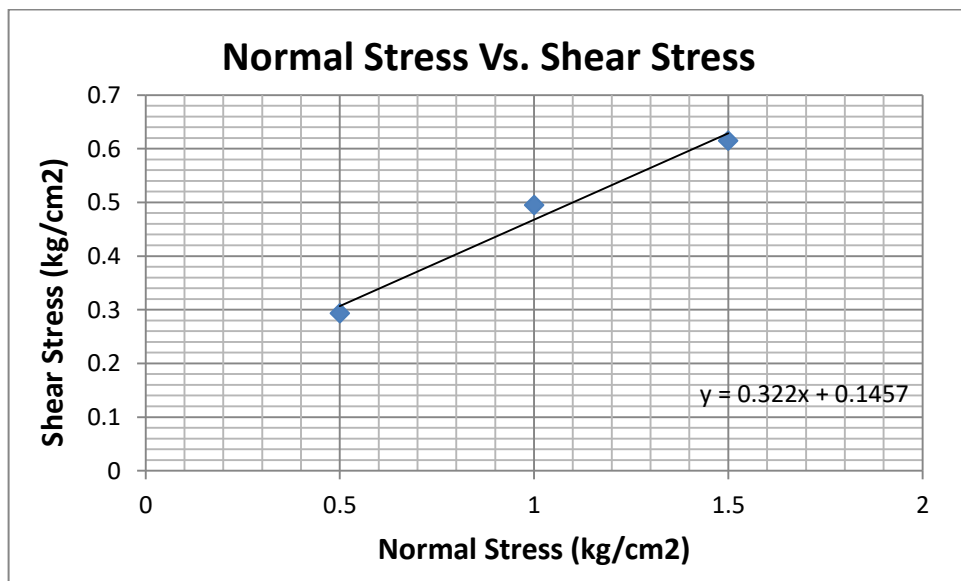
Fig. 4.23 Shear Stress at Failure for LS4

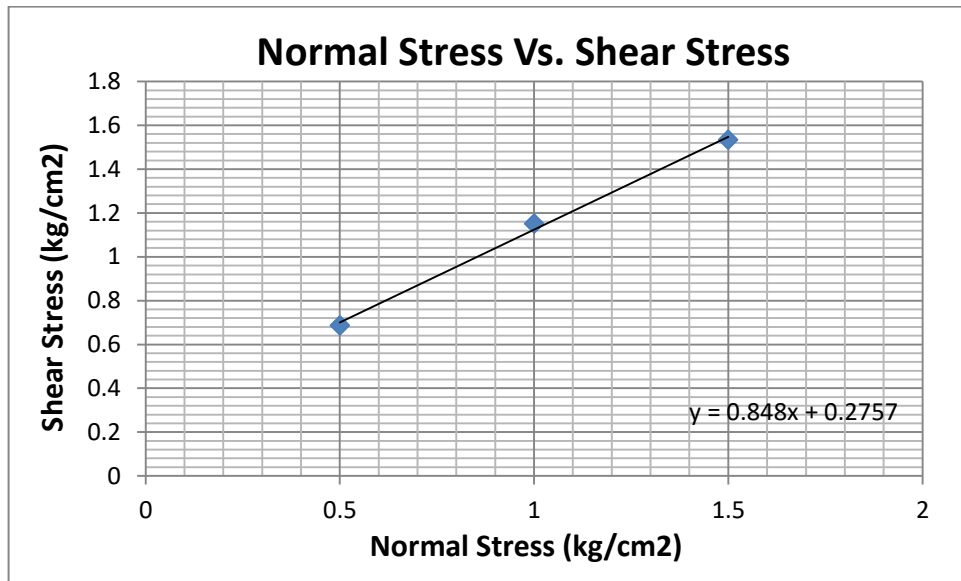
Fig. 4.25 Shear Stress at Failure for LS5

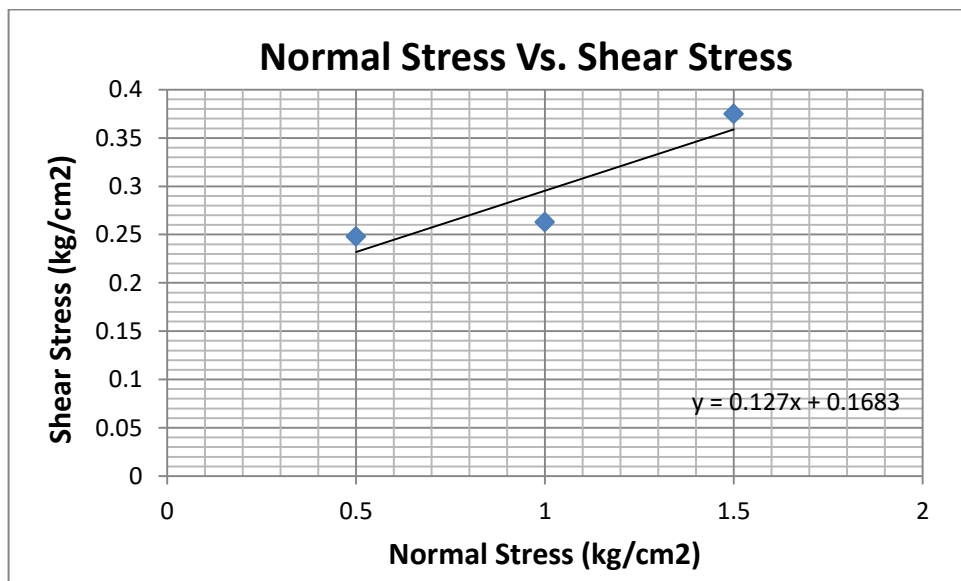
Fig. 4.25 Shear Stress at Failure for LS6

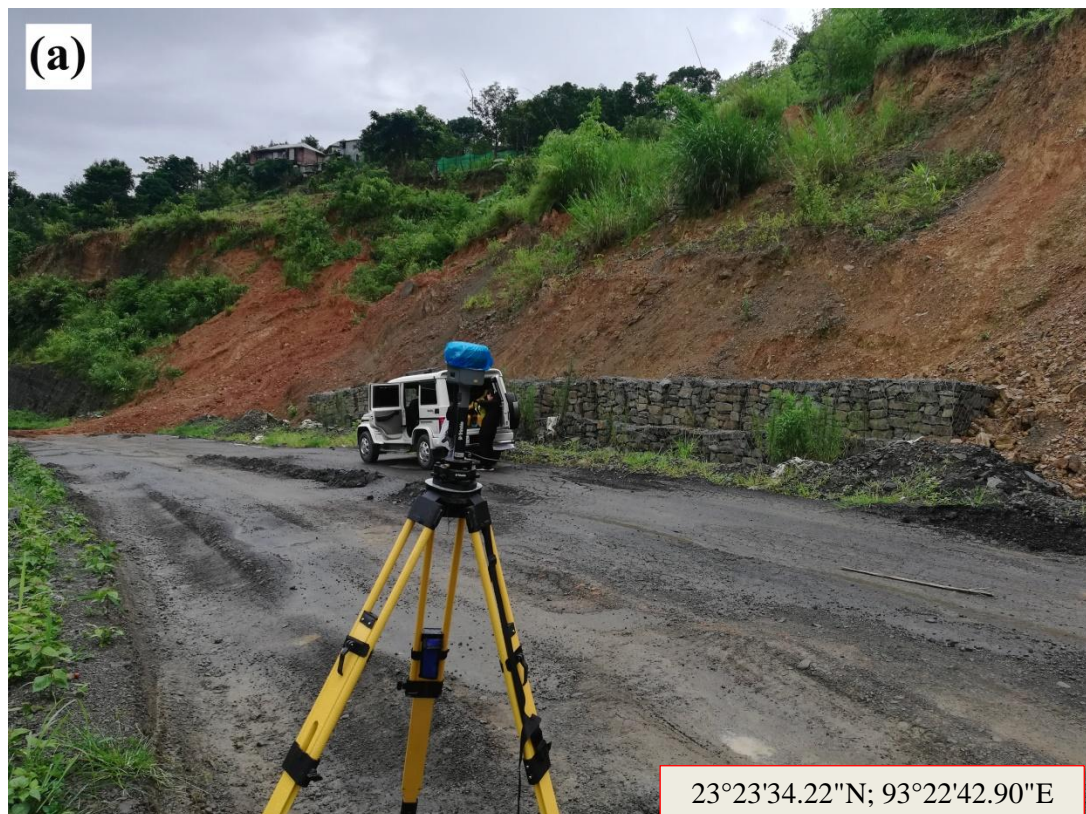
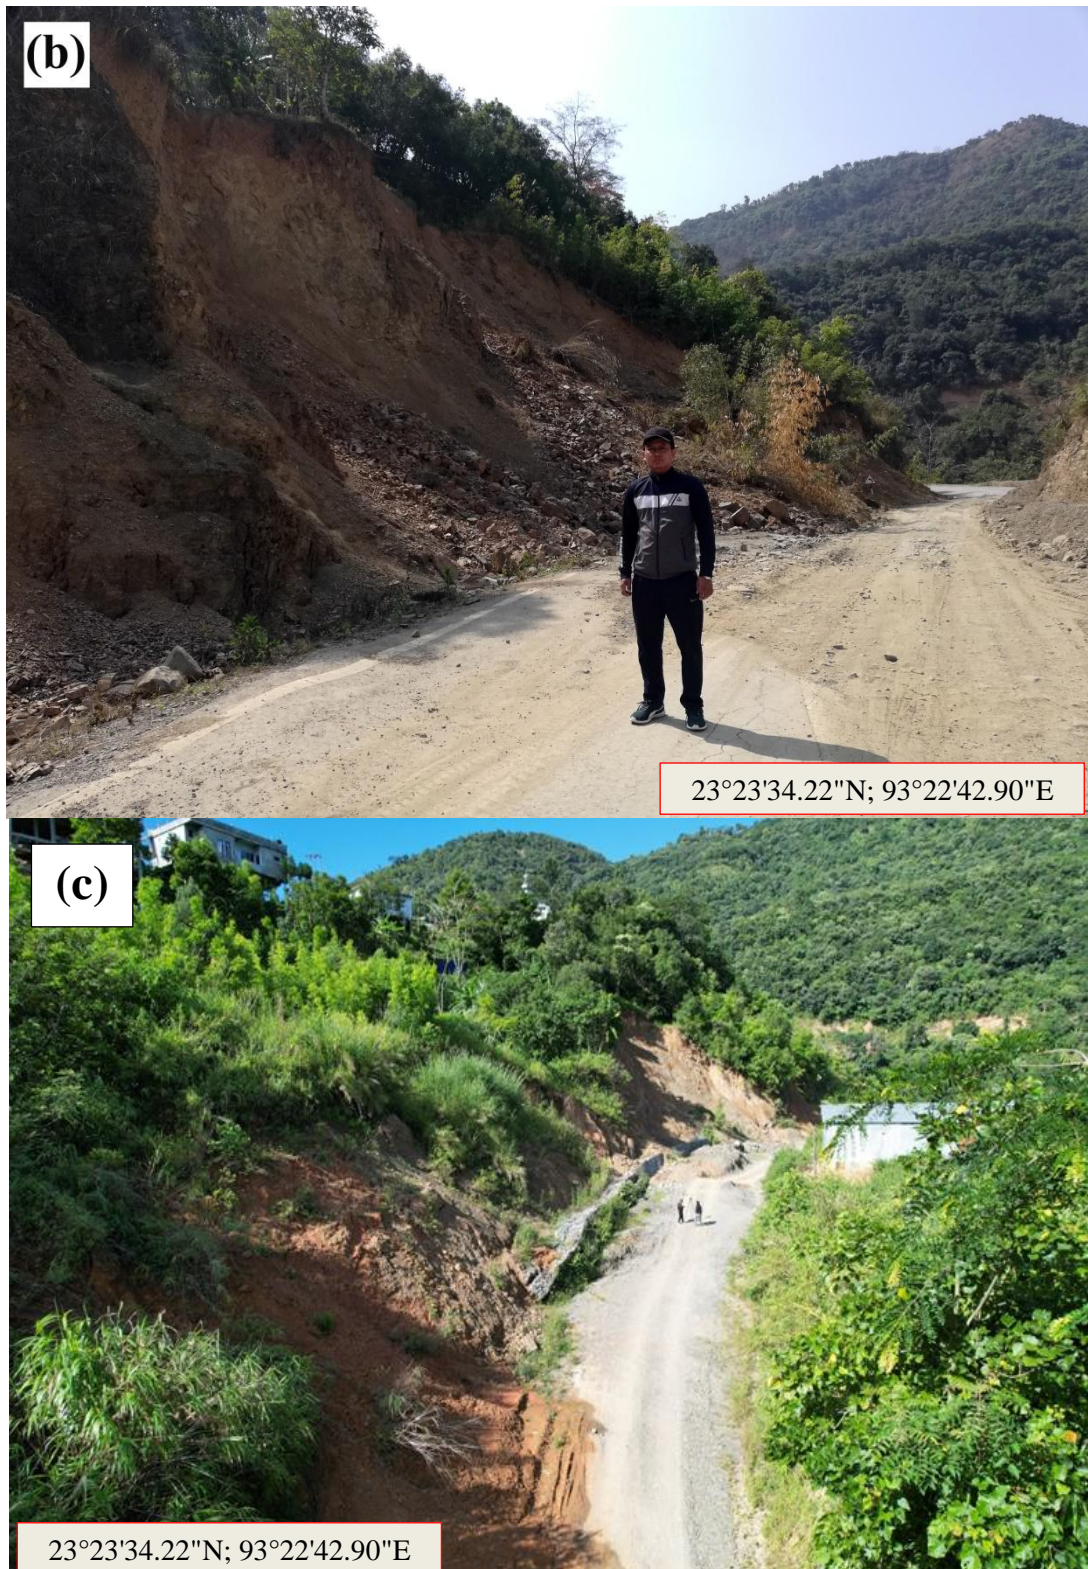
Melbuk village is located on the crown of LS1 and the road connecting Zokhawthar runs through the town. It is an active debris slide due to large-scale cut slope failure, with a relatively thick overburden, mainly loose soil, present at the upslope. The unchannelized water penetrating the thick overburden reduced the cohesiveness of the soil. Gabion walls were constructed at the base of the landslide with no slope-easing techniques used. It destroyed the road and parts of the gabion walls causing the asphalt to pop up. The affected area stretched about 100 meters in width and 62.2 meters in length. The average factor of safety for different methods is 0.827. Figure 4.27 (a) and (b) display the field photograph and figures 4.28, 4.29, 4.30, and 4.31 display LEM analyses using different methods.

Fig. 4.26 Field photograph of LS1

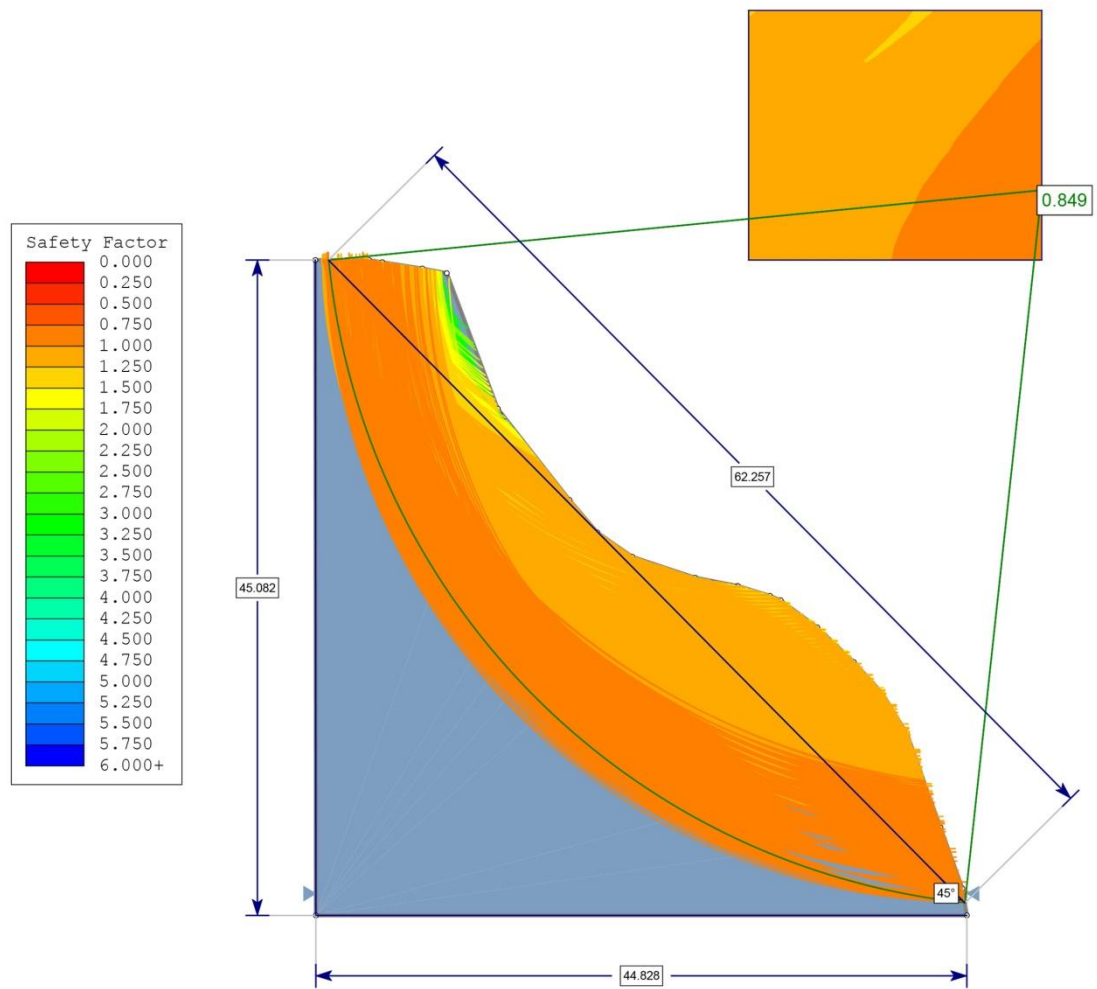
Fig. 4.27 GLE/ Morgenstern-Price method of LEM Analysis for LS1

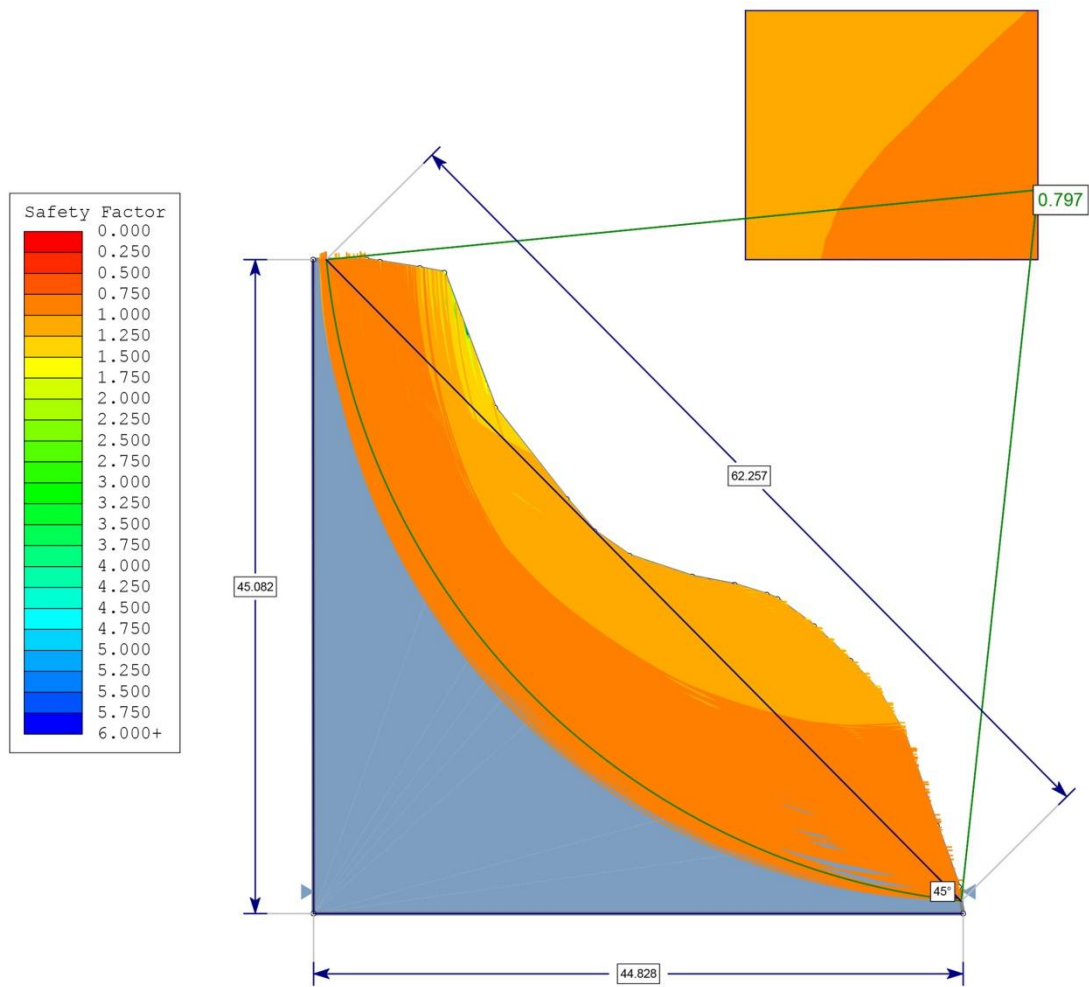
Fig. 4.28 Janbu Simplified method of LEM Analysis for LS1

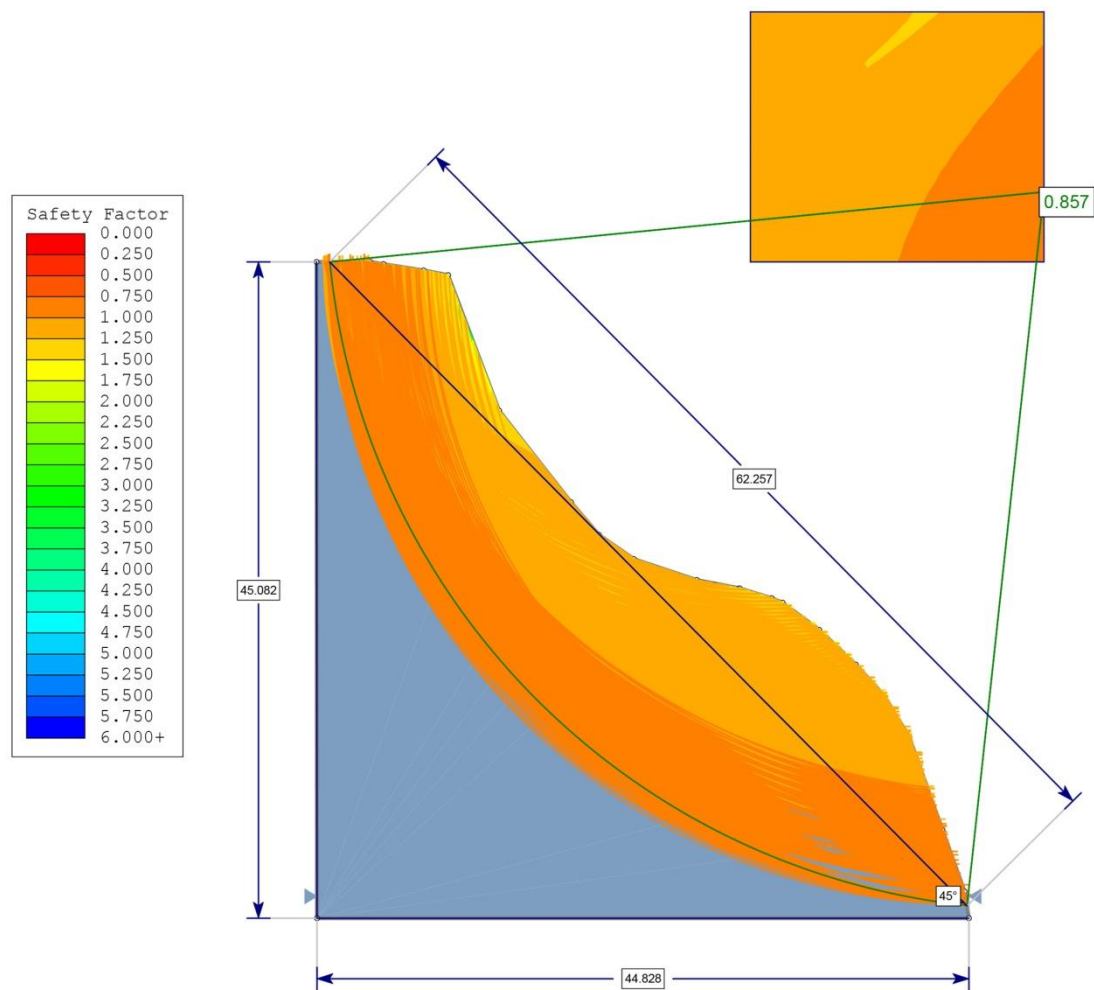
Fig. 4.29 Bishop Simplified of LEM Analysis for LS1

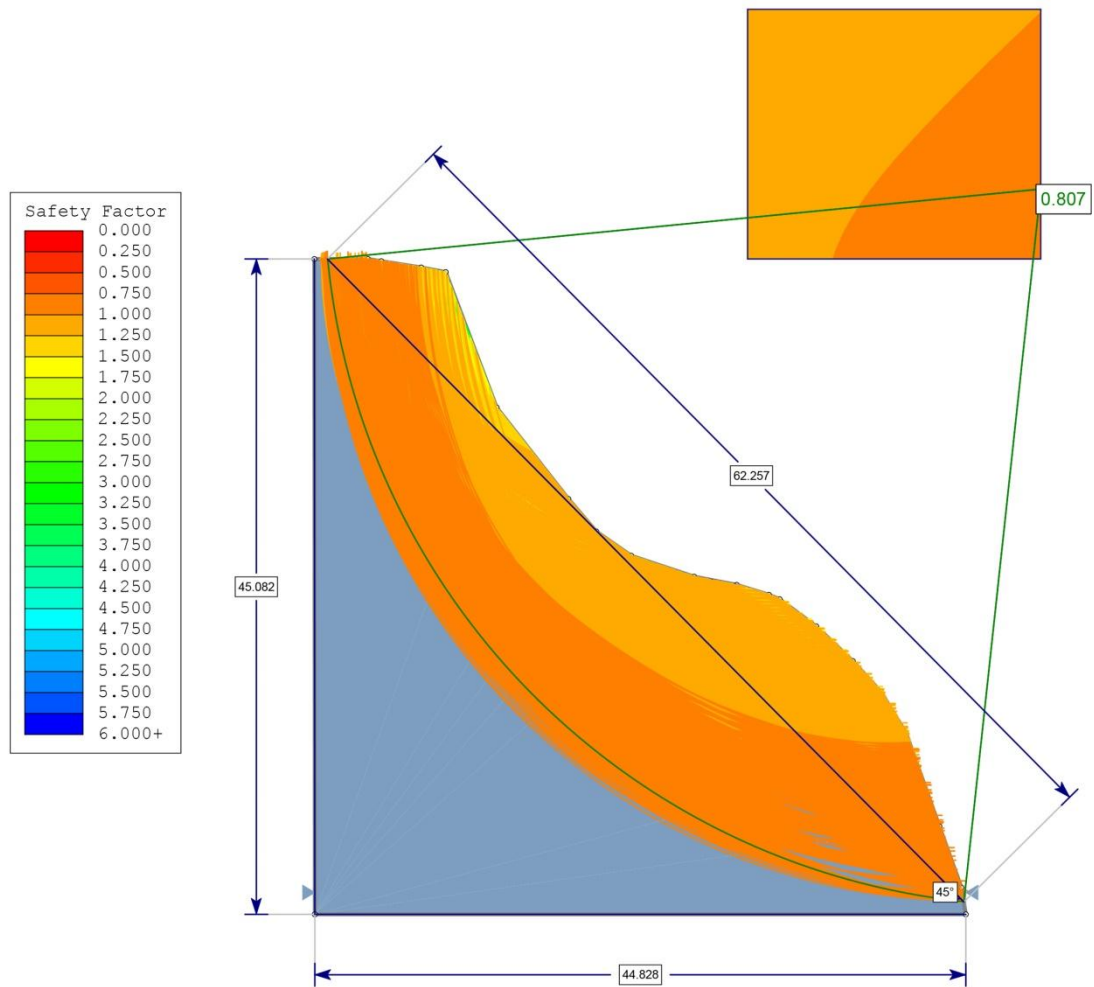
Fig. 4.30 Ordinary/ Fellenius method of LEM Analysis for LS1

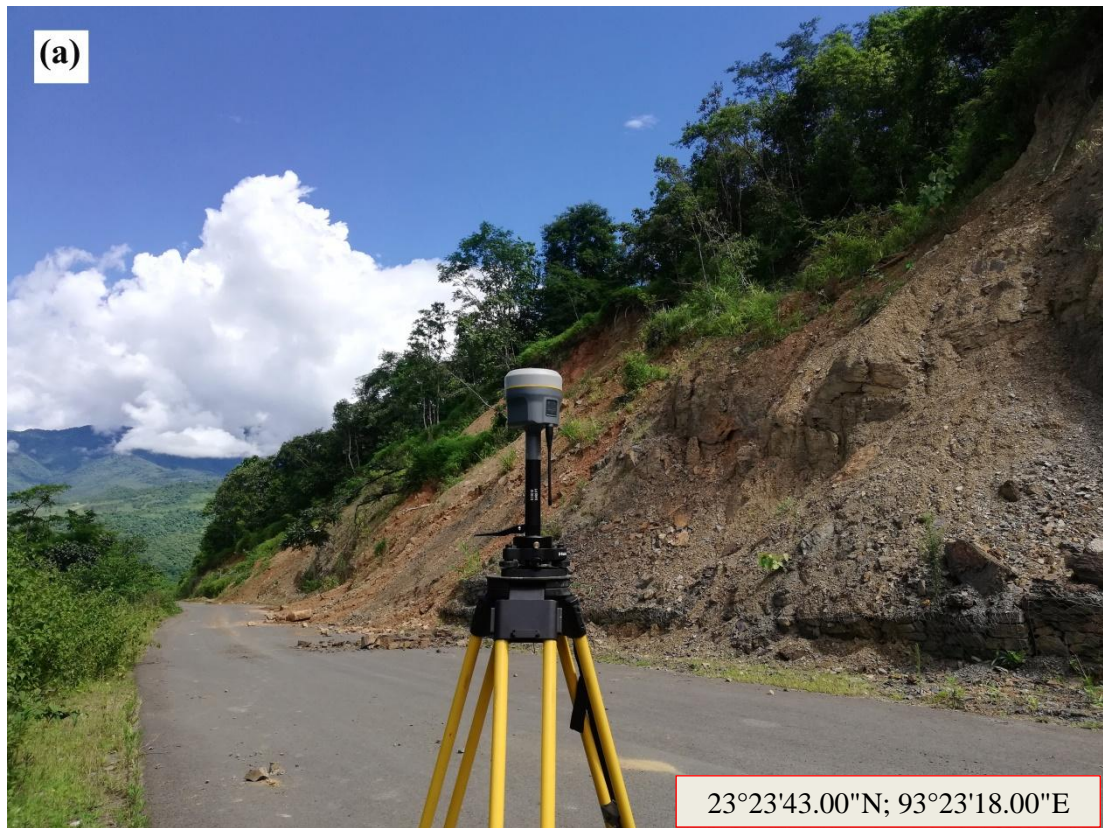
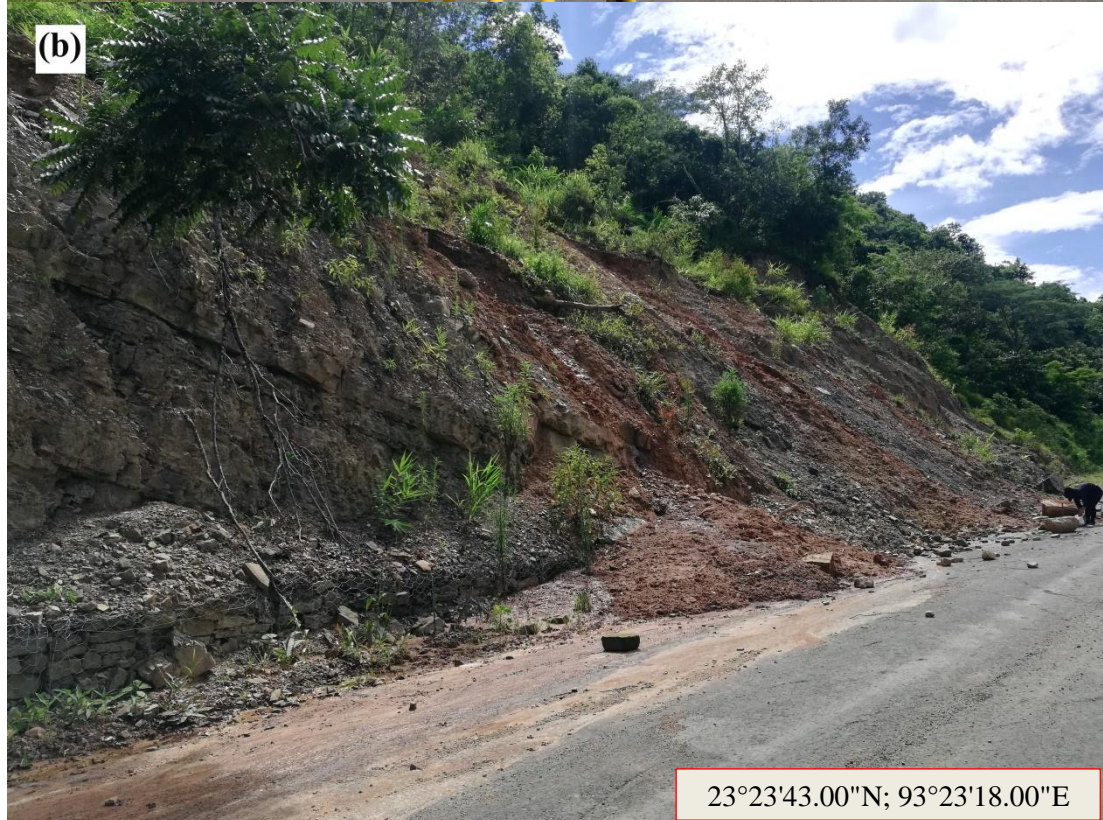
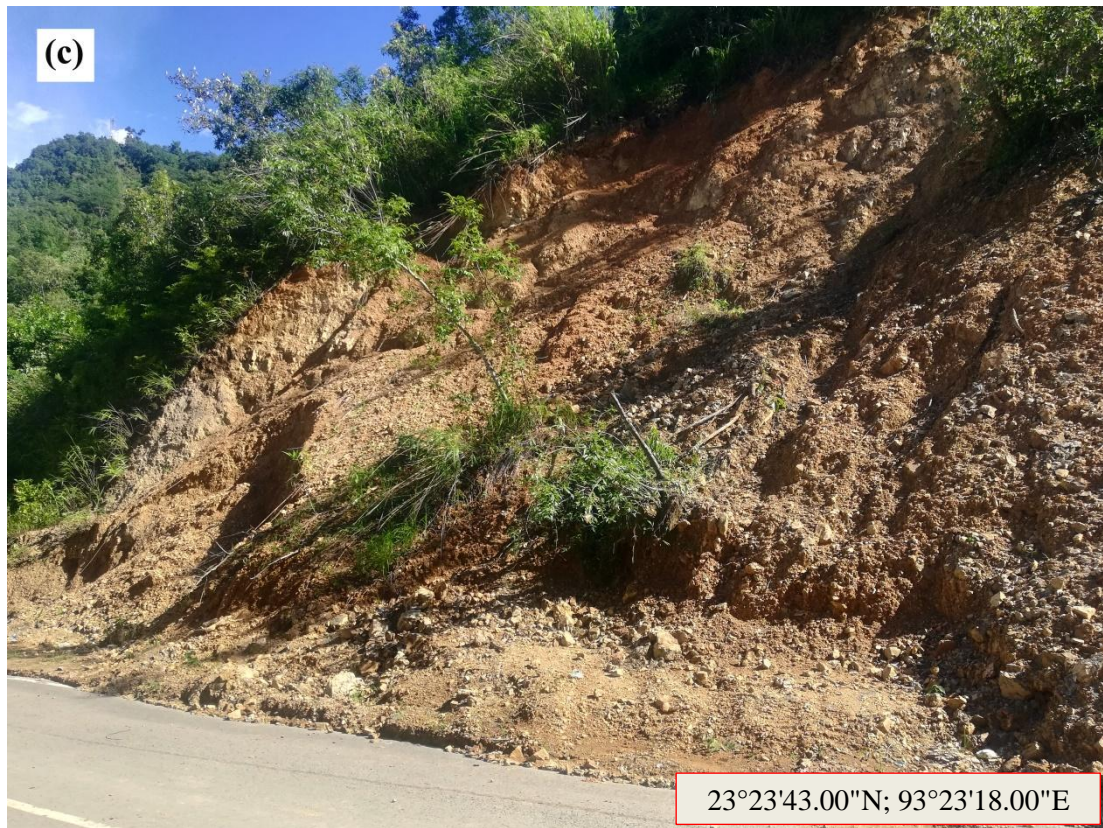
Zokhawthar Road via Melbuk is located on the uphill of LS2. It is an active debris slide due to cut-slope failure, where unconsolidated earth material moves rapidly down the slope. A gabion walls at the toe were damaged by landslide debris. The unchannelized widespread flow of water including surface runoff and those penetrating the ground contributes as one of the triggering factors for LS2 slope failure. The sliding area stretched about 189 meters in width and 69.57 meters in length. The average factor of safety for different methods is 0.719. Figures 4.32 (a) (b) and (c) display the field photographs and figures 4.33, 4.34, 4.35, and 4.36 display LEM analyses using different methods.

Fig. 4.31 Field Photographs of LS2
