**DISASTER RISK ASSESSMENT AND ROCK MASS
CHARACTERIZATION OF STATE HIGHWAY FROM
CHAMPHAI TO ZOKHAWTHAR, CHAMPHAI DISTRICT,
MIZORAM**

**A THESIS SUBMITTED IN PARTIAL FULFILLMENT OF THE
REQUIREMENTS FOR THE DEGREE OF DOCTOR OF
PHILOSOPHY**

**CENTRE FOR DISASTER MANAGEMENT
SCHOOL OF EARTH SCIENCES AND NATURAL RESOURCES
MANAGEMENT**

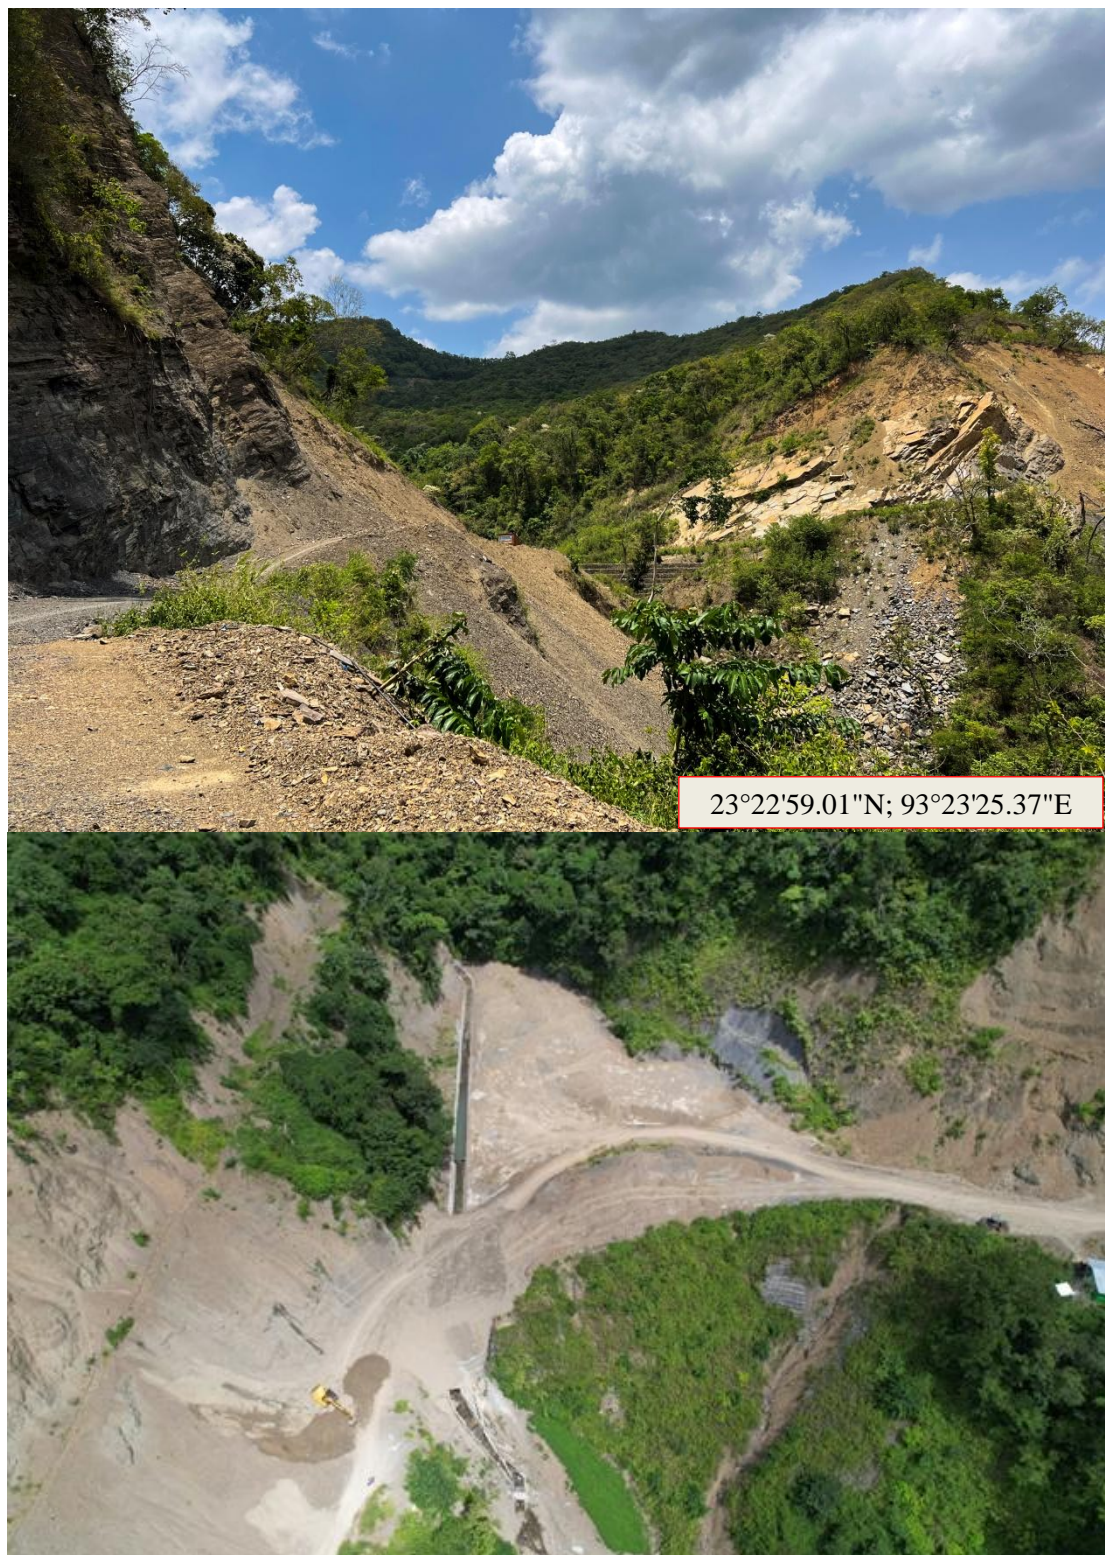
A debris slide is observed at LS3 of 142 meters in width and 101.5 meters in length. A dam-like structure for the road was constructed in a depression where a small stream is flowing. Geotextile materials were used on both sides of the wall. A wide slope cutting for road construction has made it vulnerable to failure. A wide slope cutting for road construction has made it vulnerable to failure. The average factor of safety obtained from different methods is 0.674. Figure 4.37 display the field photograph and figures 4.38, 4.39, 4.40, and 4.41 display LEM analyses using different methods.

Fig. 4.36 Field photograph of failed slope in LS3

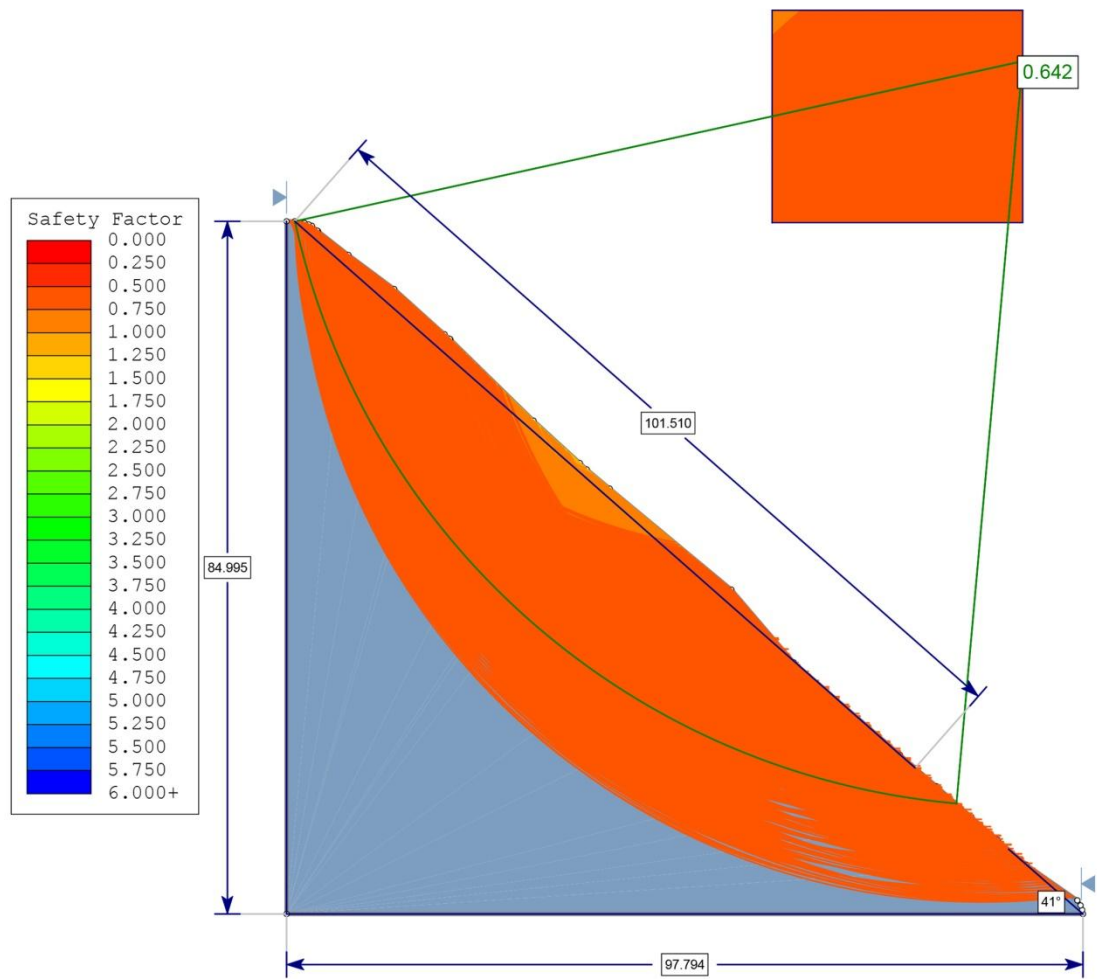
Fig. 4.38 Janbu Simplified Method of LEM Analysis for LS3

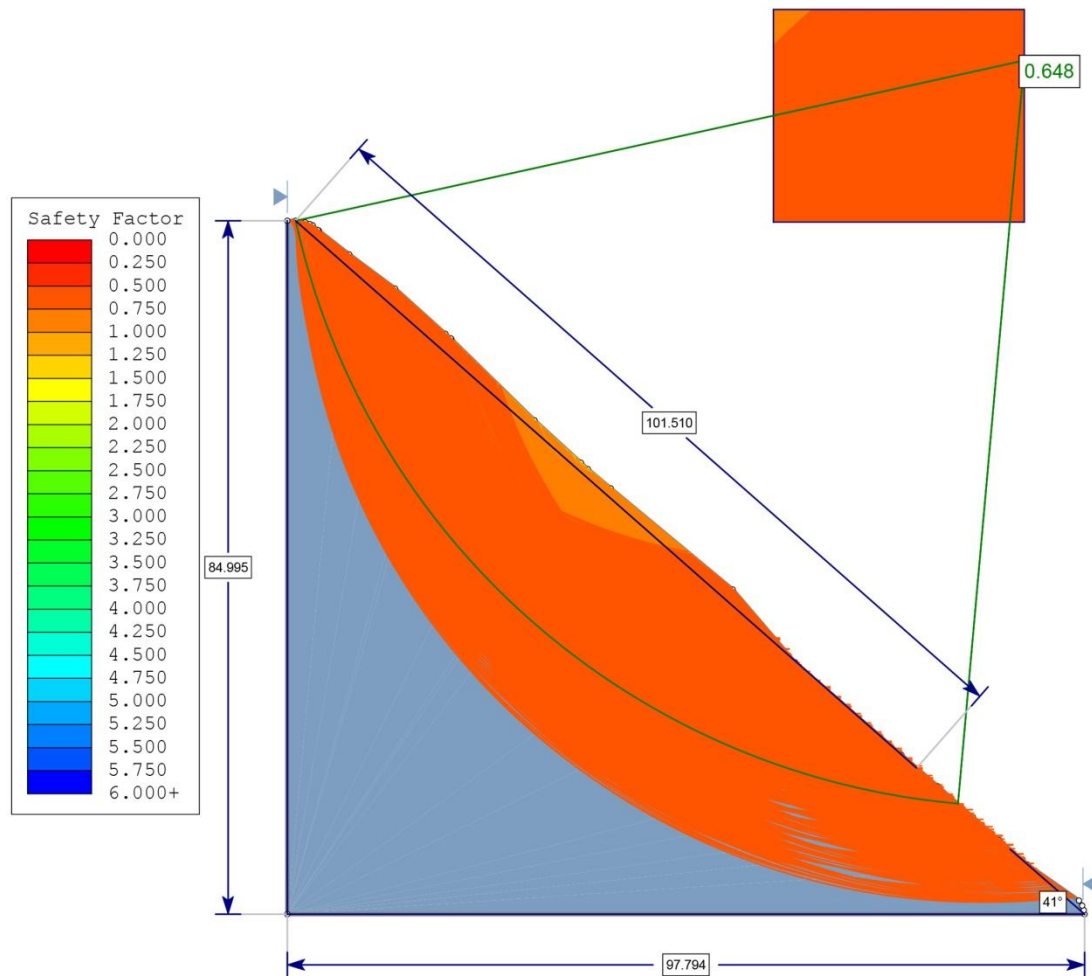
Fig. 4.40 Ordinary/ Fellenius Method of LEM Analysis for LS3

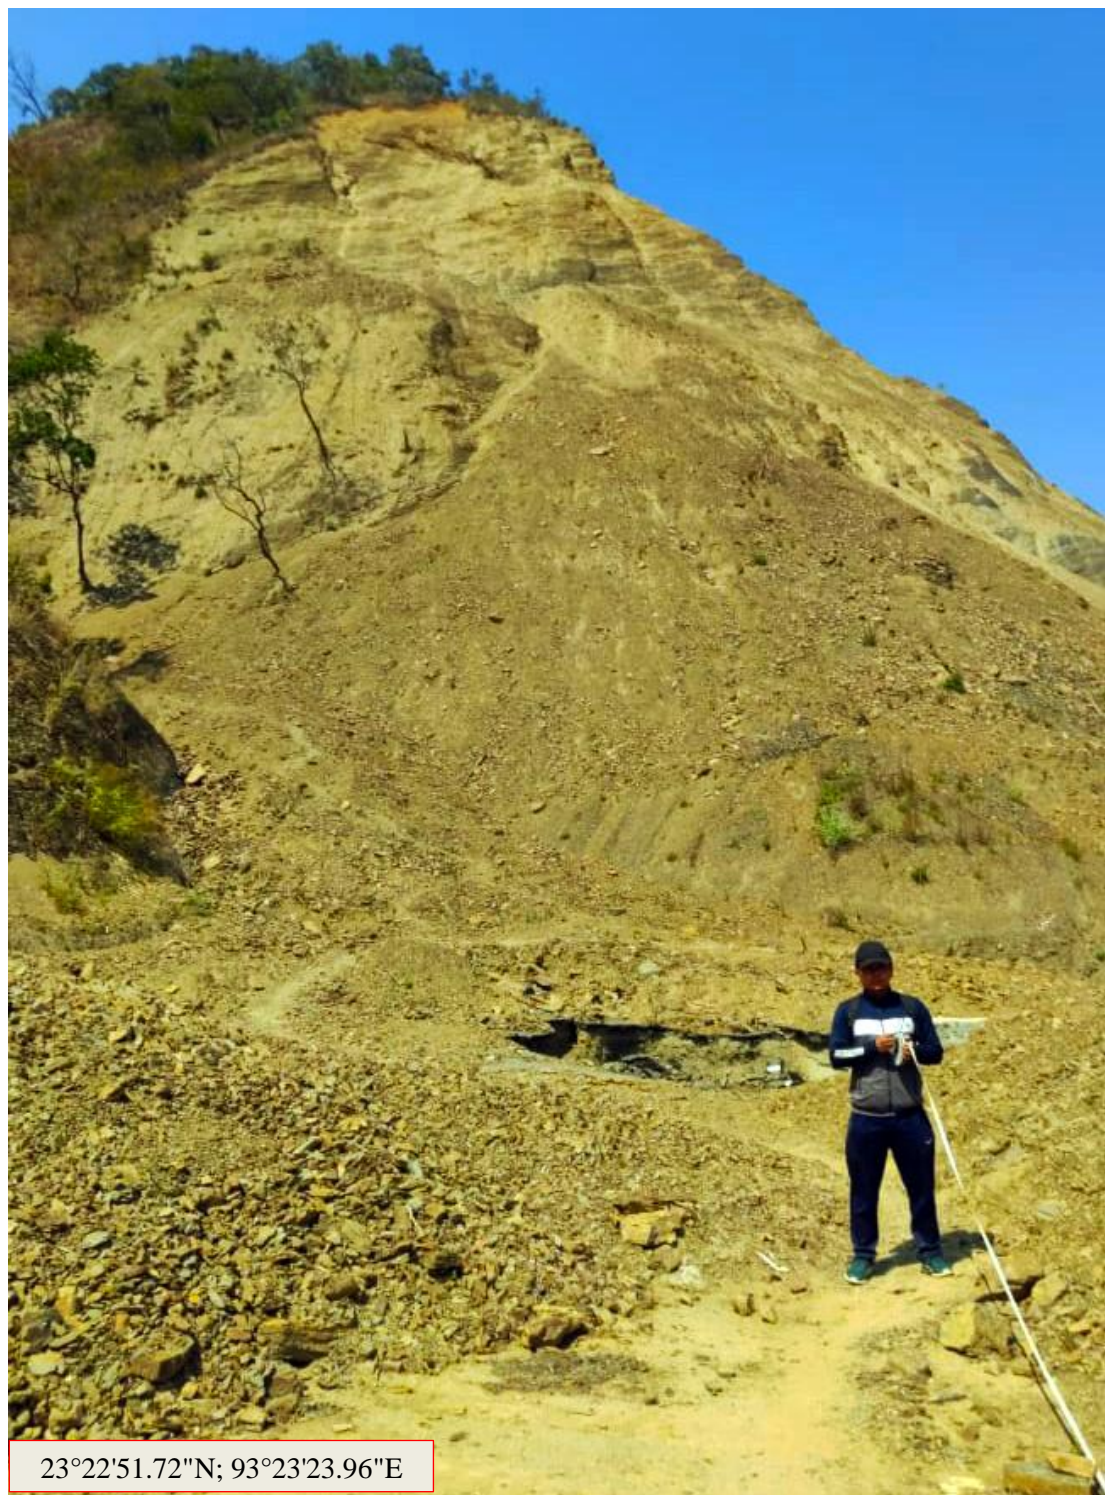
A debris slide of 145.9 meters length and 95 meters width of loose, younger material is observed at LS4. A culvert is constructed along a small stream. Fragile lithology and toe-cutting of the slope for road construction destabilized the hill, which caused landslides. Both sides of the slopes failed, and the culvert has been obstructed by this waste, resulting in water-laden debris to erosion. Part of the culvert along the road has been damaged and was overburdened by debris. The average factor of safety obtained from different methods is 0.58. Figure 4.42 display the field photograph and figures 4.43, 4.44, 4.45, and 4.46 display LEM analyses using different methods.

Fig. 4.41 Field photograph of LS4

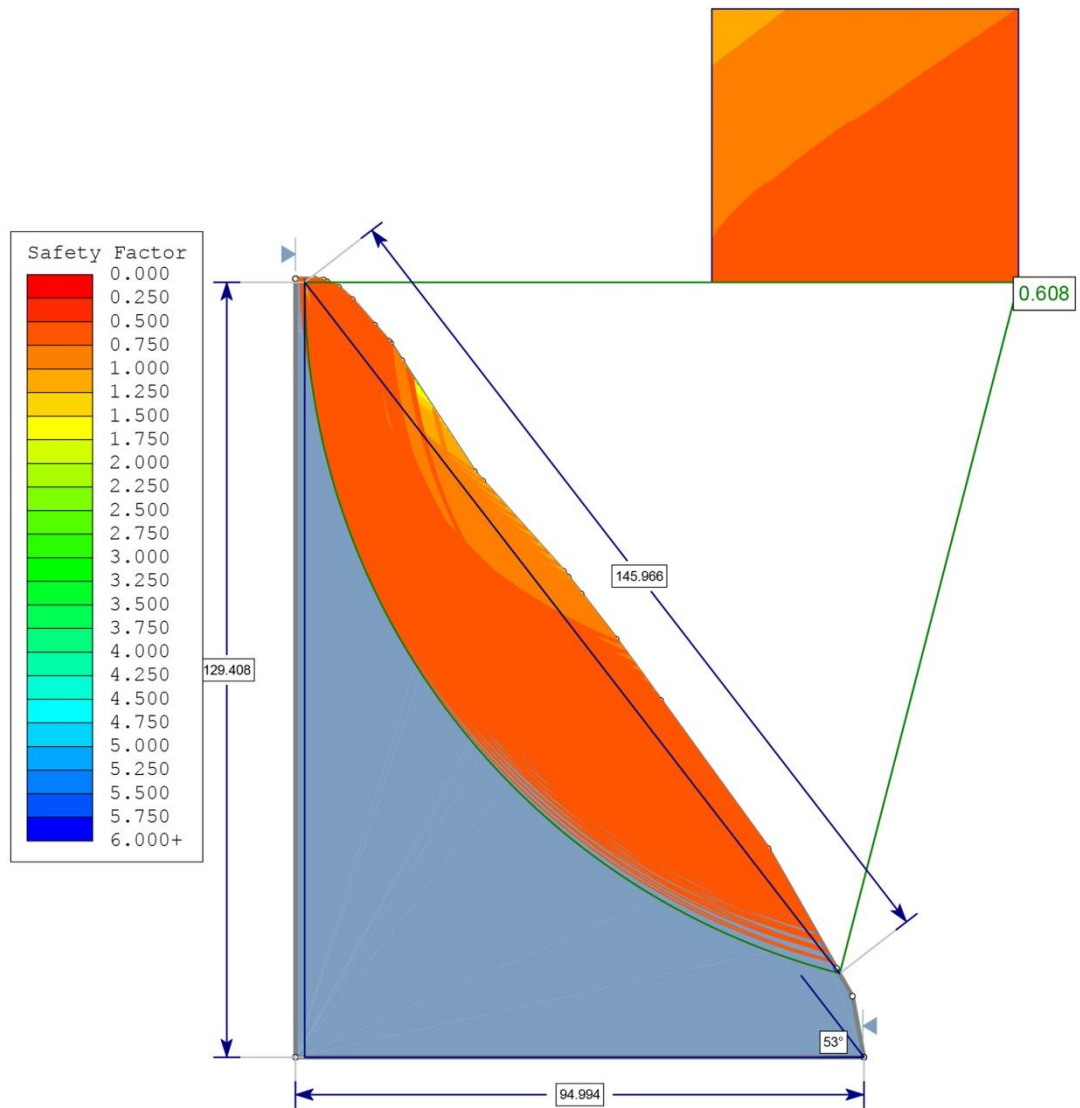
Fig. 4.42 GLE/ Morgenstern-Price Method of LEM Analysis for LS4

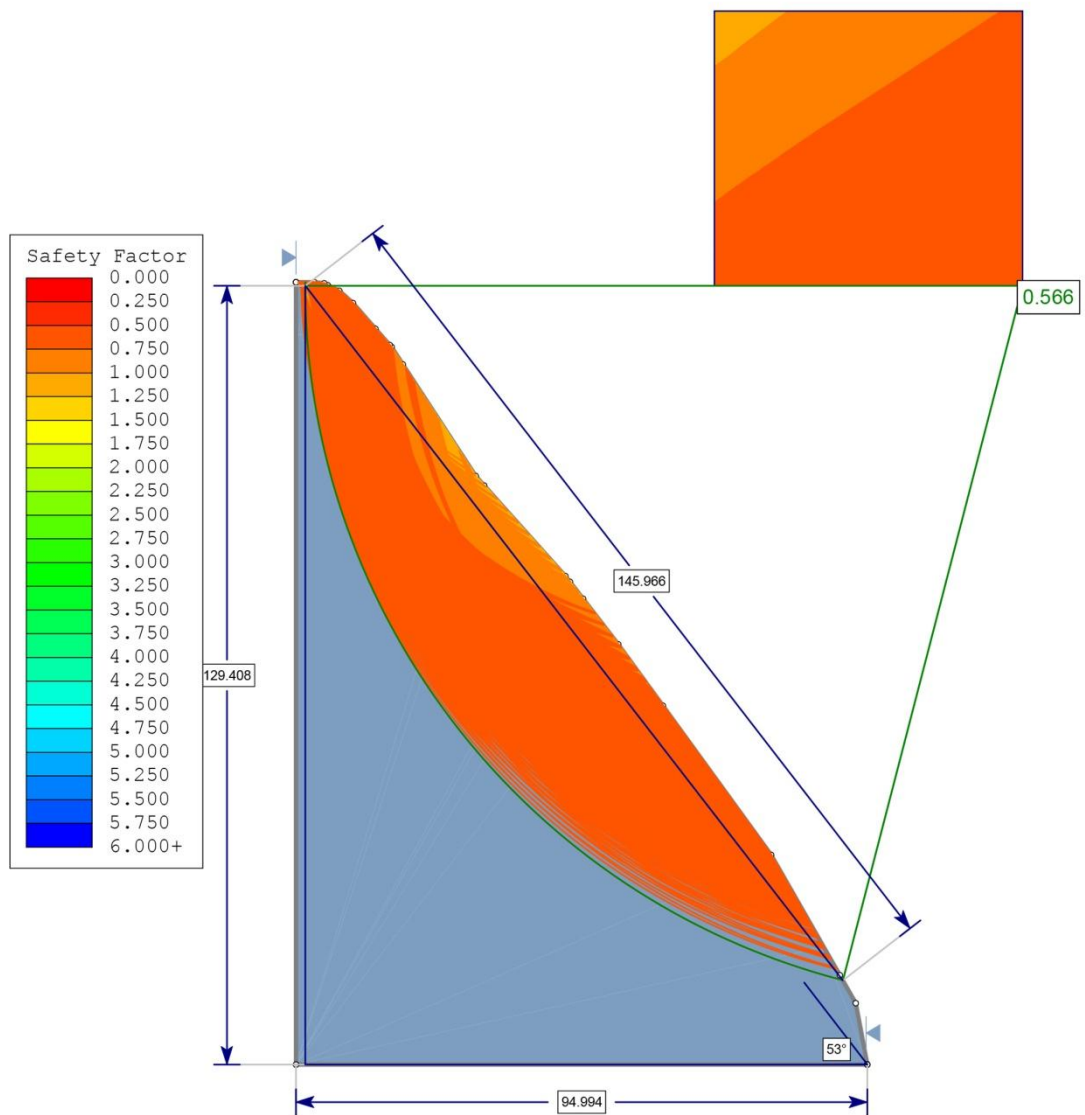
Fig. 4.43 Janbu Simplified Method of LEM Analysis for LS4

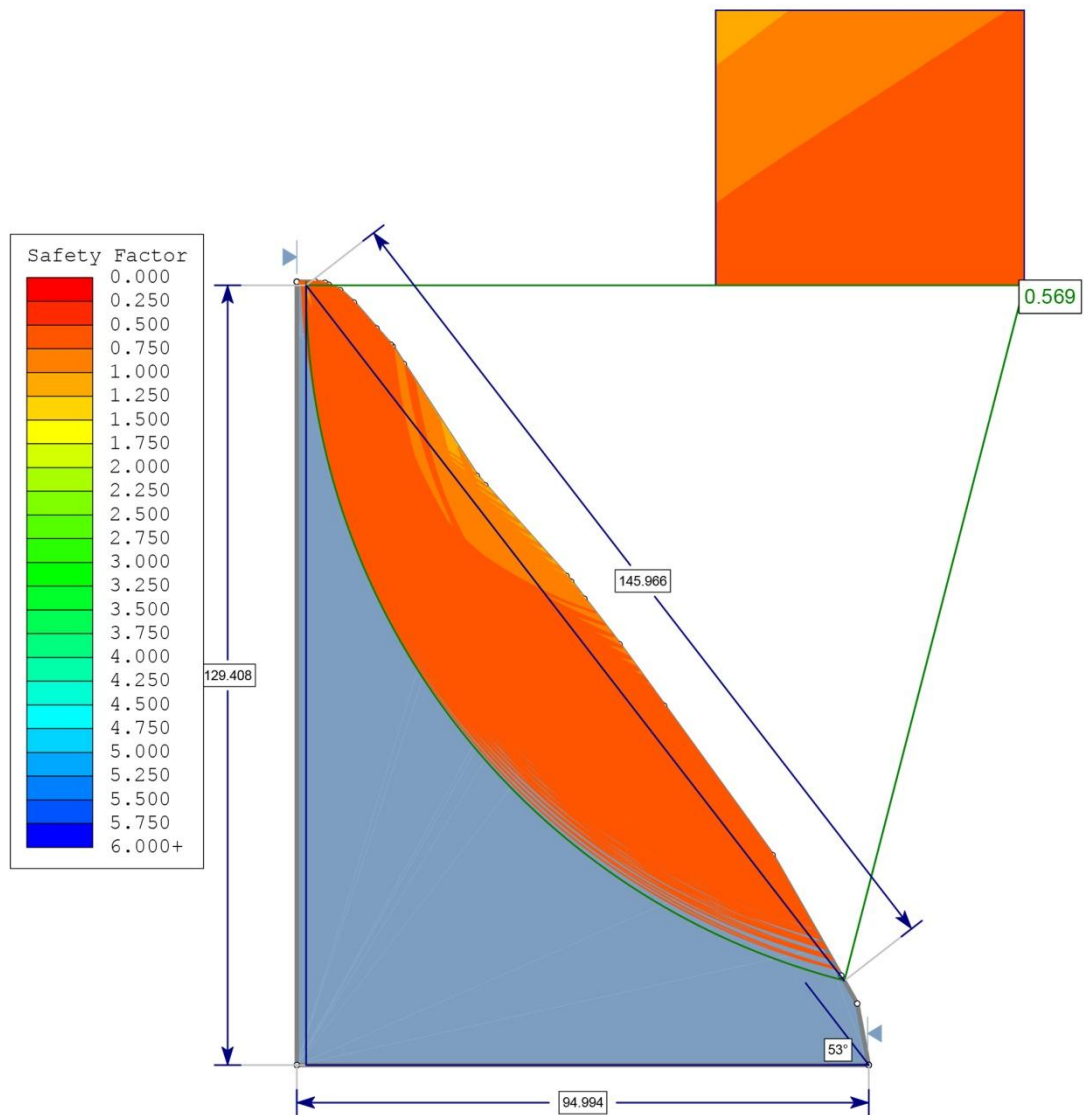
Fig. 4.45 Ordinary/ Fellenius Method of LEM Analysis for LS4

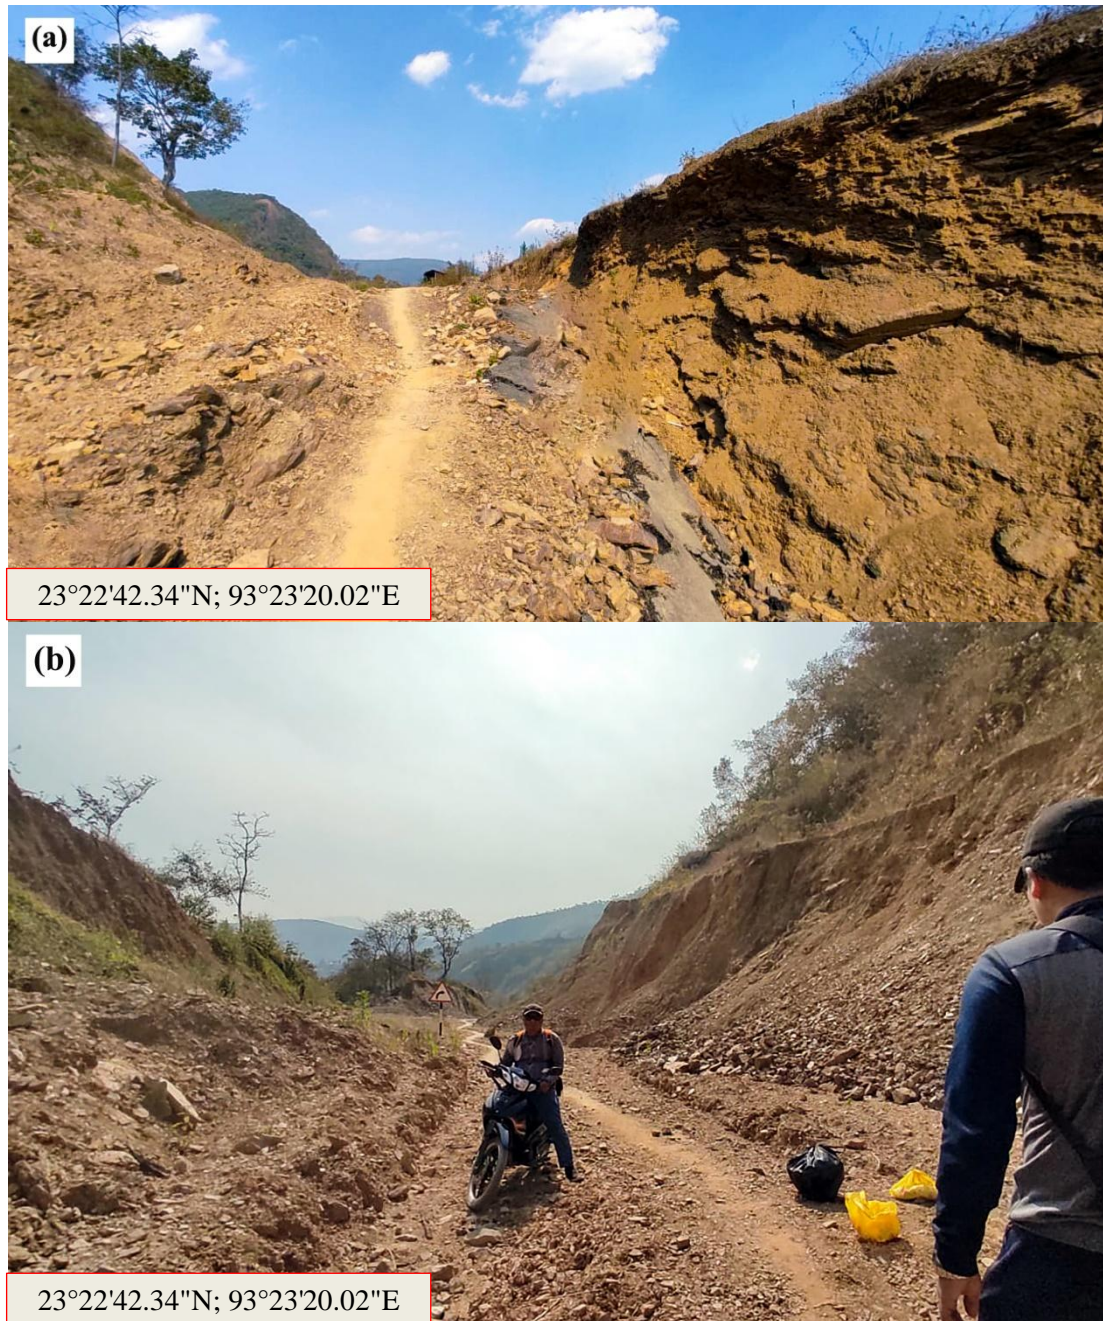
Fig. 4.46 Field Photographs of LS5

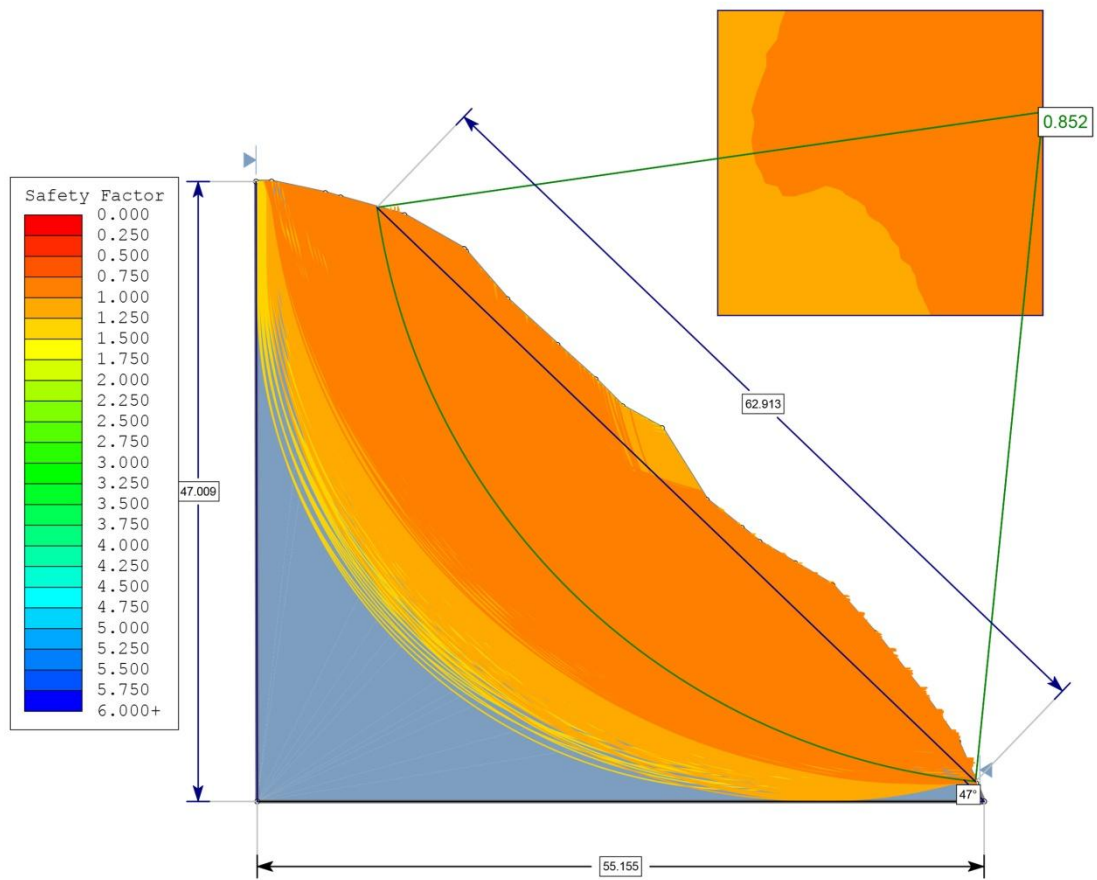
Fig. 4.47 GLE/ Morgenstern-Price Method of LEM Analysis for LS5

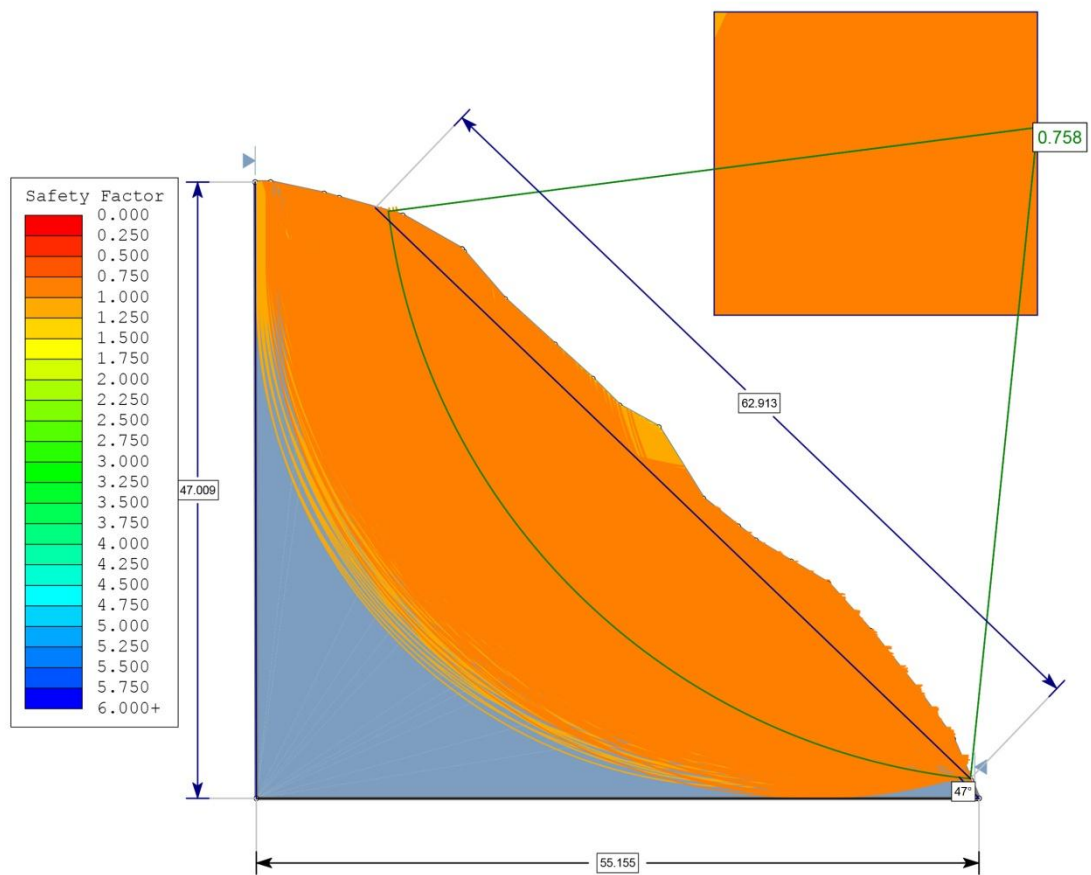
Fig. 4.48 Janbu Simplified Method of LEM Analysis for LS5

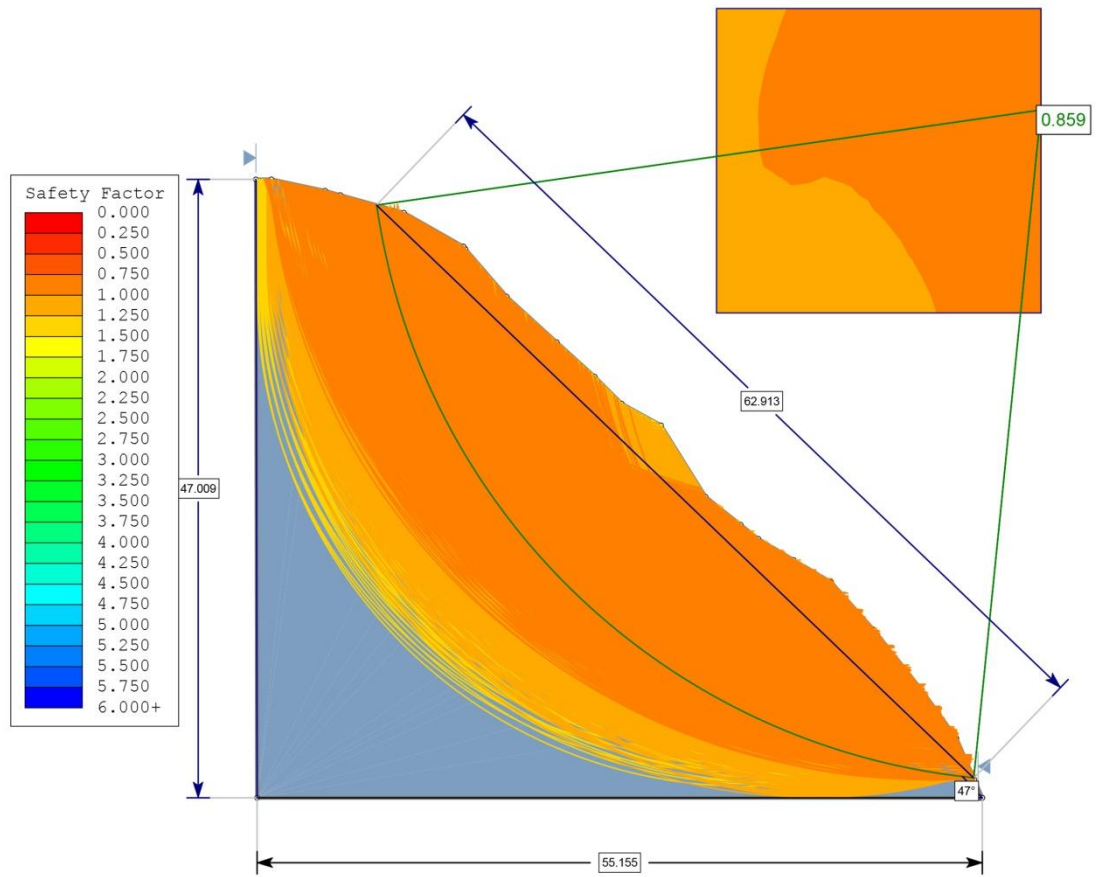
Fig. 4.49 Bishop Simplified Method of LEM Analysis for LS5

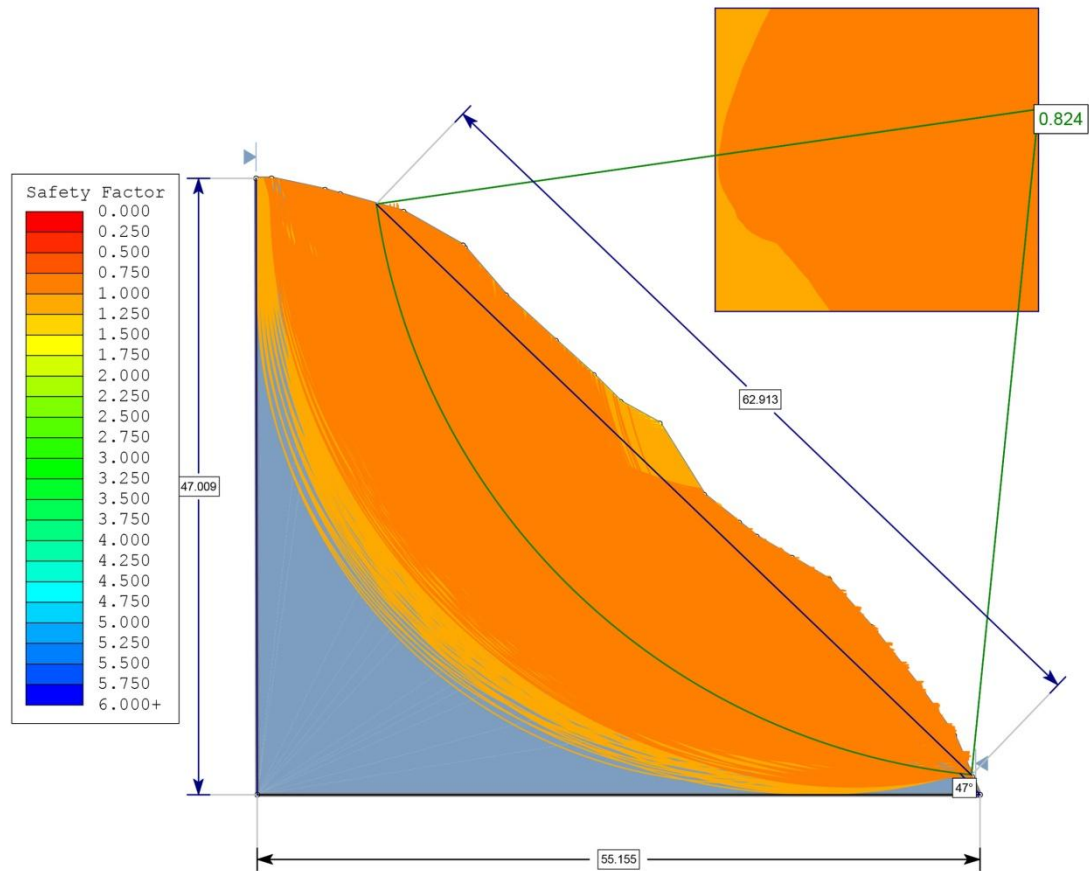
Fig. 4.50 Ordinary/ Fellenius Method of LEM Analysis for LS5

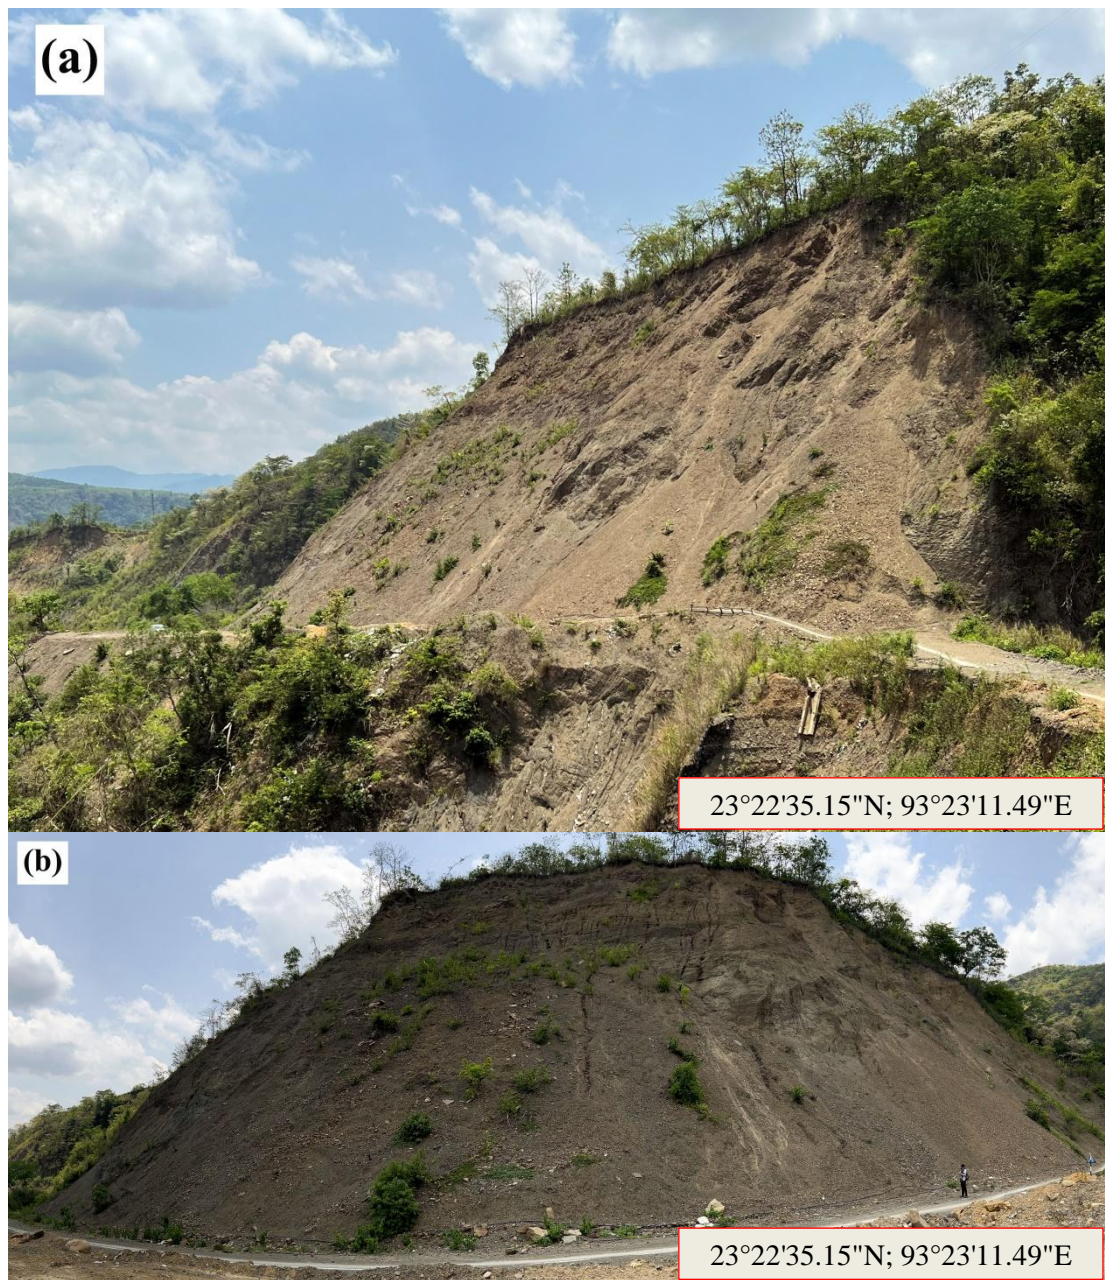
The construction of road for highway has been extended in the slope LS6. An overburden of thick colluvium covered the crown portion of the hill. A toe cutting at the mid-slope for the road destabilized the slope. It is a retrogressive landslide where sliding occur in a segmented failure manner. The dimension of LS6 is 112 meter width and 54.7 meter height. The average factor of safety obtained from different methods is 0.59. Figure 4.57 display the field photograph and figures 4.58, 4.59, 4.605, and 4.61 display LEM analyses using different methods.

Fig. 4.51 Field Photographs of LS6 (a) Side view of LS6 (b) Panoramic view of LS6

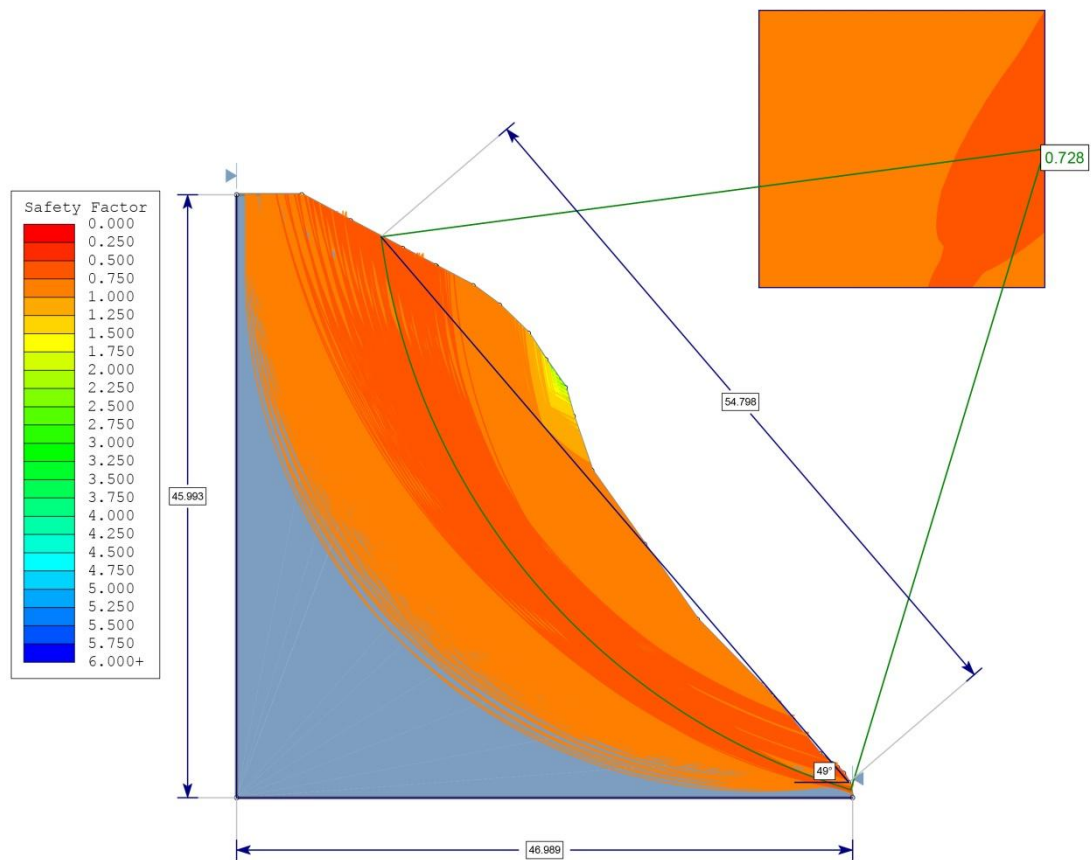
Fig. 4.55 Ordinary/ Fellenius Method of LEM Analysis for LS6

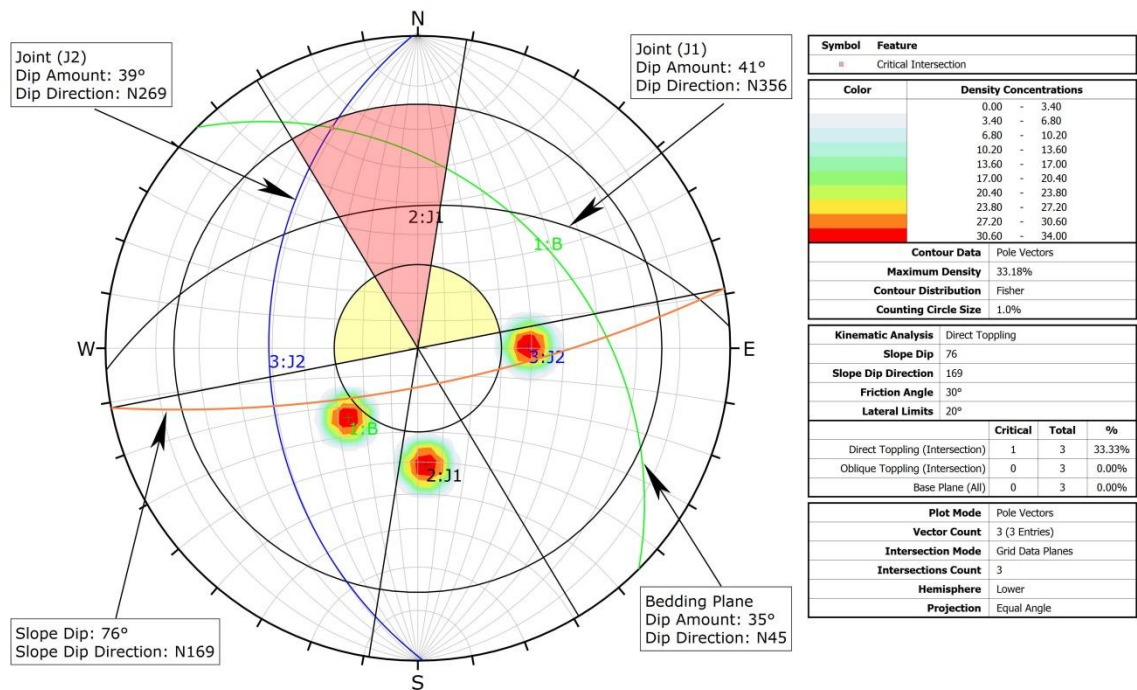
Fig. 4.58 Stereographic Projection showing the potential for direct toppling failure at S1

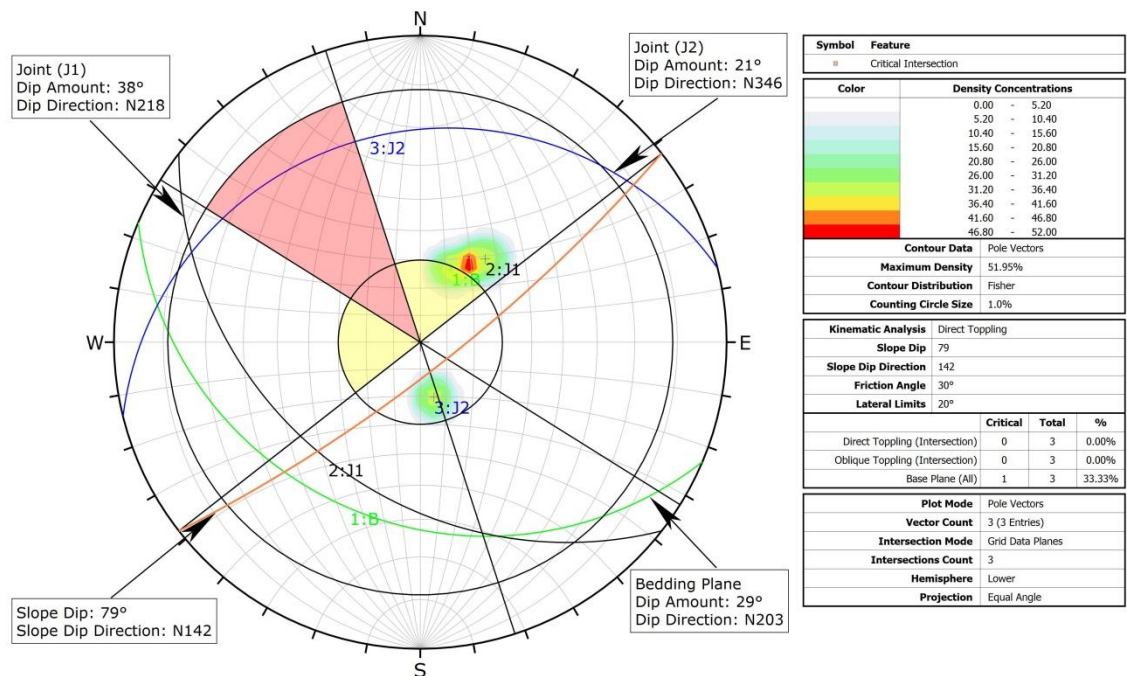
Fig. 4.59 Stereographic Projection showing the potential for direct toppling failure at S2

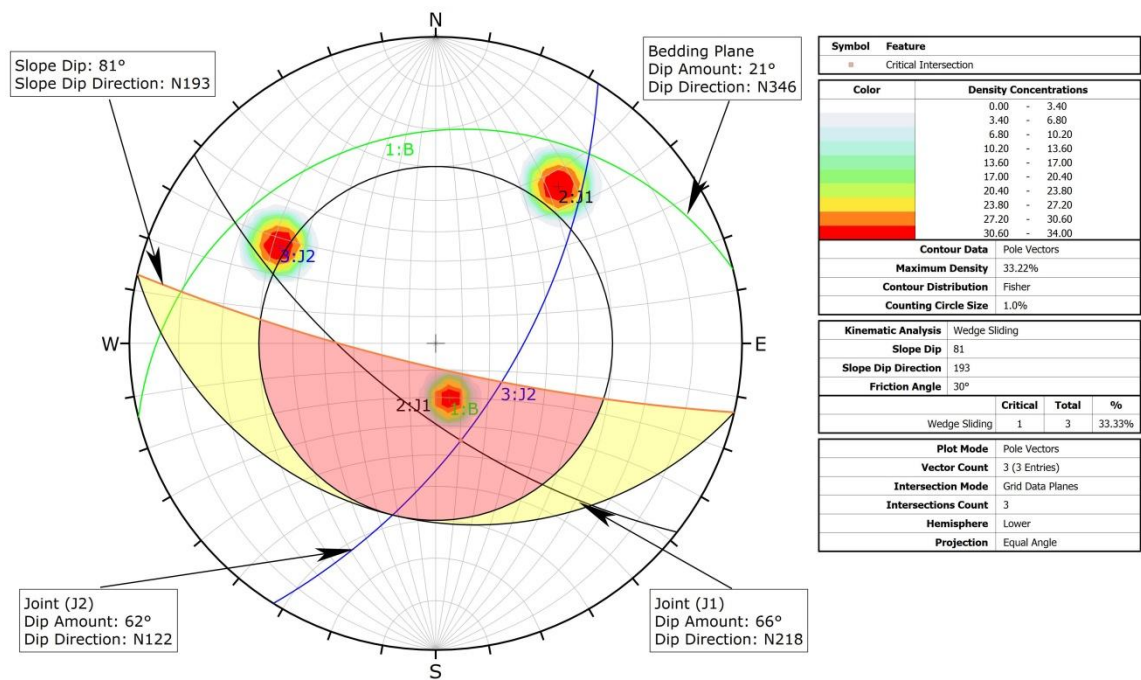
Fig. 4.60 Stereographic Projection showing the potential for wedge failure at S3

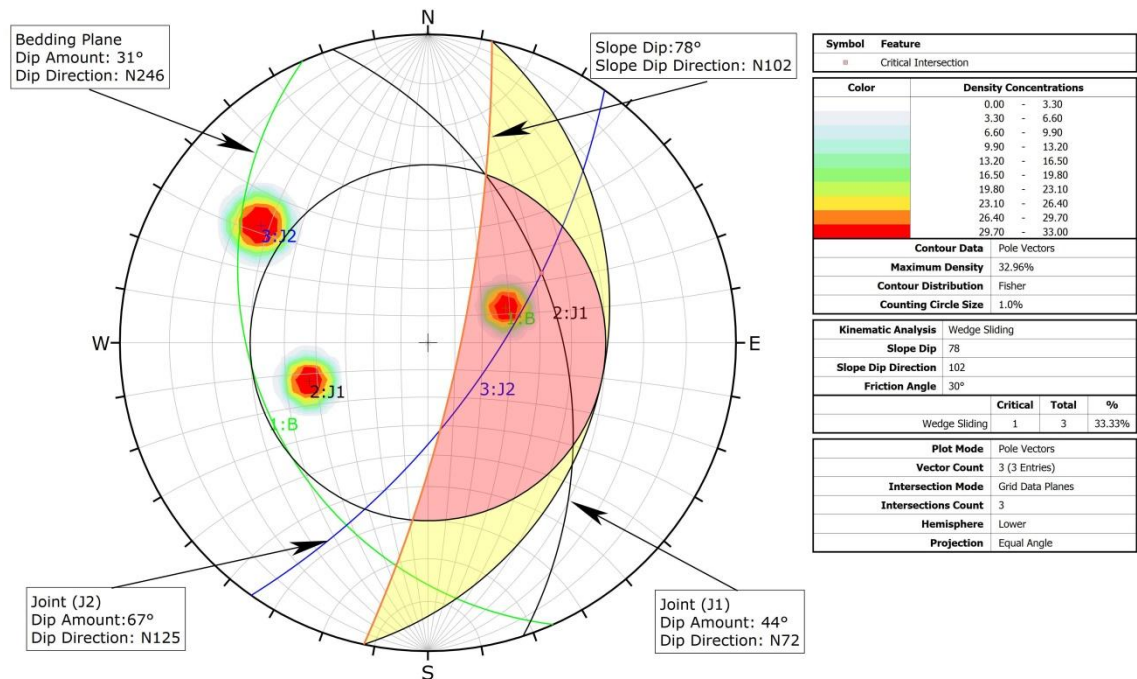
Fig. 4.64 Stereographic Projection showing the potential for wedge failure at S7

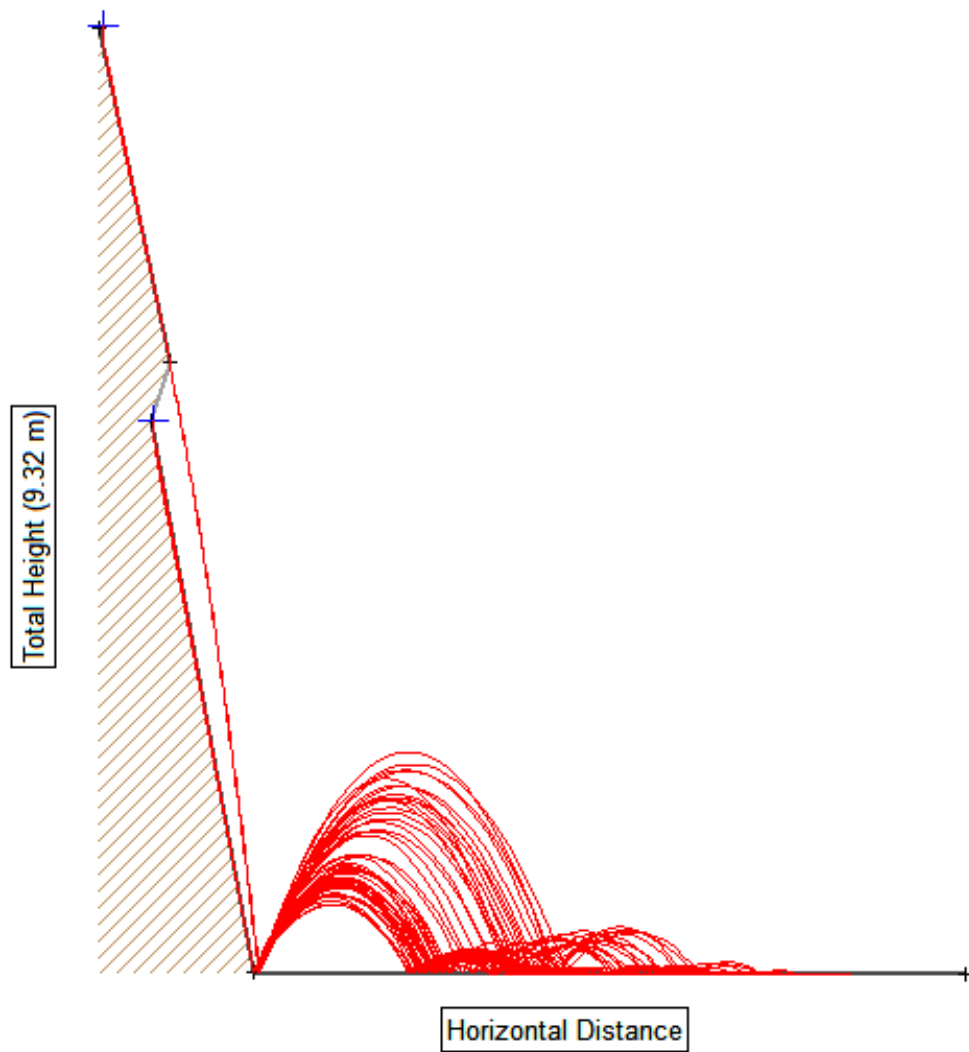
Fig. 4.66 Simulation of Rockfall trajectories detached from R1

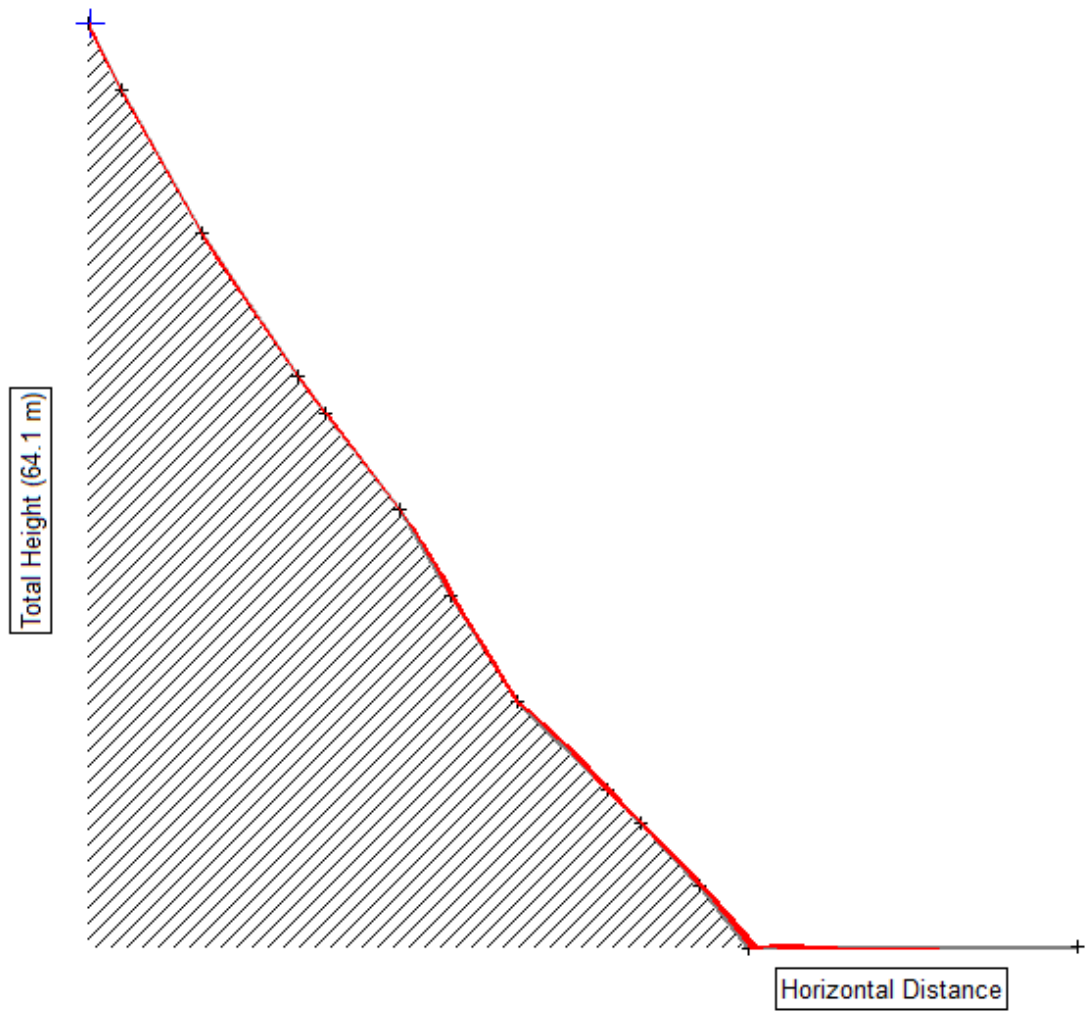
Fig. 4.68 Simulation of Rockfall trajectories detached from R3
