**DISASTER RISK ASSESSMENT AND ROCK MASS
CHARACTERIZATION OF STATE HIGHWAY FROM
CHAMPHAI TO ZOKHAWTHAR, CHAMPHAI DISTRICT,
MIZORAM**

**A THESIS SUBMITTED IN PARTIAL FULFILLMENT OF THE
REQUIREMENTS FOR THE DEGREE OF DOCTOR OF
PHILOSOPHY**

**CENTRE FOR DISASTER MANAGEMENT
SCHOOL OF EARTH SCIENCES AND NATURAL RESOURCES
MANAGEMENT**

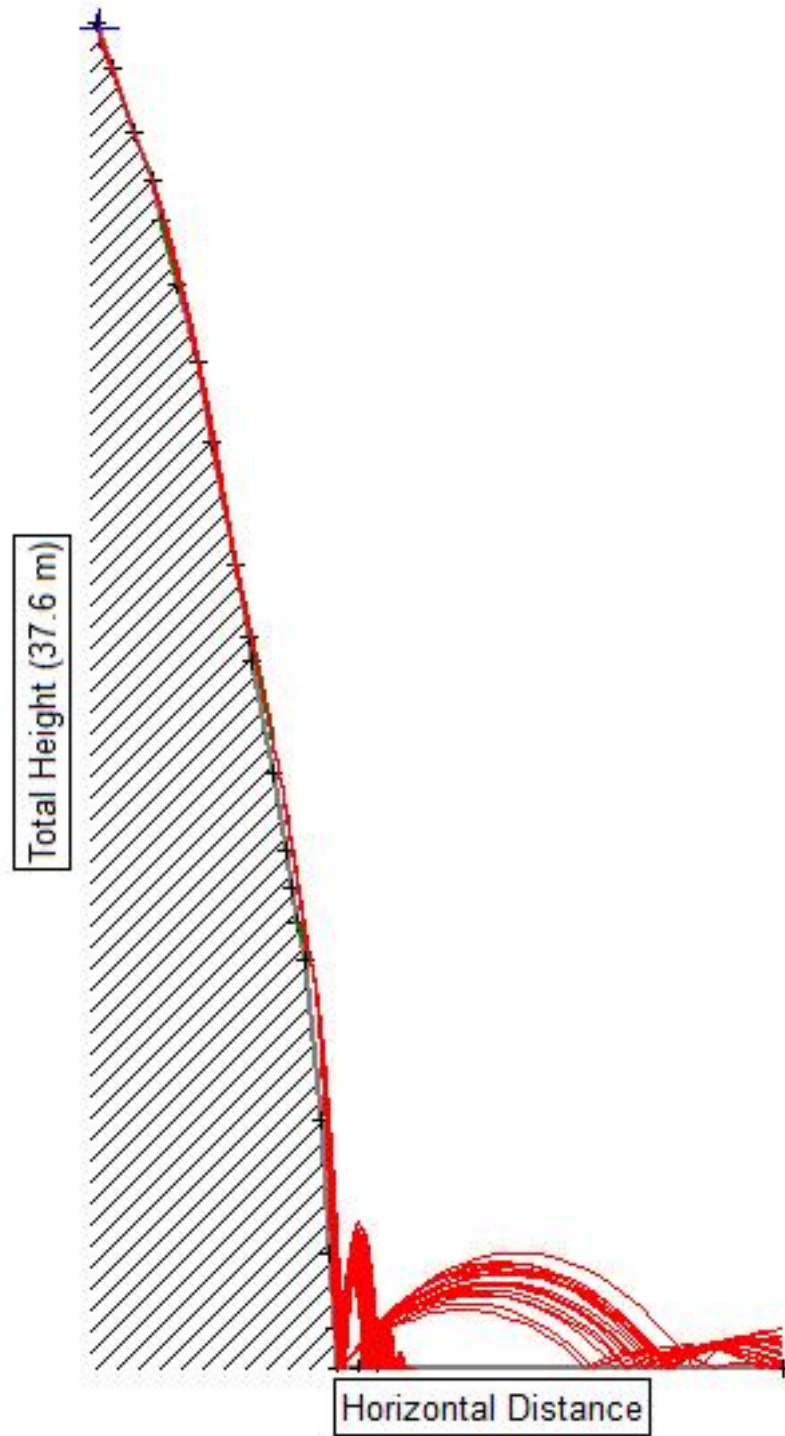
Fig. 4.70 Simulation of Rockfall trajectories detached from R5

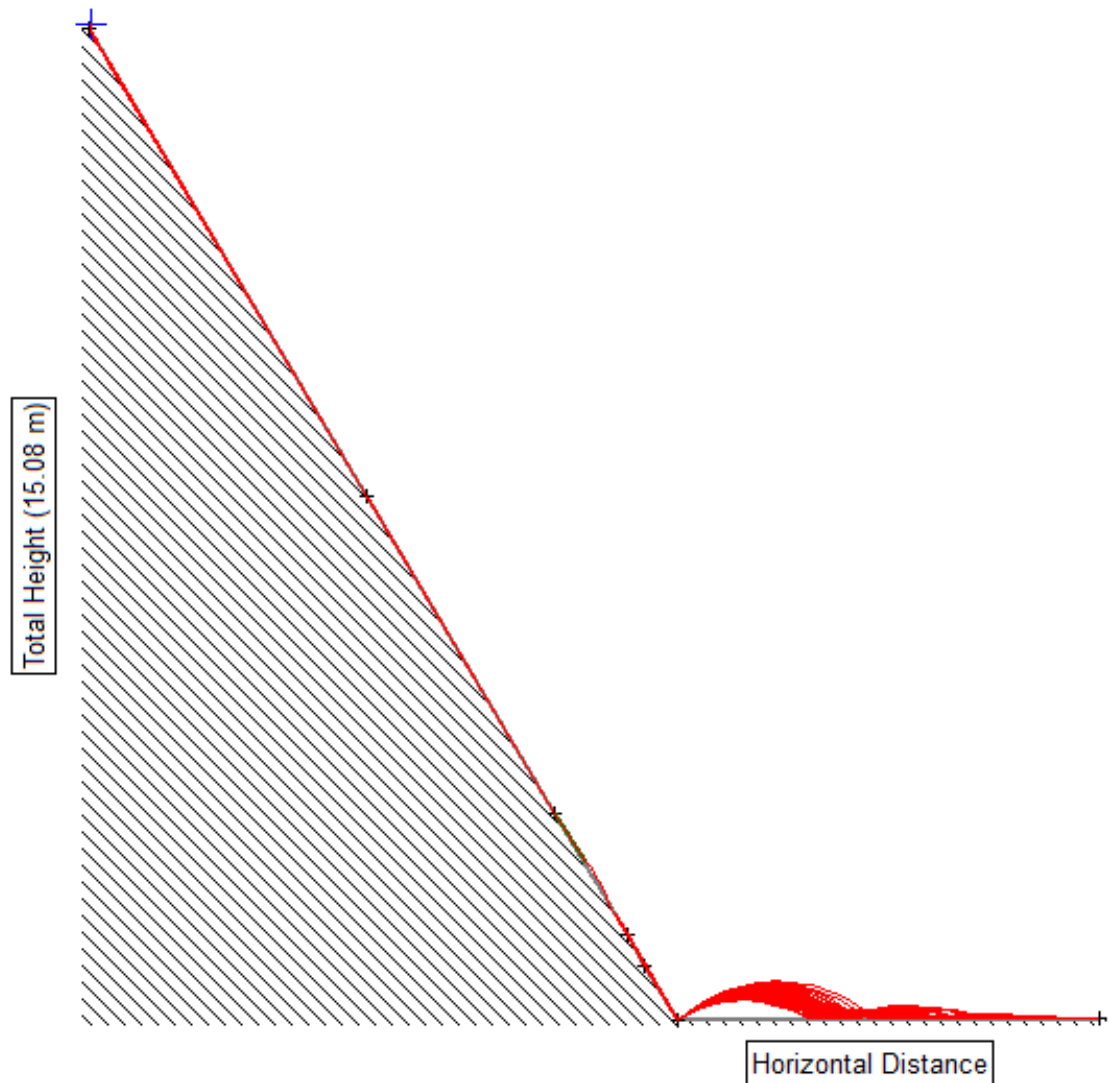
Fig. 4.71 Simulation of Rockfall trajectories detached from R6

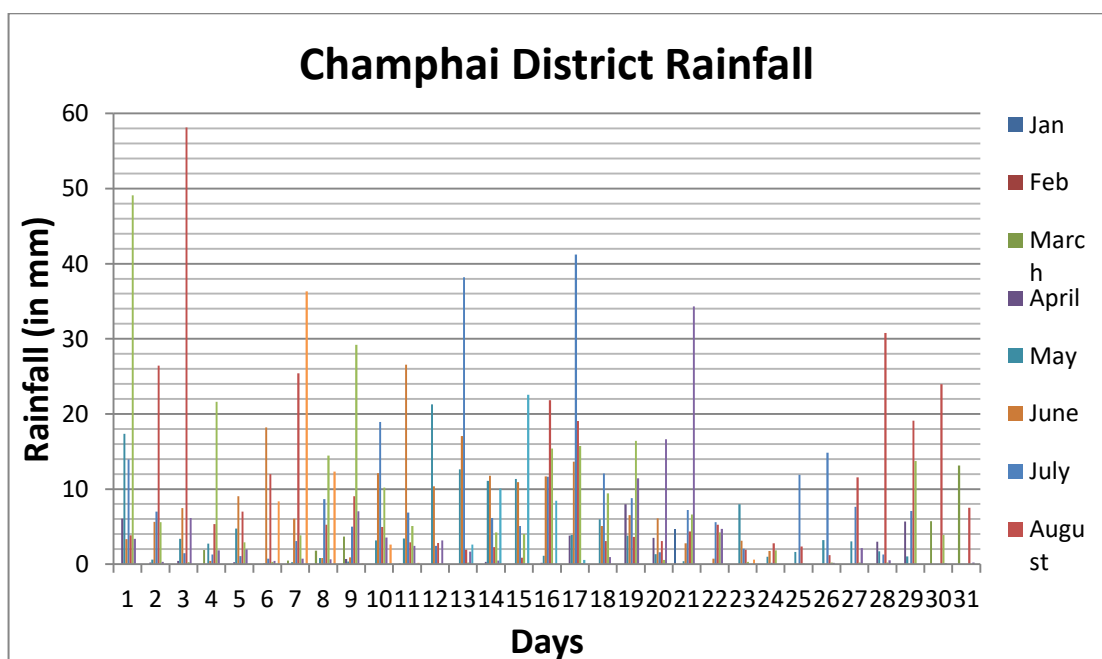
Fig. 4.76 Rainfall data of Champhai District in 2021

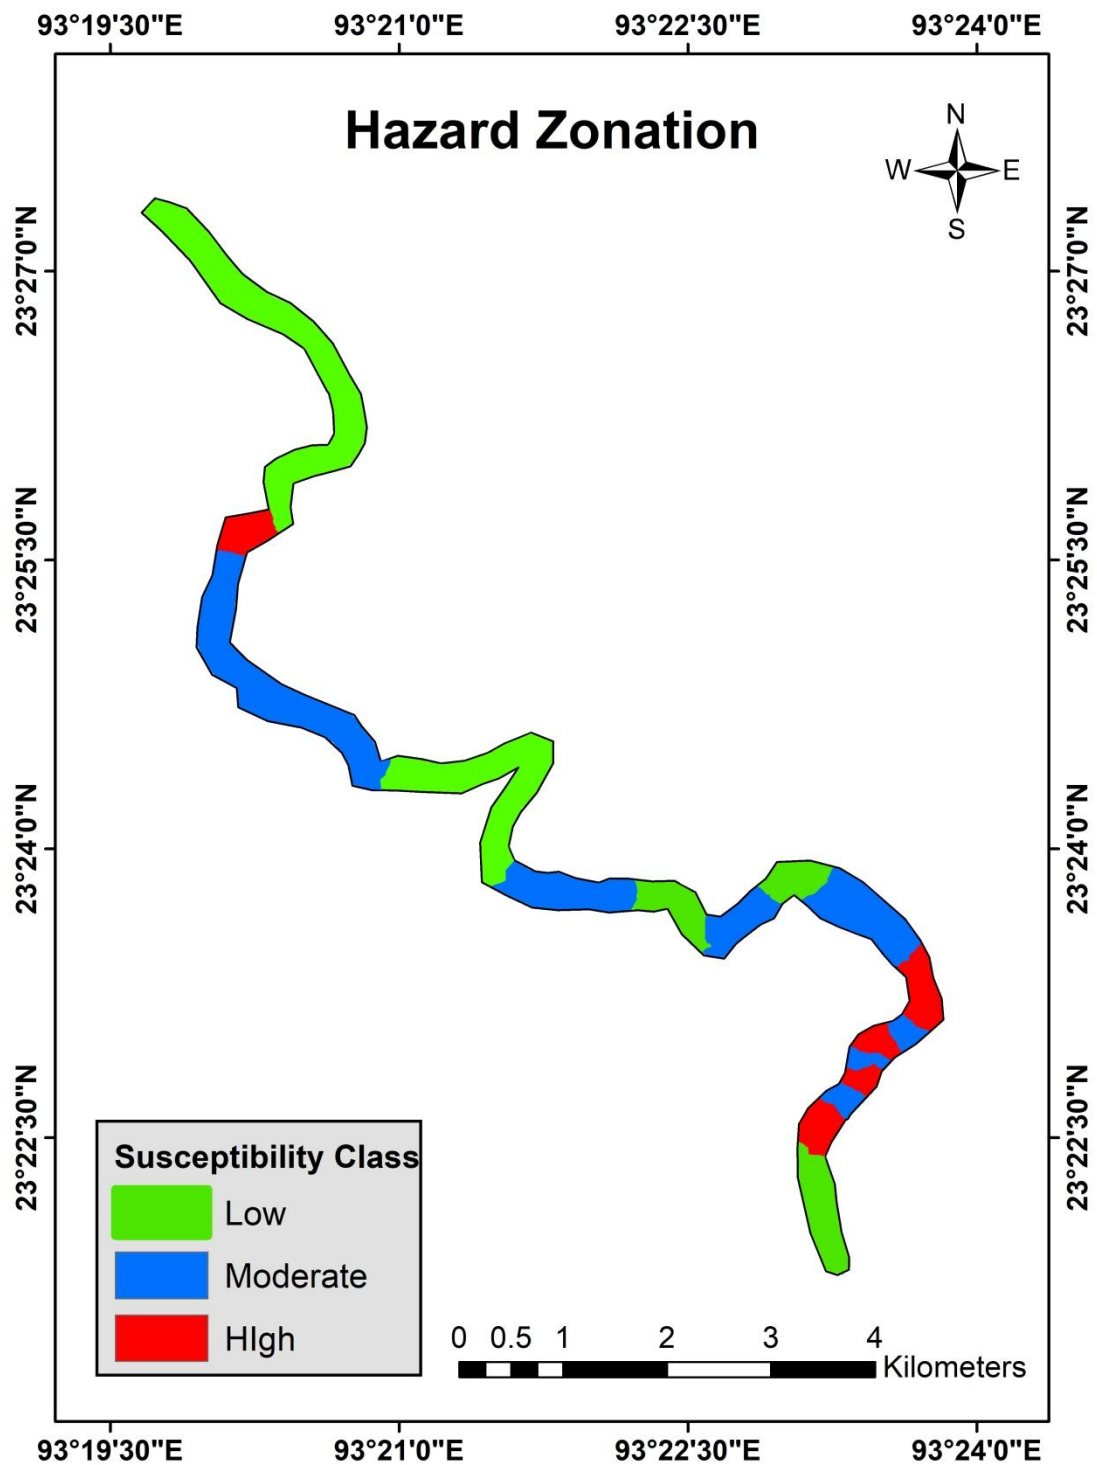
Low Hazard Zones: LS2 (partial), R2, S2 – relatively stable conditions with higher GSI/RMR and lower failure indicators.

Fig. 4.77 Hazard Zonation Map of study sites

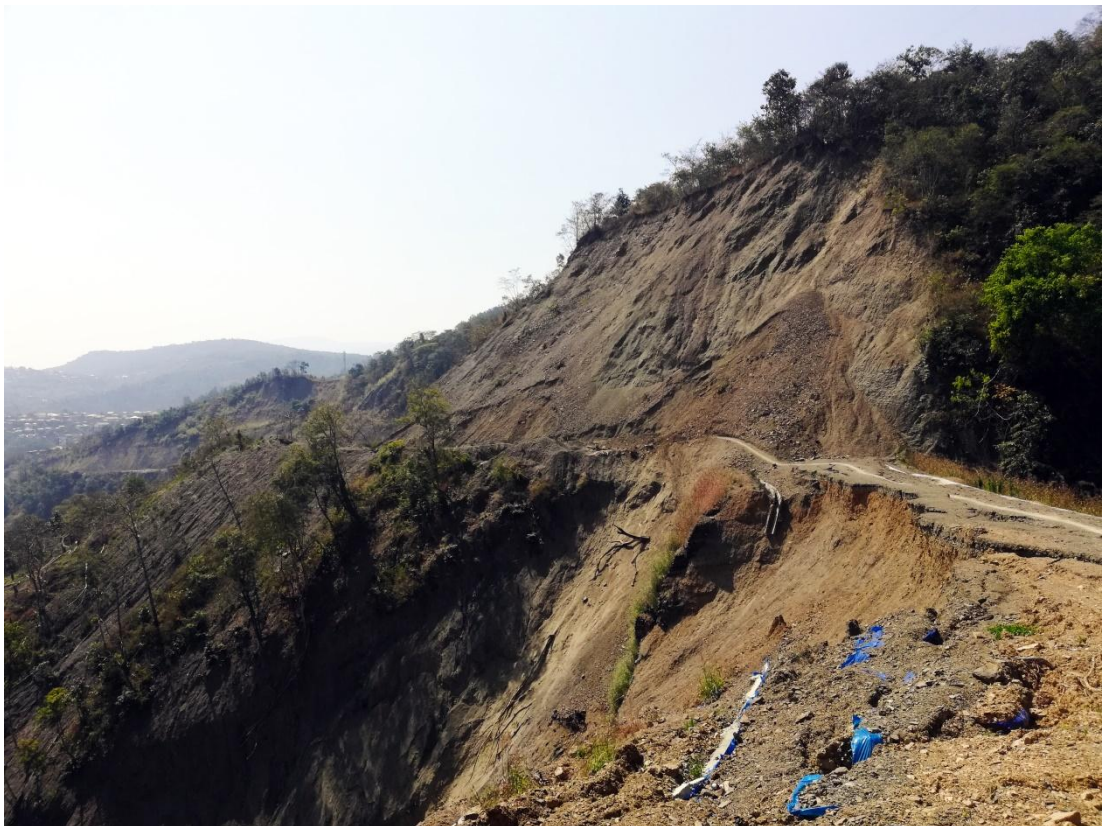
Fig. 7 Retaining wall collapsed due to slope failure

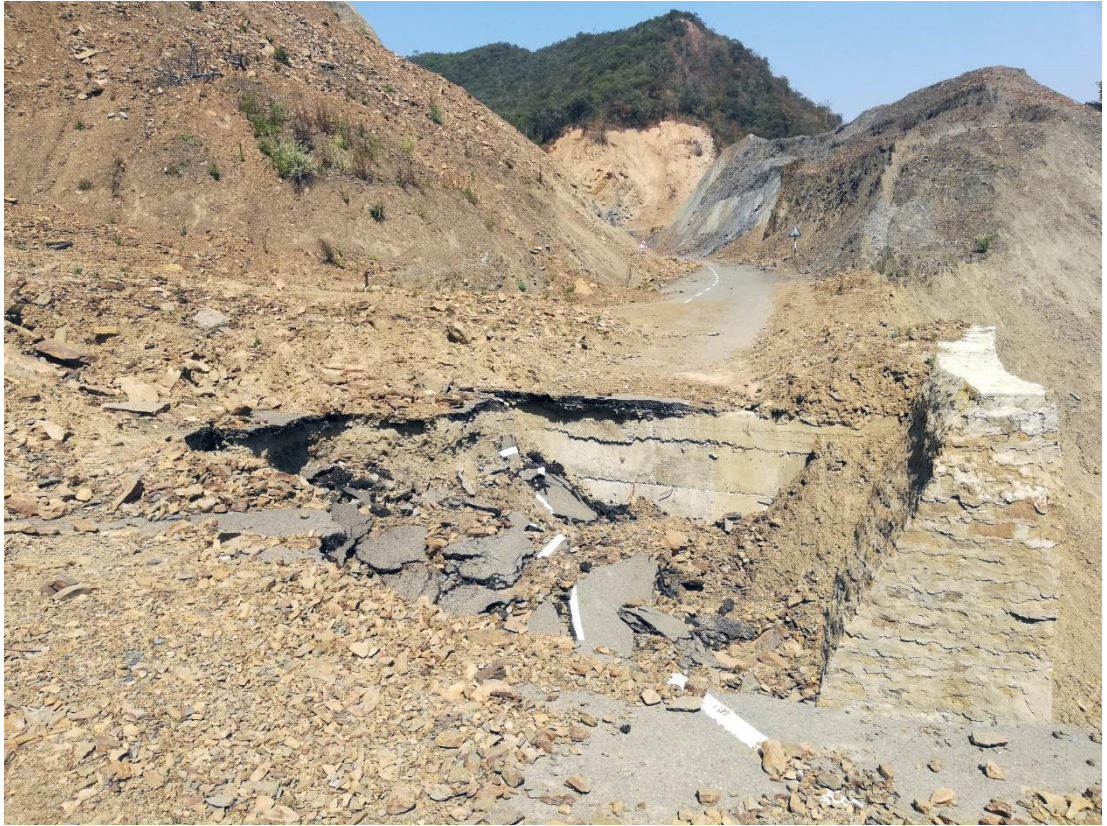
Fig. 8 Road, Curvert and Retaining collapsed

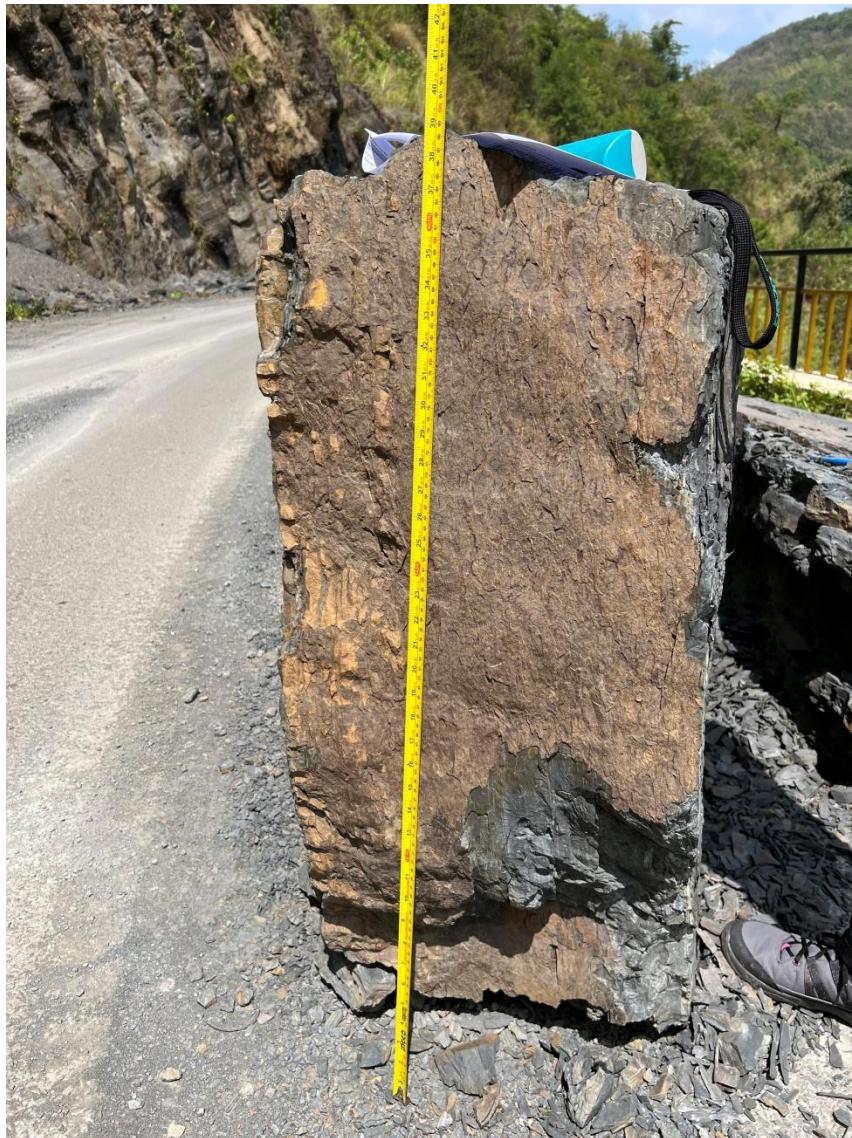
Fig. 16 Block of rock that detached from the slope bounced across the road
